**U.S. Army Corps
of Engineers**
Engineering and Support
Center, Huntsville

Child Development Center, Infant/Toddler (Medium Size)

**Building 4021
Fort Riley, Kansas**

**ESTR - Phase I (Project Review)
Project No 68850**

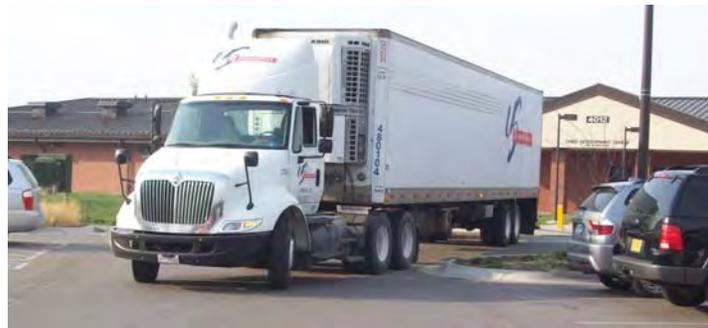
A large amount of site work was required to prepare the site for this facility. Due to its location (sits on top of a hill), it was not possible to provide an access drive to the mechanical room and kitchen. A road, separate from the parking lot was provided for busses and deliveries. However, the team saw that the 18-wheeler for the kitchen just blocked the parking lot to unload.

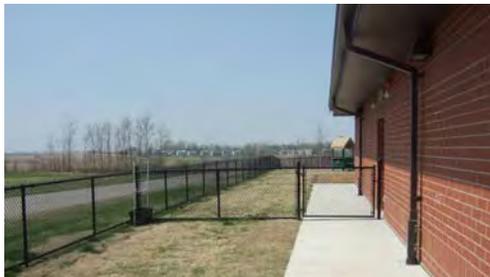
- The playgrounds are not flexible enough for the various age groups, especially when rooms are reconfigured. Sometimes groups have to walk through other spaces or around the building to get to an age appropriate playground. This has been the subject of several parent complaints.
- The location of the fencing for the playground does not follow the current standard. Installation personnel are concerned that the fence around the playground should have been taller due to its location next to a busy street and the woods.

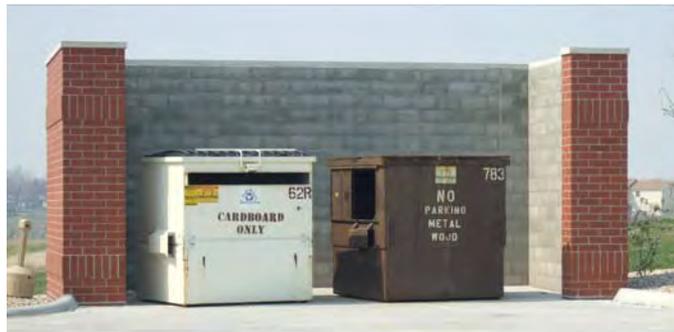
- Sod would be preferred over seeding because of how quickly the building opened and the fact that the outdoor area is an integral part of this facility. Playgrounds need to be ready when the facility opens. It has been a year since the facility opened and the seeded grass is still not fully established.
- The dumpster screen provides no real screening from the facility, the parking area, or the main entry road.

- The placement of sod in the playground turf areas should be recommended.

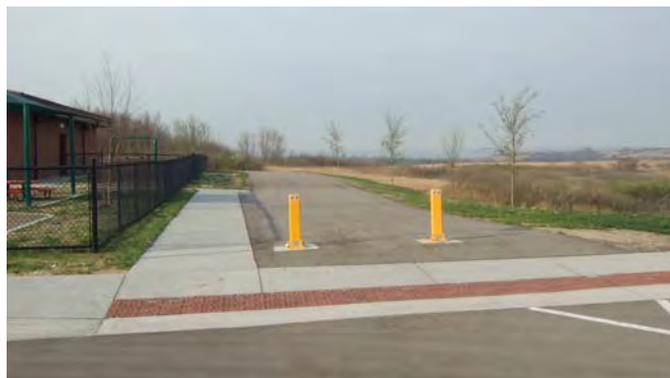
- The fire lane around the facility had removal ballards to prevent entry however there were no curbs or fencing adjoining the lane; traffic could easily drive around the ballards.

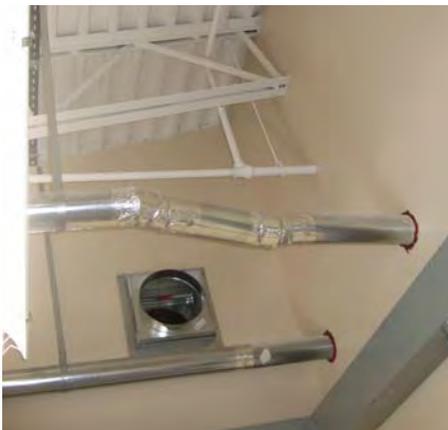
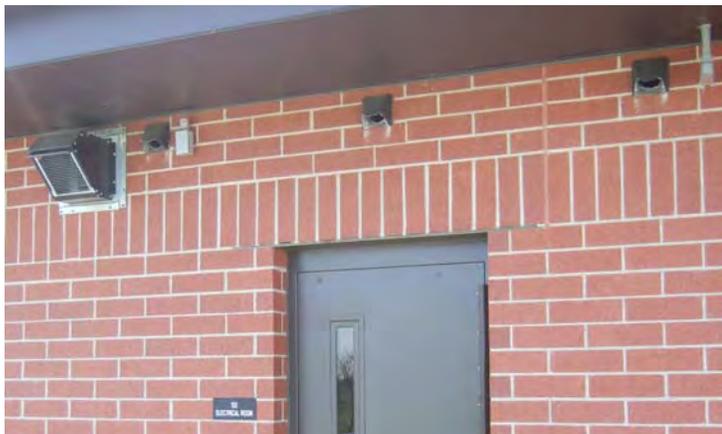
- The laundry room in this facility is not located on an exterior wall. The dryer vents have a number of bends in them as they pass through the electrical room to the exterior wall. This causes a fire concern with built up lint, and they are constantly cleaning the vents.

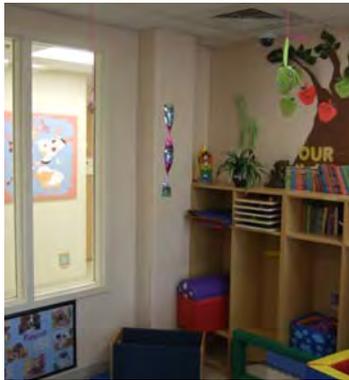
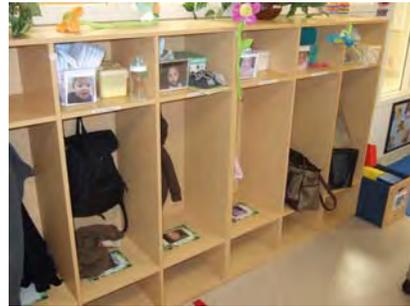
- Some of the infant rooms cannot accommodate 2 groups of toddlers as planned in the standard design. This is due to the dimensions of the room, location of the door, and the kitchen area. In addition, evaluators noted that columns occurred within the spaces, and that the cubbies were larger than allowed for in the standard.

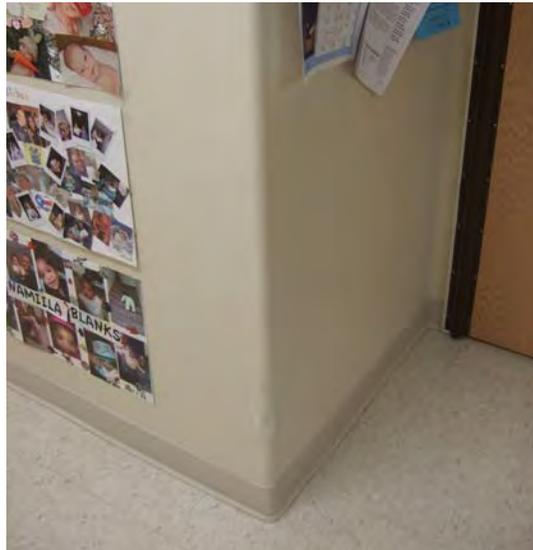
- Corners on the walls are rounded, which is great for safety, however, the corners are damaged easily. Standard corner guards will not work since the corners are rounded. The construction contractor needs to be responsible for corner protection that is appropriate for the corners he constructs.

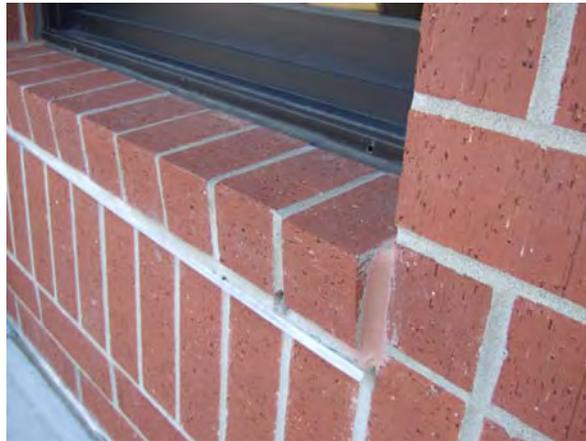
- Ceiling grid in active play room has come down a couple of times. Could either be from play or from the wind. They have issues with wind blowing rain in under some of the doors. They also had a roof leak one time from the blowing wind. In addition, the ceiling of the active play room was between 8' and 9'.
- Training Room and Break Room are too small for the staff of 61 - 70. Their staff at this point is 61 caregivers.
- Intercom system cannot be heard in kitchen (cannot hear phone buzz). Also cannot hear PA system on playground. Need to have intercom phones in each playground so that they do not lose ratio on the playgrounds if someone needs to call for help.
- Metal flashing under windows and around base of building is a safety hazard to children. The sharp corners need to be corrected.

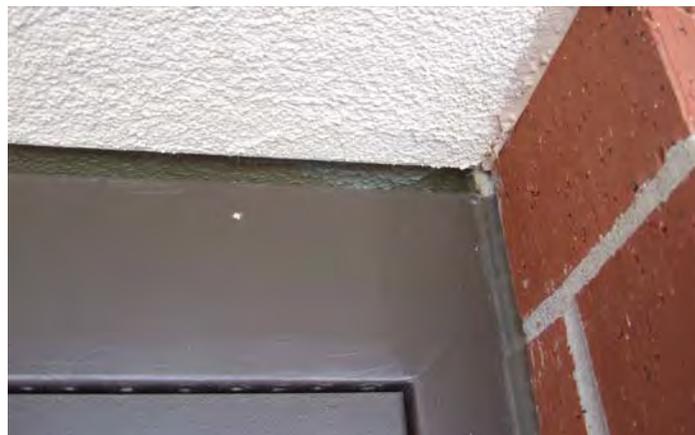
- The exterior door from the corridor to the playground on the infant/pre-tod/toddler end of the building has a unsealed gap above the door frame. This does not occur on the door at the base of the “T”.

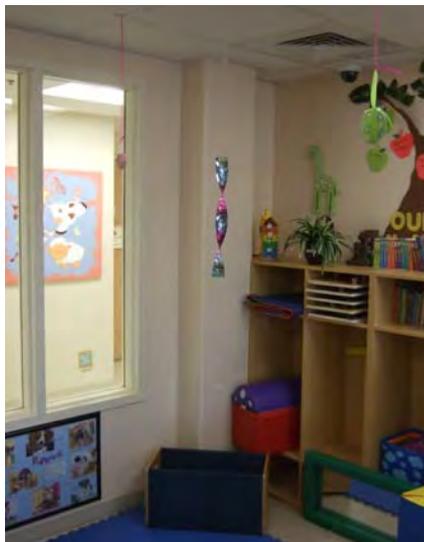
The only structural issue discovered during the visit had to do with the impacts of the structural columns in the spaces. The internal columns take up space in the activity rooms and cause safety hazards in the Active Play Room.

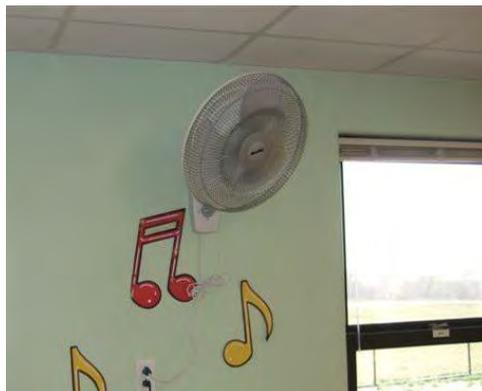
- The office and reception areas have been described as being “stuffy” by their users.
- The Video Room cooling load appears to have been underestimated. The equipment located in that room has shut down due to overheating. The Director frequently checks the equipment to ensure that it is operating.
- The HVAC system adequately handles the heating and cooling loads for most of the classrooms. Transitional Care – Room 148, however, overheats in the summer. The staff working in this room have mounted oscillating fans on the walls in an attempt to maintain more comfortable conditions. The fans were in operation during our visit. The classroom was warmer than the other classrooms in the building.

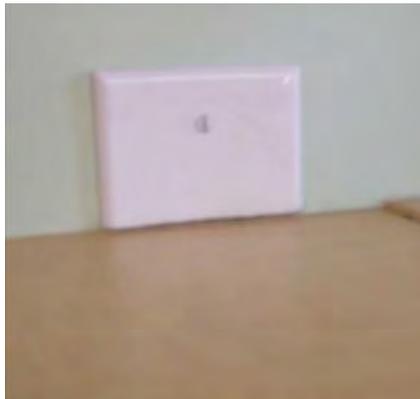
- The receptacles in several of the children’s rooms were partially covered up by the larger than stated size of the cubbies in the design. The cubbies were closer to 15” in width versus the design of ~9” width. This caused the cubbies that were also 54” tall to half way cover some of the receptacles. The solution in the field was to cut the covers in half and mount the half cover to the box. This is an NEC NFPA 70 section 406.6 and 406.6(C) code violation. The contractor should have modified the cubbies, or moved the receptacle to allow for its intended function, or removed the receptacles and patched the wall. The architect will verify the size of the cubbies was nonstandard so as to not have this issue again.

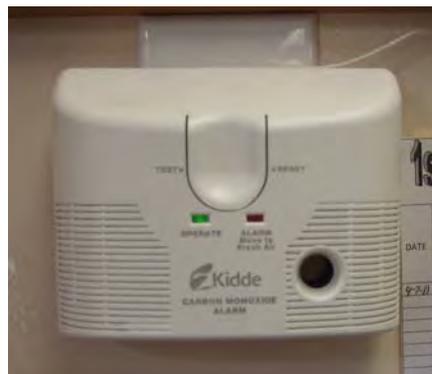
- Carbon monoxide detectors were required in the project and the solution was plug-in type in the receptacles. This method of not hardwiring the CO detectors was allowed within the contract and is not unacceptable according to UFGS 28 31 49 Carbon Monoxide Detectors. This was not a desirable method for the user and should have been hardwired.

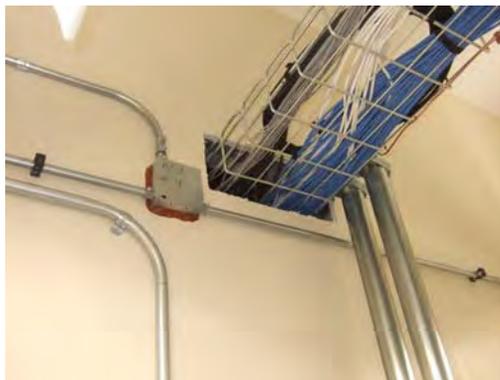
- The communication room 141 should have had a fire rated penetration for the communication cabling.

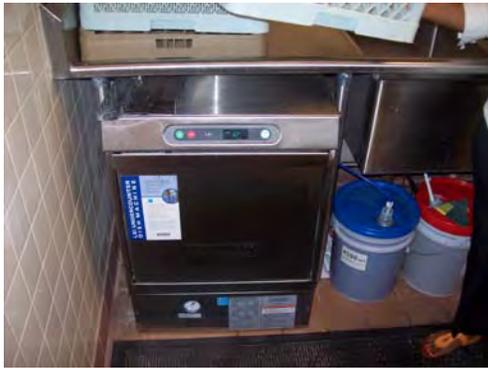
- Kitchen set up is small; storage is inadequate; original range had no oven, had to buy new; had to buy separate oven to keep up with demand; kitchen sink capacity is inadequate. The dishwasher in the kitchen does not serve the capacity. It only holds 1 tray at a time, and the length of the cycles requires this to operate nearly continuously. In addition, there is no vent for the steam from the dishwasher, and this results in the steam activating the smoke detector in the kitchen. To remedy this situation, the exterior door of the kitchen must be kept open.

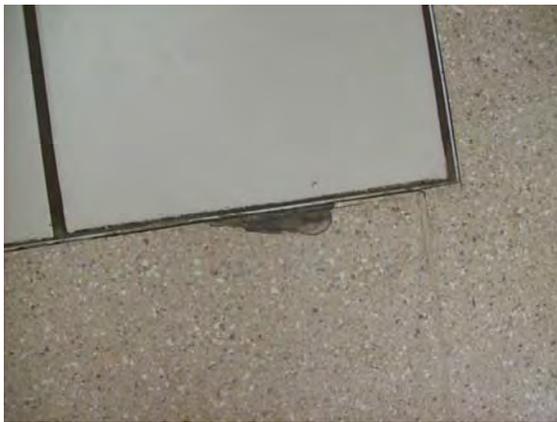
- Some durability issues with the sheet vinyl floor in the activity rooms. In one room it is coming up adjacent to the tile floor of the toileting area.

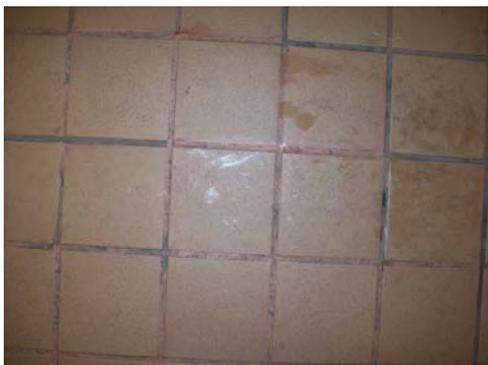
- Grout in quarry tile floor in kitchen is extremely discolored. At one time someone tried to “paint” the grout. It seems that the grout was not sealed when installed.

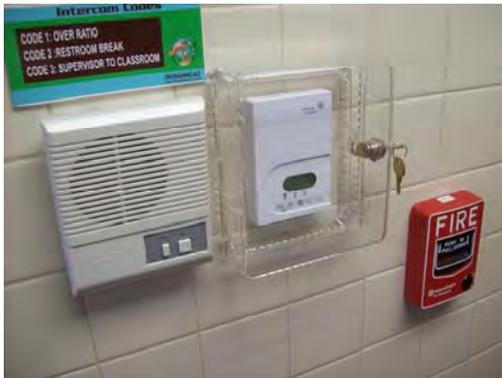
- The air conditioning is the largest problem with the facility. The facility administrators stated that they feel the load is too much for the air conditioning system that is installed; it is too small. Activity Rooms may be either too hot or too cold, as well as higher humidity levels. The facility administrators stated that the humidity issues were very noticeable in the Infant and pre-toddler rooms. Kitchen air conditioning goes out every 2-3 months.
- Each classroom has its own thermostat, but they are locked. There is no HVAC sensor at 1' A.F.F. Thermostats are located right next to return grills.

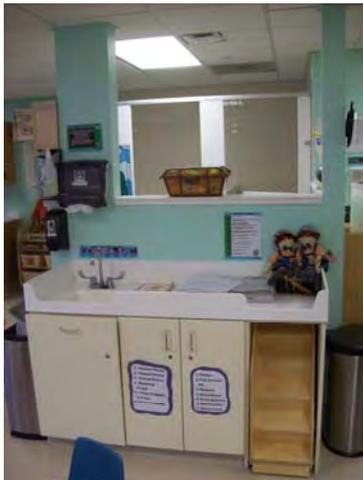
- Exhaust was not provided above the diaper changing table except in one room. In that room, then there was no exhaust above the toilet area. In the other rooms, the exhaust fan was basically above the lavatories in the toileting area.

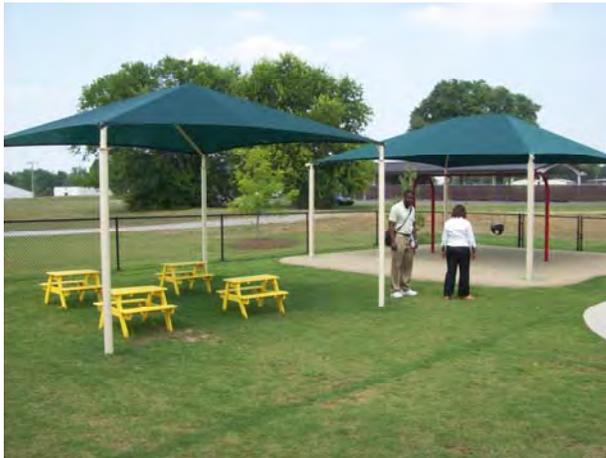
- Resilient surfacing in playground is starting to crack and crumble in some areas. Not sure if its from children picking at the little pieces.
- Infant/Toddler playground was provided with a shelter over the grass area with nothing under it. They have placed picnic tables under it.

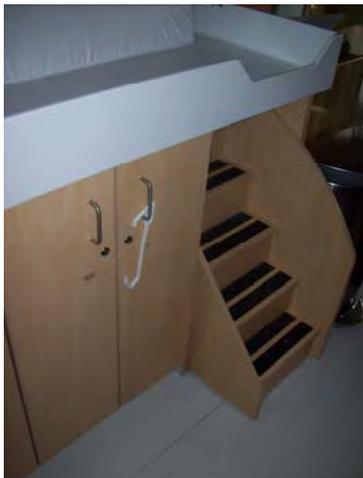
- Steps on diaper changing stations do not recess fully into the cabinet. This reduces program area and creates a safety hazard. Need to ensure standard requires steps be fully retractable.

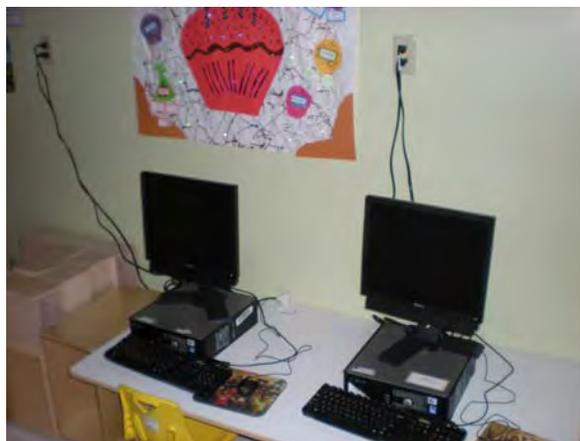
- The kitchen was having similar issues with the circuited receptacles on circuit 41 of RP-1. I was unable to verify the reason for overloading of the four receptacles on the circuit.
- Computers could only be located at one location in the kindergarten rooms due to the amount of plugs. This will continue to be an issue unless the computers are placed on separate desks or a comparative surge protector with multiple plugs is utilized. The room-by-room indicates four outlets are to be evenly spaced along these pertaining walls.

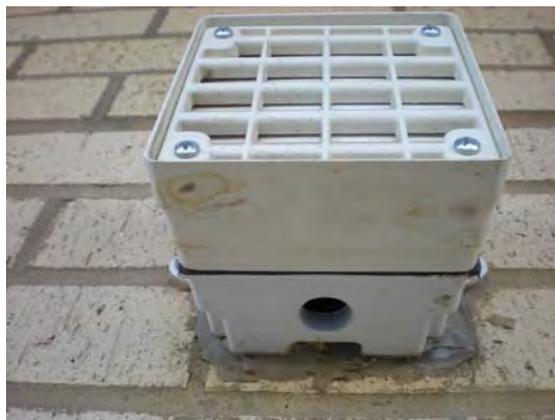
- Exterior telephones were located along the wall within the play areas. One exterior wall telephone was located on drawing T-103, but must have been modified to be placed in two separate locations centralized in each play area.
- Speakers are mounted on the exterior walls of the building as shown on drawing FA-101 and have the bottom conduit hole left open. These holes should be plugged using a conduit plug from the wall box manufacturer and installer of the intercom system.

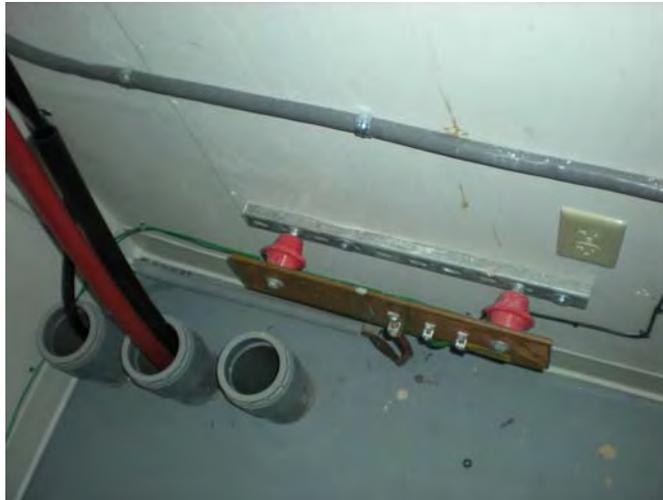
- Conduits should have been sealed in accordance with specifications 33 70 02.00 10 Electrical Distribution System Underground 3.7.1.2 Sealing indicates the conduits should have a sealing compound applied. For the empty conduit, 26 20 00 Interior Distribution System 3.1.4.7 Stub-Ups indicates a plug should be provided where no equipment connections are made and 3.1.3.1 indicates a pull wire should be provided in empty conduits. Ensure the empty conduit and open conduits are sealed properly to keep gases from entering facility.

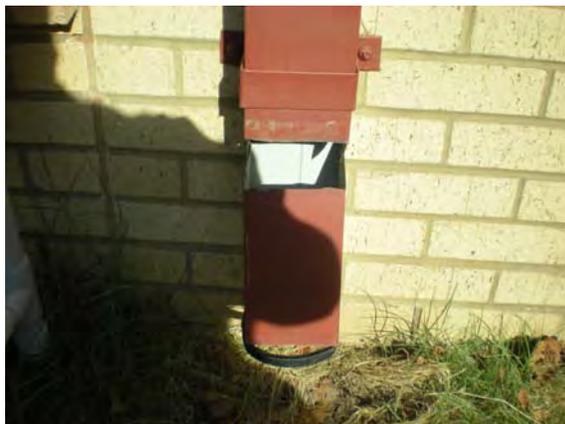
- The screws had come out of the bottom section of some of the downspouts. This one has lost both screws. Also the plastic band that had been placed on the downspout was coming off in several locations. They need to be reattached and in a more permanent way. Also there were no splash blocks under some downspouts causing erosion and possible structural issues over time.

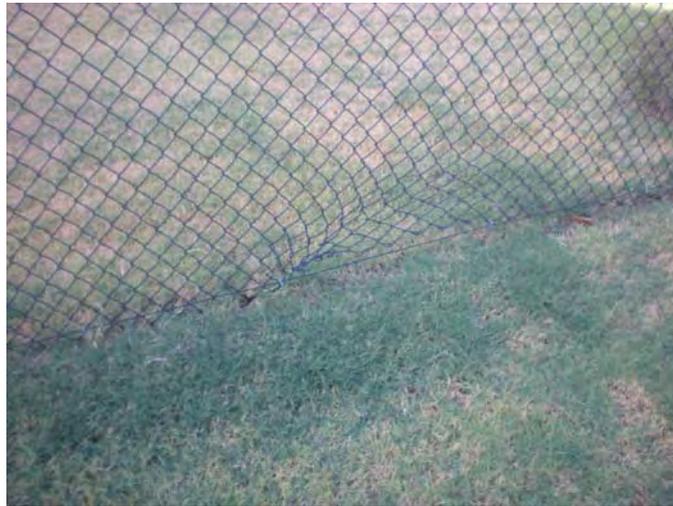
- Fence in several locations had been torn up due to mowing which could be dangerous for children.

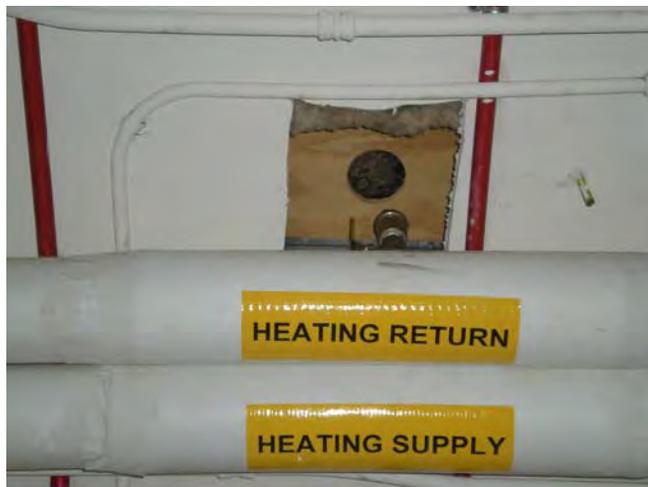
- This area was open in ceiling inside the mechanical room. It seemed work was not complete. Ensure fire rating is kept after completion of work.

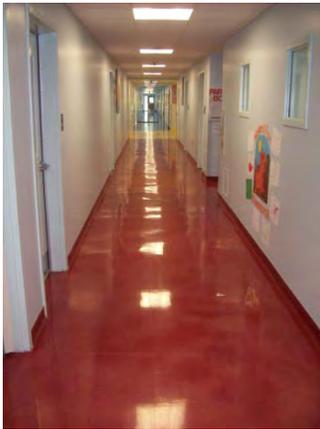
- There were problems with the concrete slab; contractors had quality issues.
- Radiant floor issue – slab may need to be thicker. Location of tubing within the slab is critical. On this project, the tubing was not placed deep enough as tubing was cut during construction. It appears it was designed correctly, but not constructed per the drawings.
- They also had problems with getting the spacing of control joints. The ACI recommends control joint spacing, and contractors should follow this guidance. The contractors try to reduce the number of joints and create areas that are too large. Joint spacing was designed correctly, but they cut out a number of the joints during construction.
- Floor unevenness causes buffer to burn off high and low areas resulting in having to replace VCT.

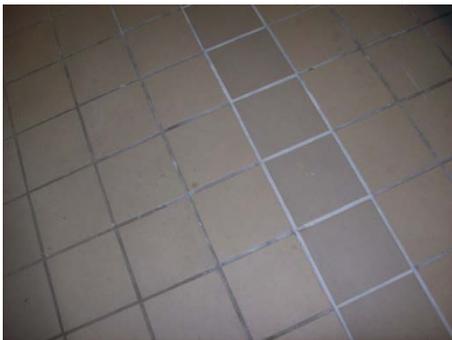
- Staff toilet room does not have key lock door or an electrical outlet in the room.
- Quarry tile in kitchen was cracked and some had to be replaced. Has full-height Ceramic Tile on walls.
