**U.S. Army Corps
of Engineers**
Engineering and Support
Center, Huntsville

Gate 10 CDC (Gardner Hill) (0-5);

Building 7404 Fort Campbell, KY

**POTR – Phase 1
Project No 58583**

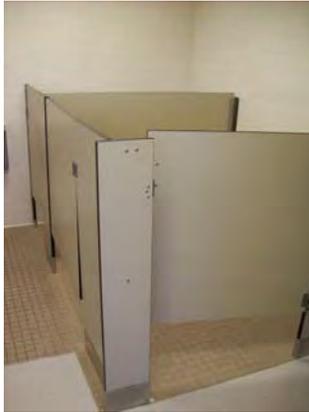
- Corners of the toilet partition at the ADA stall in the pre-school rooms work loose. They are not overhead braced, nor do they have extra support at the base. This needs to be addressed in the criteria.

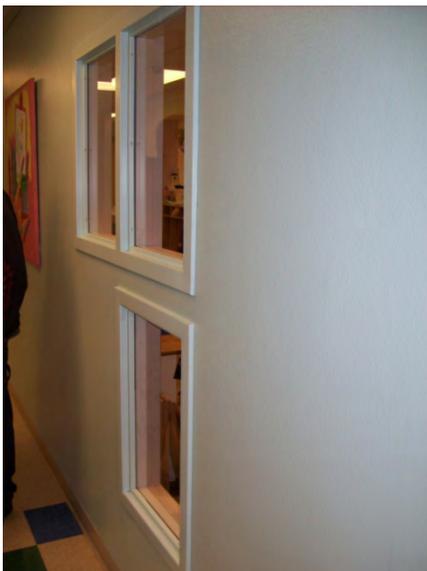
- Lack of low vision panels in the hallway. The contractor came back and installed them after the G-9 report said they were required.

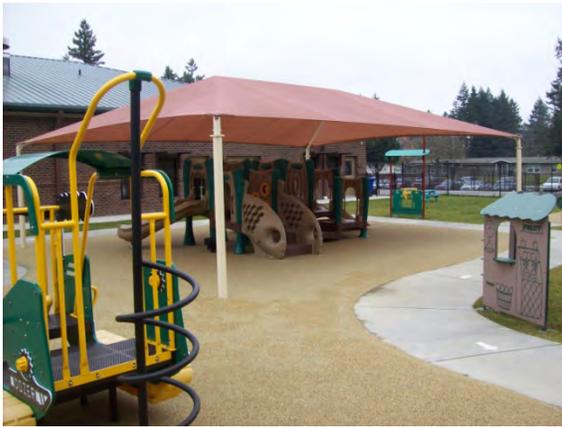
- Breast feeding is done in the rooms. They find that moms are not uncomfortable doing this in the actual activity room.
- Roof on boiler house is not sloped properly. Water pools up and leaks around the roof penetrations.
- Playgrounds are very nice and well equipped. The infant/pre-toddler playground has a trike path which is a bit overkill, since they can't ride trikes at this age. However, the caregivers use it as a stroller path. Playground play equipment is age appropriate. Pre-K/Kindergarten playground is a little smaller since the building was shortened to stay in scope.

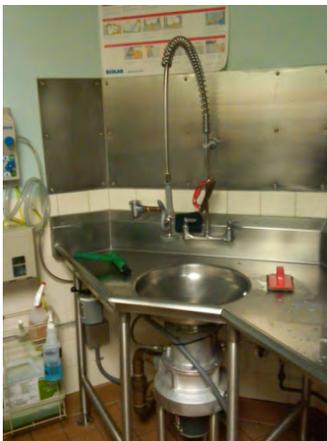
- The cook rearranged the kitchen to be more efficient for use. The wall behind the dishwashing area needs full height protection. The original tile wainscot was not sufficient, added stainless steel guard.

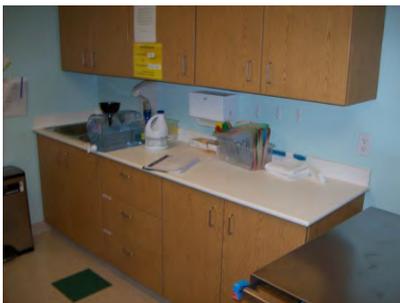
- Steamer is bolted down, can't clean behind it. Need to be on wheels.
- Mop gets caught on grout and tears up mop. Strands of the mop gets caught on grout which makes floor look bad. Grout gets stained.
- Laundry room could use a laundry sink as opposed to a kitchen sink.

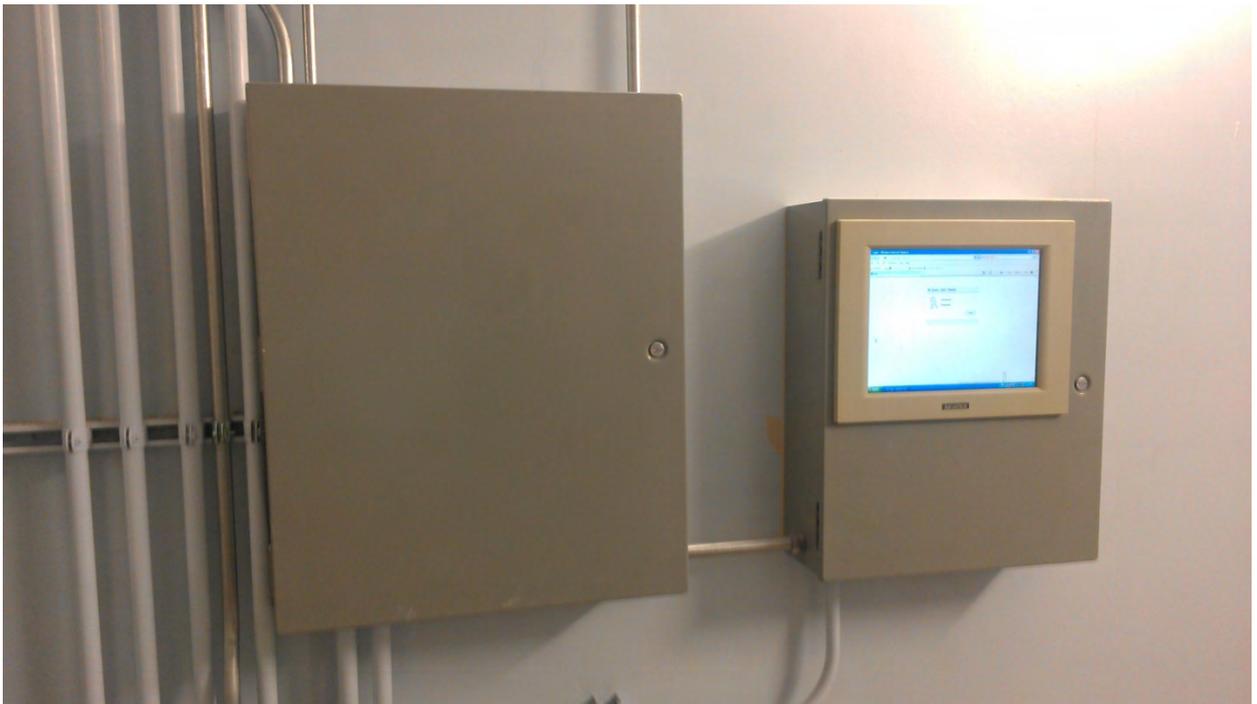
- The AHU filters are difficult to change due to the arrangement of the equipment in the mechanical room. Suggest requirement for maintenance access be added to standard.
- AHU filters are a type not stocked by installation maintenance. Site specific requirements should be included by the local Corps district.
- The HVAC control system is not standard to the installation. The maintenance staff is not familiar with it's operation. Site specific requirements should be included by the local Corps district.

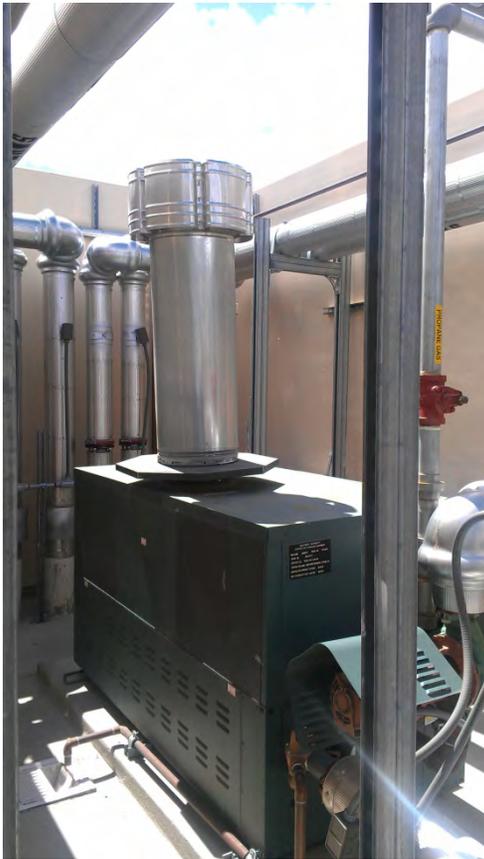
- The chiller and boiler are installed in an enclosed equipment yard that is too small to allow for proper airflow around the equipment. The boiler is exposed to the weather. All equipment should be installed in a mechanical room if possible to extend service life. Air cooled chillers need to be installed in an equipment yard with enough free space to allow for proper airflow.

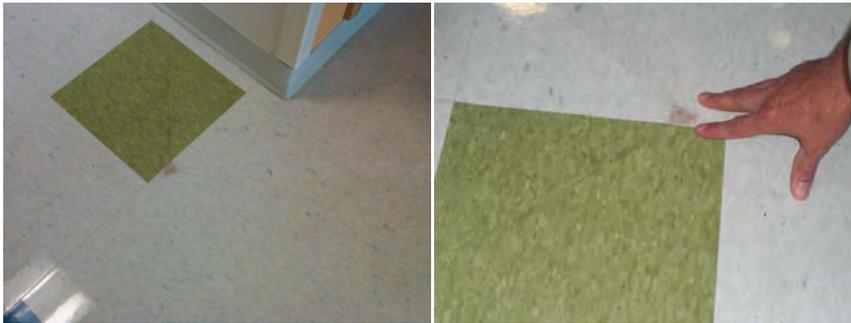
The floor slab is settling at one end of the facility. There is a noticeable change in elevation around one of the diamonds at the base of the column. Ultimately this may require floor work and VCT replacement.

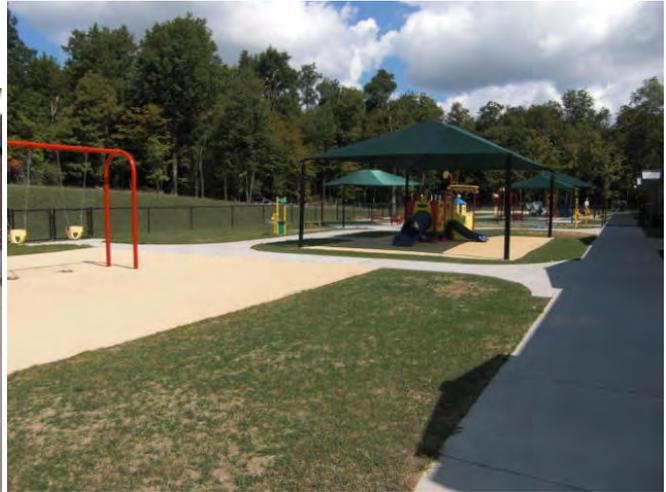
- Critters are digging under the fence and using the bathroom on the safety surfacing. Foxes live under the shed next to the building.
- Document if playgrounds include concrete trike path, shade structures, and correct play elements. Ensure the playground equipment is age appropriate for the playground where it is installed, and that it is commercial quality.
- There is no play equipment for infants through 18 months old children in playground area.

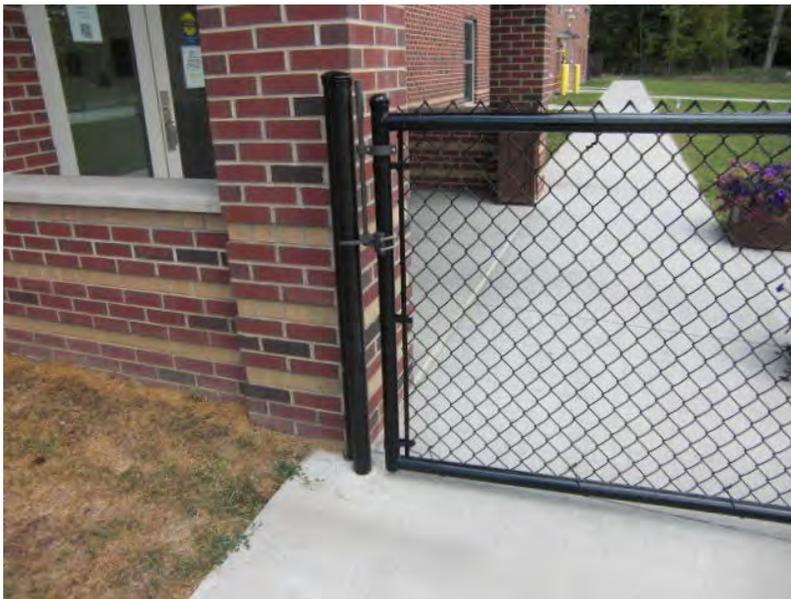
- Need to be more specific on the requirements of the gate latches. The latches provided are lightweight and breaking.

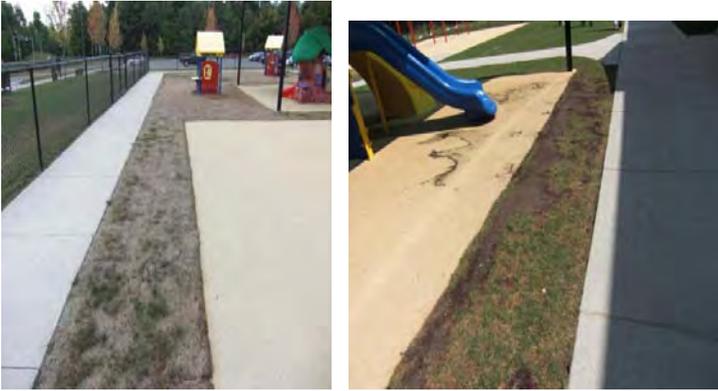
- Sod didn't take in the playgrounds. Usage is wearing out the grass that was there.

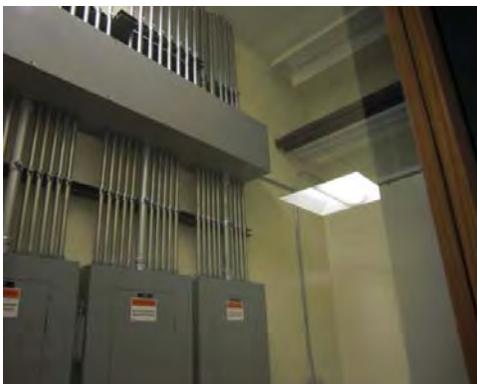
- Document if the lighting fixture is damage or hanging open? Lighting ballast in the indoor electrical room was causing a beeping sound.

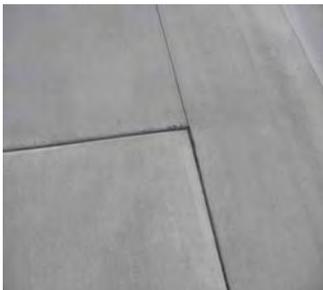
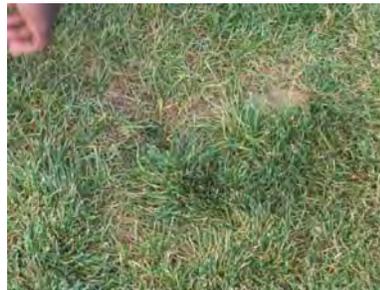
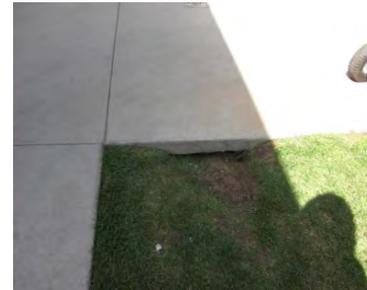
- A gate was not provided into the infant/pre-toddler playground next to the building main entrance.
- Uneven sidewalk and holes in the playground area create trip hazards.
