**U.S. Army Corps
of Engineers**
Engineering and Support
Center, Huntsville

Pershing Child Development Center

**Building 1140
Fort Eustis, VA**

**POTR – Phase 1
Project No 69811**

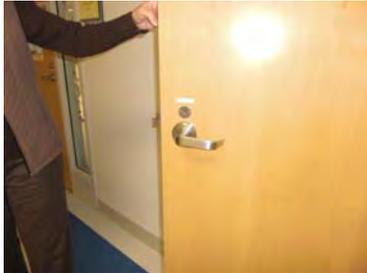
- On the doors into the rooms, some of the locks and handles are constantly getting stuck when pushed down to open.

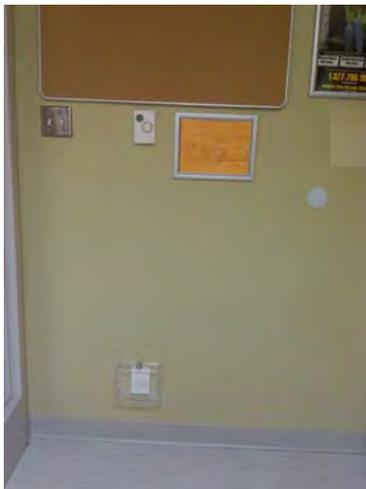
- The Activity Rooms have a temperature sensor located 12" AFF, directly below the thermostat. Some of the clear plastic boxes have come off/been broken off.

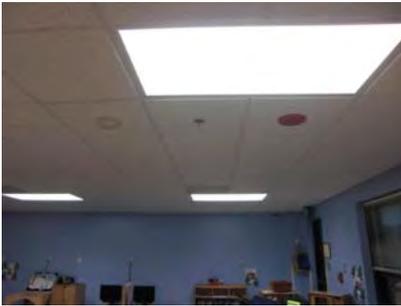
- Intercom is hard to hear. The speaker is in the wall next to the sign-in desk. In addition, there is a microphone in the ceiling.
- The lighting in child accessible areas is enclosed by lens.

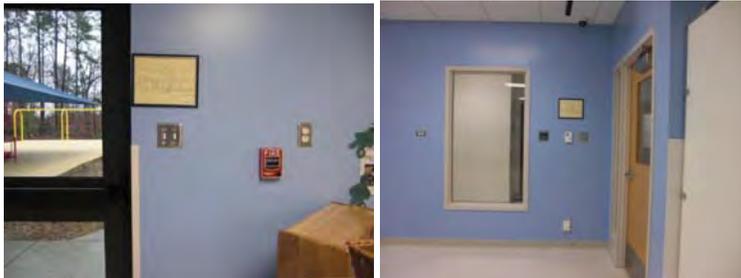
- The lighting is controlled by switches. The lighting controller has been overridden. Switch lighting replaced the motion sensors. The lighting in the communication and video rooms stays on all the time.

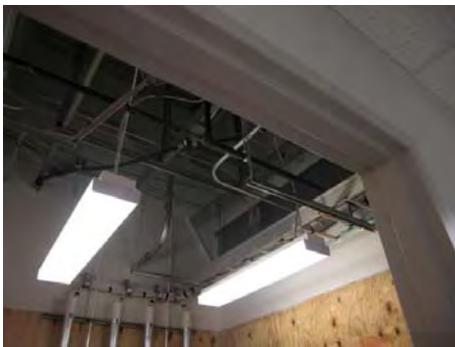
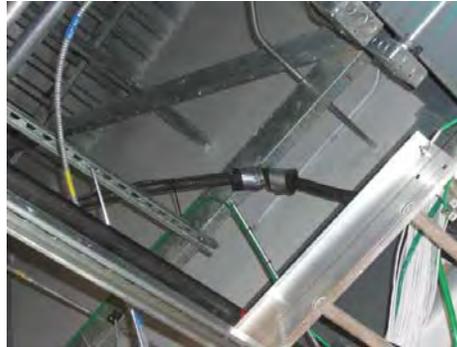
- There is a pipe that passes through the communication room over the data termination racks. It may be the condensate line for the air conditioning unit.

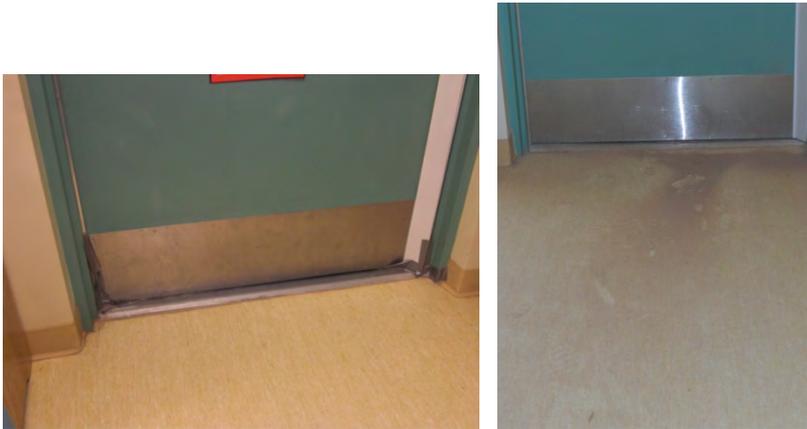
- The recessed pull handles on the cabinetry have been, and continue to be, a safety hazard. There is a sharp edge inside of the pulls which have resulted in cuts on the fingers of both staff and children.
- Doors are not properly sealed; allows sand to blow into the rooms.

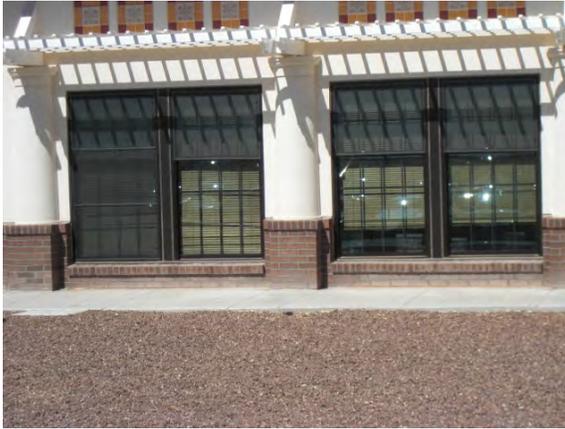
- Doors had too much space at the top of the door, and were not sealed. When it is windy and rainy, the water would enter the top of the door and drain through the inside of the door and leak out at windows and at the bottom of the door. They manufactured a solution to solve the water problem, but now they are having issues with being able to close some of the doors.
- Have some serious noise transmission problems, especially through duct work. When there is drumming going on in one room, it is heard throughout the building. Also, the pipe in the wall adjacent to the Training Room has no sound insulation. When the water is turned on in the janitor's closet, it is very loud in the Training Room.
- Playground equipment is not age appropriate.
- Need full screens on the windows because the half screens at the top of the windows keep sliding down.

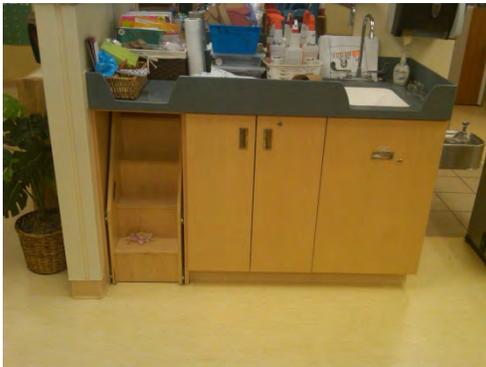
- Could use a cabinet door over the stairs in the diaper changing station in the pre-school rooms.

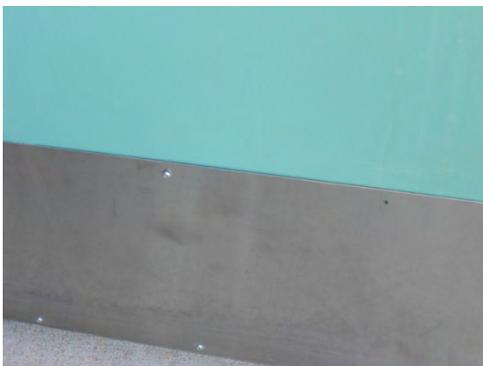
- Recommend not providing kick plates on the doors, as they have sharp edges, and really become a concern if they start to separate from face of door.

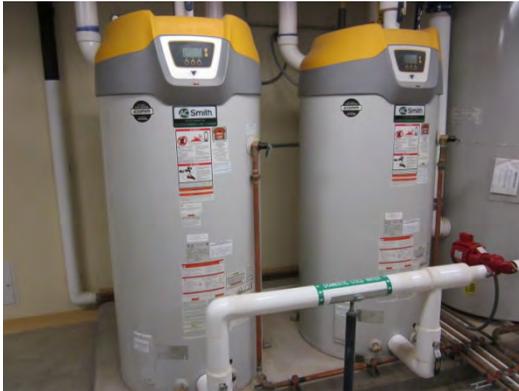
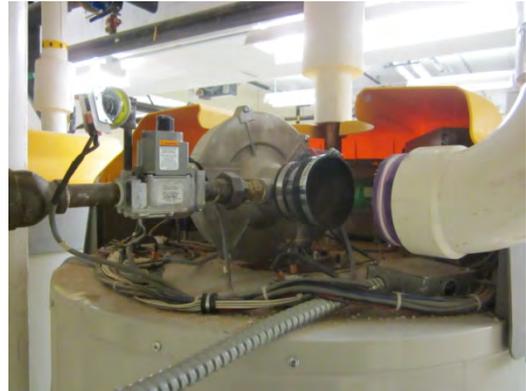
- The condensing potable water heater was making a loud “popping” sound at the vent terminations when the natural gas-fired burner ignited. The combustion air duct was disconnected from the combustion air fan to correct this problem.

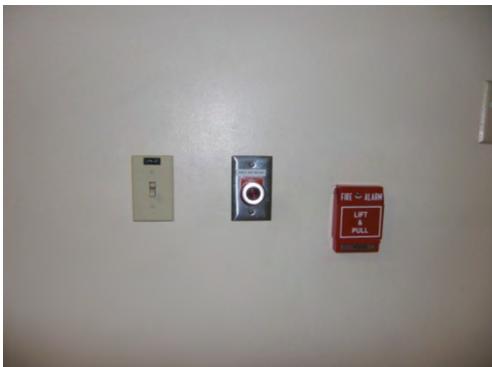
- The pull stations malfunction and were replaced. The occupant felt the pull stations were installed too low. The pull stations were within a child's reach.

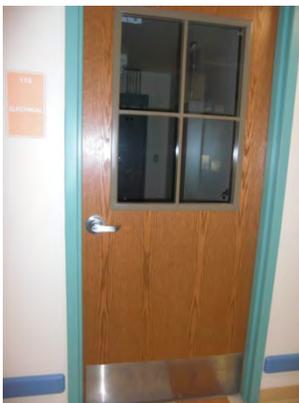
- Need double action fire alarms. The single action alarms are too easily pulled. The glass tube type is not the best for CDC due to the pieces of broken glass that occur when the alarm is pulled.
- Need key operated lighting override at the front desk. They have only a button that provides a limited amount of additional time.
- The lighting in the closets and storage areas are controlled by motion sensors. These lights should be on 24 hours a day.
- The electrical room should not have a door with a window.

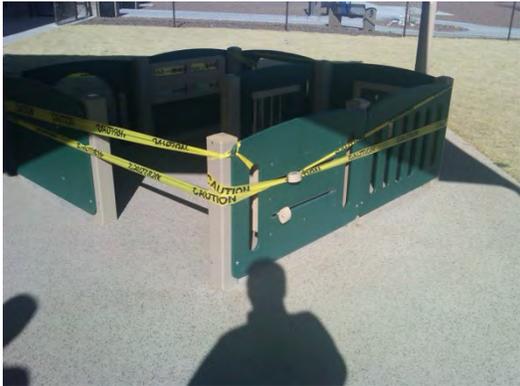
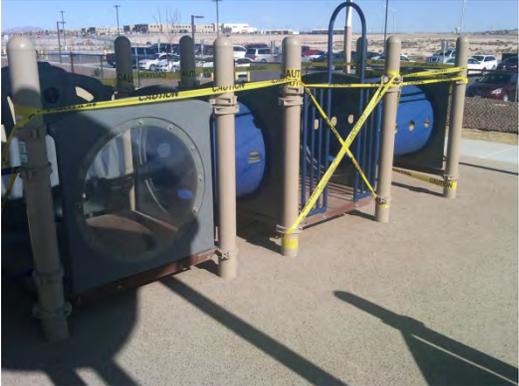
- Play equipment is not age appropriate. The following items are in the infant play area:

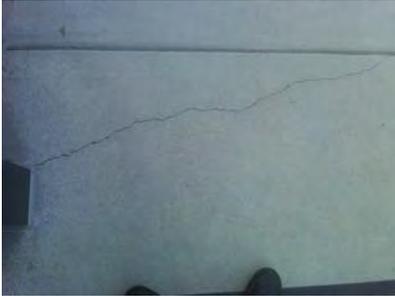
- There is one crack in the sidewalk around the perimeter of the building.

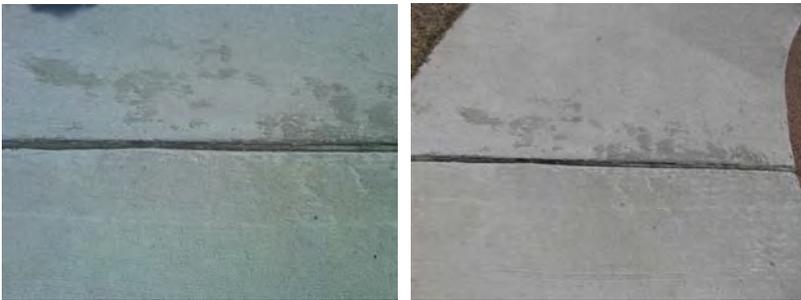
- There is one joint in the concrete trike path that the installation safety office feels is a tripping hazard.

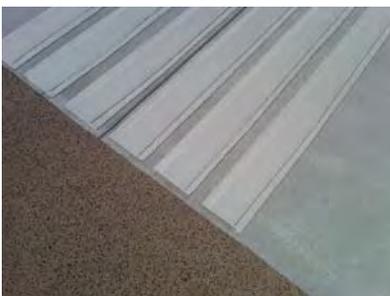
- Rumble strips on the trike paths are applied, not cut in concrete.

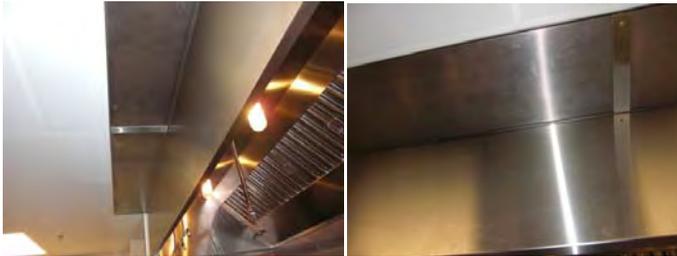
- Mechanical room is very hot. Causes issues with condensers located in Mech Room. No place for heat to escape. DPW says these units need to be removed from the Mechanical Room. These are for the supplemental units and the kitchen refrigerator/freezer.
- The kitchen exhaust fan is not sufficient.

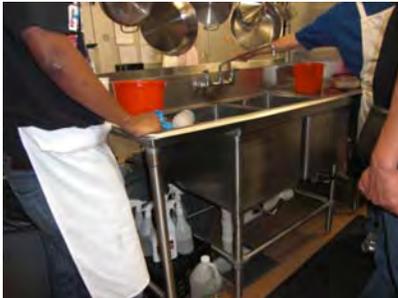
- The kitchen cold water comes out hot then turns cold.

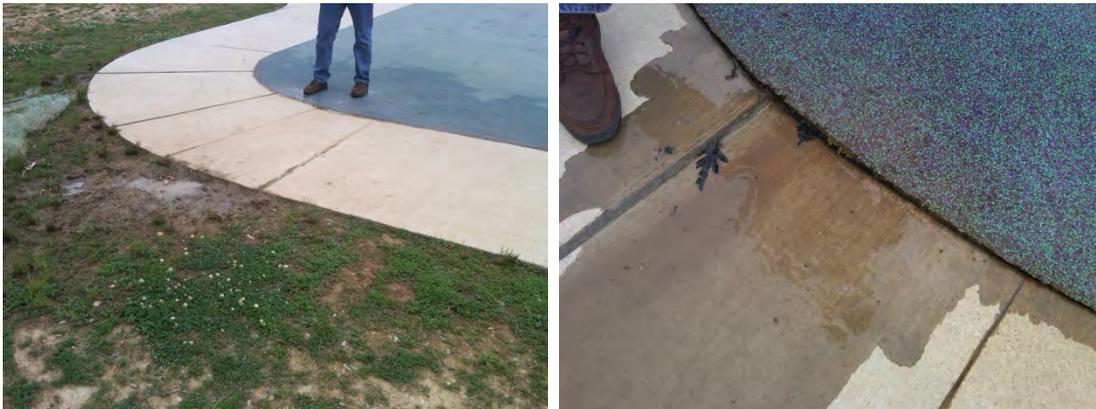
- On-going issue with playground surfacing. The surfacing is not draining properly. Need drainage under the poured in place surfacing. Recommend putting concrete slab under the surfacing with proper drains.

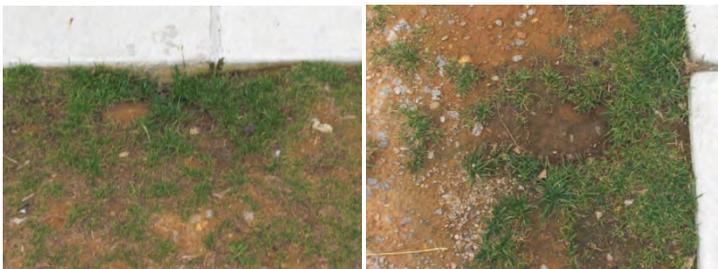
- There are pot holes and sewer manholes in the playground areas.

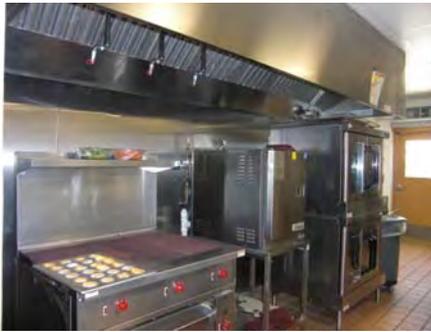
- Stove top on this type of stove does not get hot enough. They have to start the stove early in the morning for it to be ready for lunch.

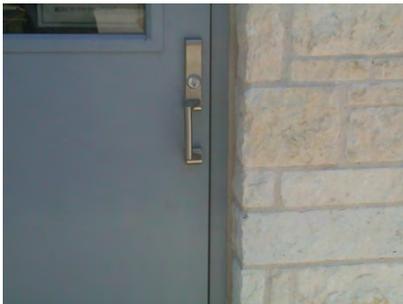
- The limestone on the exterior of the building is spalling in areas, which creates a choking concern.
- Door hardware on exterior of the building does not allow you to get back into the building unless the door lock is deactivated.

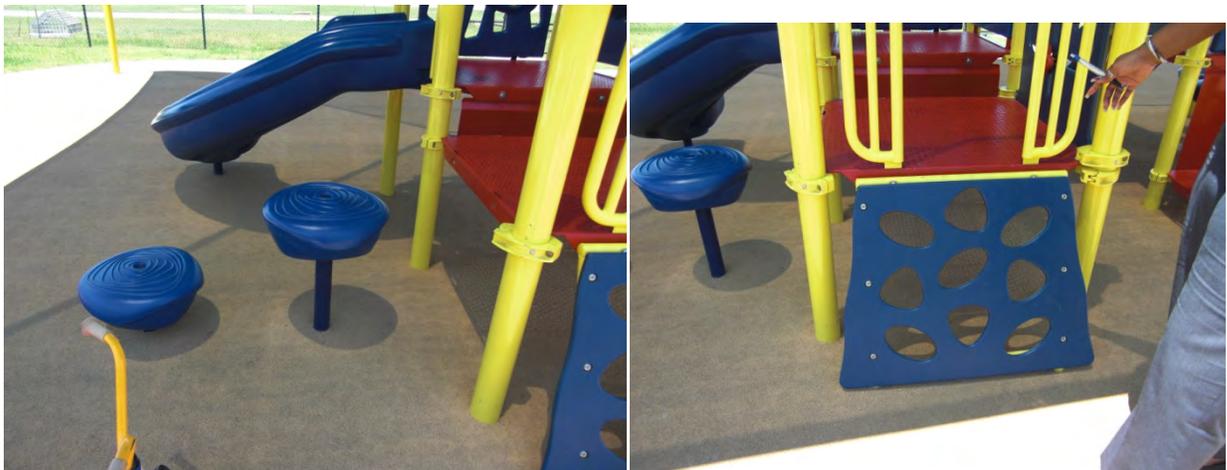
- One play structure, in the pre-school/pre-K/Kinder playground has had several injuries. The areas of concern are the 2 pods used to climb into the structure - these have a long stride, no handrail, uneven surfaces, etc. Children have fallen off these and then cracked their heads on the edge of the platform; one such injury requiring stitches. The other area of concern is in the same area of the same piece, which has an inclined wall of holes for climbing up to the platform. A child's foot can slip through the hole which could lead to a broken leg.

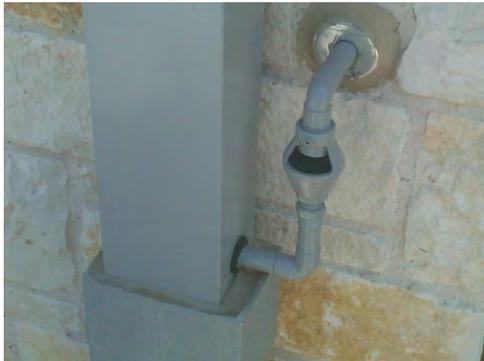
- Finger concern on condensate pipes that tie into the downspouts.

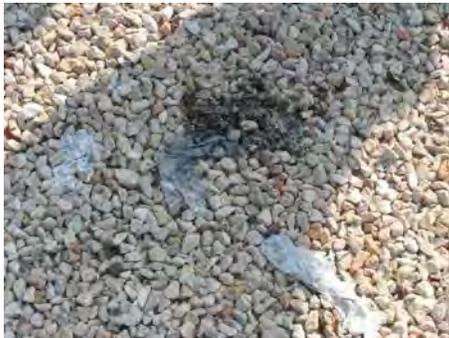
- The sewer lift station and pump cannot handle baby wipes being flushed. Anything containing cotton fibers will clog the system. This is currently being handled by training and signage in the facility. This had been a major issue with the facility in the first several months.

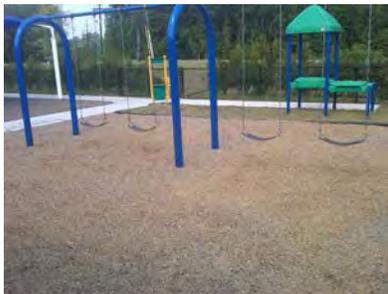
- The older 2 age group playgrounds are located within 50 feet of a busy street, but only a 4' high fence was provided. There is concern that at some point a child will climb that fence and get hurt. Need to consider taller fences being required in conditions such as this.

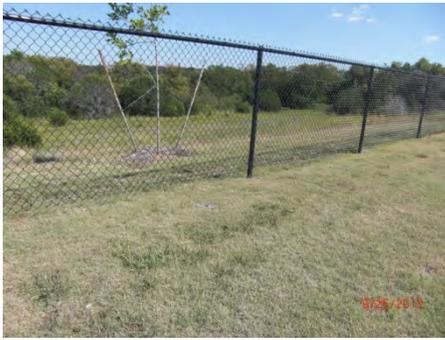
- The fence has been an issue since they moved in. There are some gaps under the fence large enough to let wildlife into the playgrounds and to let children crawl underneath the fence and get away. The Contractor has promised they would fix this in early October.

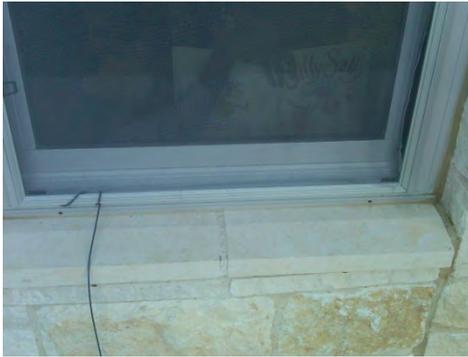
- Laundry has lint trap on the floor. When it is opened, sewer smells fill the building. The installation feels the laundry should be on the exterior wall.
- Some of the window screens are being damaged by children pushing on them.

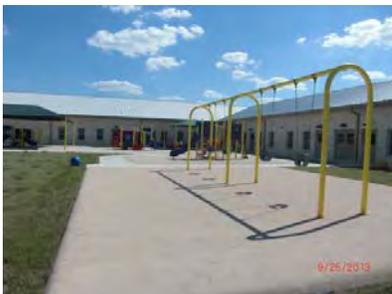
- The intercom system announcements are not always understandable on the other side of the playground area.

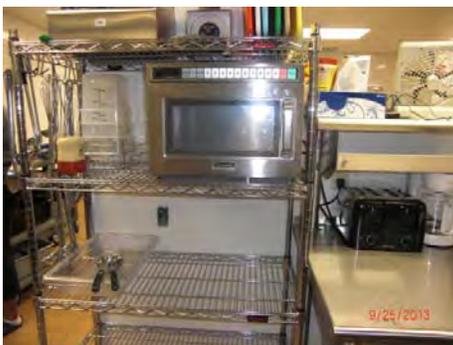
- The Fire Alarm goes into the trouble alarm settings and it must be shut off. It sometimes gives false fire alarms.
- The microwave and the toaster could not be used at the same time. This caused the breaker to trip. The oven and kitchen appliances cords burned out. The kitchen was operating at the wrong voltage.

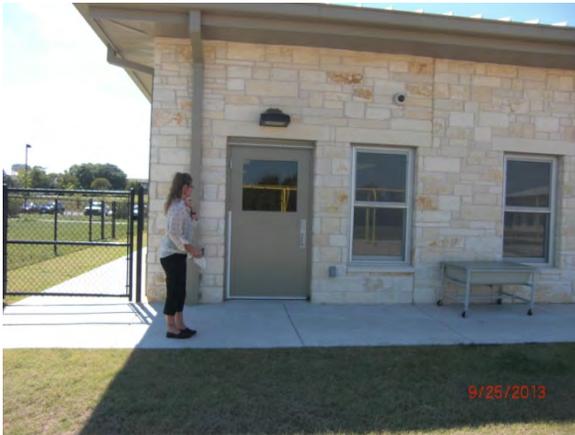
- The sewer lift station was not set at the correct voltage. This caused the lift station to malfunction.
- The security cameras do not have a good view of the exit doors to the playground area. A person exiting the activity room is out of view of the camera until she enters the playground. More camera angles are needed in the playground areas.
