**U.S. Army Corps
of Engineers**
Engineering and Support
Center, Huntsville

Large Consolidated Fire, Safety, and Security Headquarters Facility

**Building 20709
Fort Bliss, TX**

**POTR – Phase 1
Project No 64608**

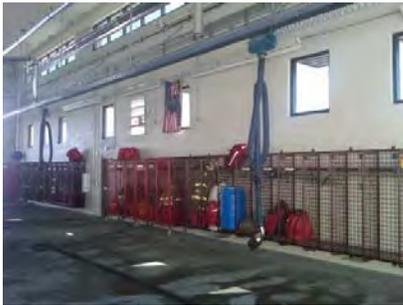
- There were equipment procurement problems.
- One overhead electrical plug missing in Apparatus Bay.
- Warranty has been an issue.
- There are various water leaks though out the facility.
- Apparatus Bay exhaust systems has major problems mainly due to size of connector to exhaust.

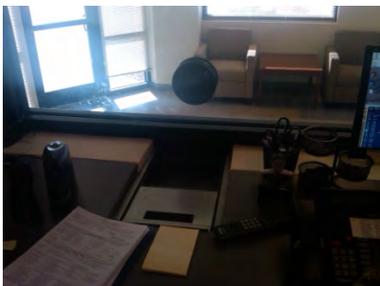
- The conversation ports between the detention waiting area and the MP Desk need to be amplified.

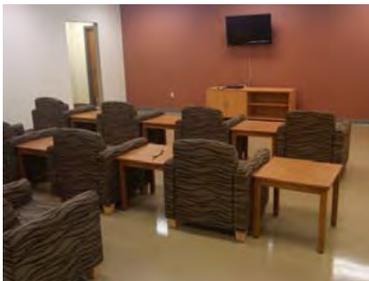
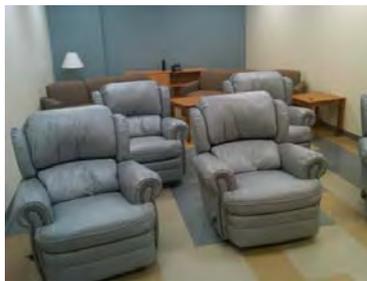
- There were general discussions about lessons learned and nice to haves. The team walked through the entire facility during normal business hours to see day to day operations. We also engaged with the staff to get a overall sense of the facility from the staff point of view.
- The open day room was not getting much use. Instead they were using the enclosed recreation room more. For the standard look at ways to ensure better utilization.

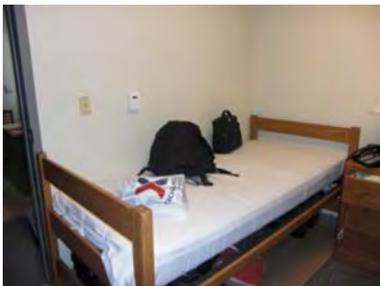
- The furniture did not fit the dorm rooms. Some of the furniture was too large for the rooms. This was due to the facility being resized.

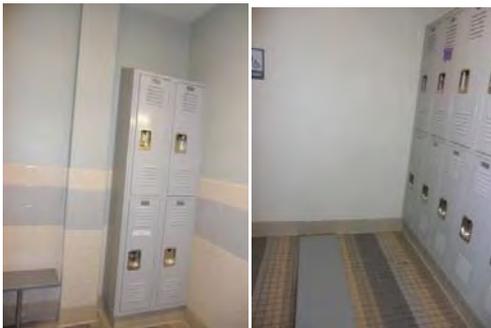
- More lockers are needed in the Patrol Area and the bathrooms need more storage space

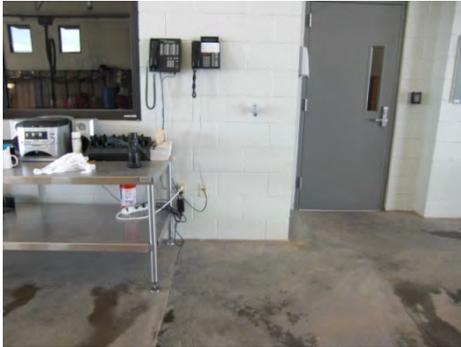
- The bathrooms are undersized.
- There were no funds to tie-in the facility communications with the installation's communication system. The contract should have provided funds for this connection.
- The card reader requires a pin and card to gain access. The firefighters want only a pin coded card reader on the doors.

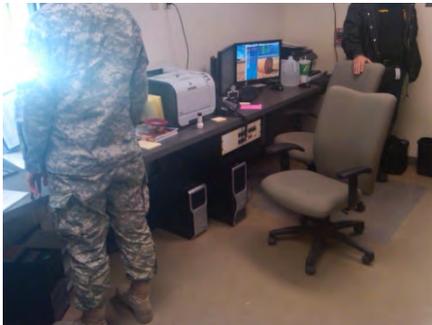
- The computer Aided Dispatch Room size did not match-up with the furnishing installed there. The MP Desk also needs data outlets and additional cooling because of the computers, printers and monitors.

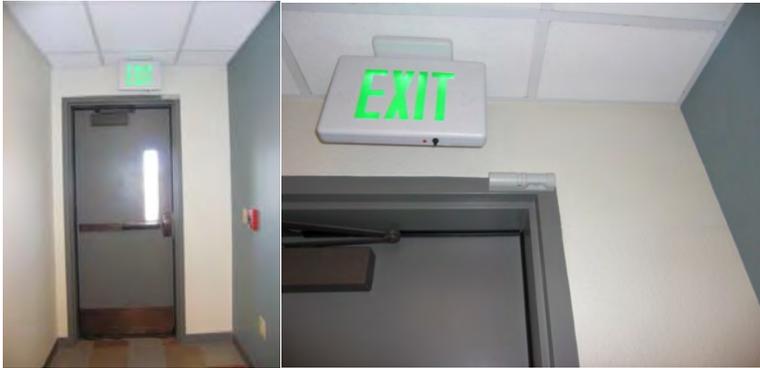
- The Request for Proposal should require the equipment operation manuals to be provided to the occupant. CEHNC needs to contact the contractor and request the equipment operation manuals.
- ADA standards for the front door need to be revised to include automatic door openers. The front doors do not always work.
- The occupant would like a gas connection in the patio area.
- The designer should correlate the door frames and the IDS equipment early in the design process. For this project the door frames did not work with the IDS equipment. The lock detection on the outer doors needs to be deactivated.

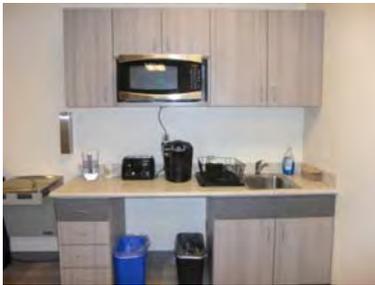
- The kitchenette should be changed into a full kitchen.

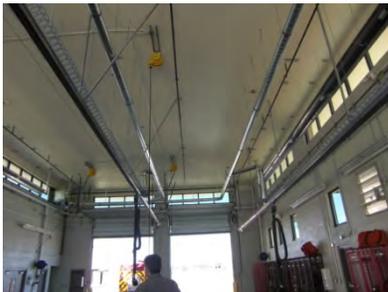
- The Apparatus Bay Doors are hard to open. The ventilation system may not exhaust all fumes to the outside.

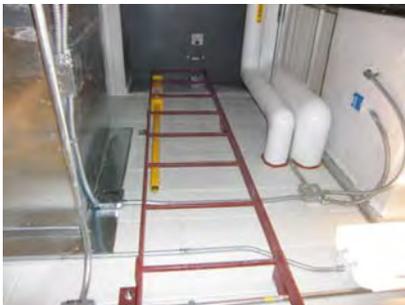
- The designer needs to redesign the roof hatch. A guardrail should be placed around it to prevent falls.

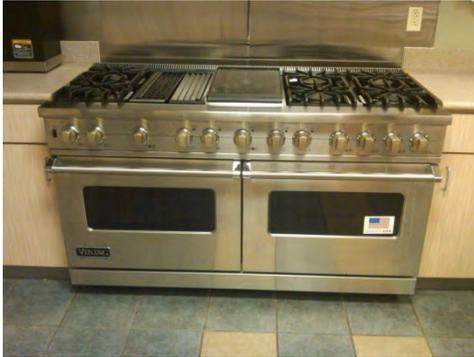
- Add all major equipment to milcon. This includes things like kitchen equipment.

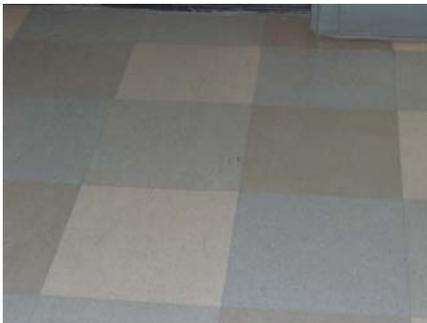
- Kitchen needs 2 refrigerators, not 1 refrigerator and 1 freezer. Actually needs a refrigerator for each Company (i.e. a 3-Company station would need 3 refrigerators).
- Look at security of the detention area. Should there only be one door into that area, and should it be provided with a vestibule?
- Look at stained concrete floor in MP and guard area. VCT is not holding up well and is marking from all the traffic.

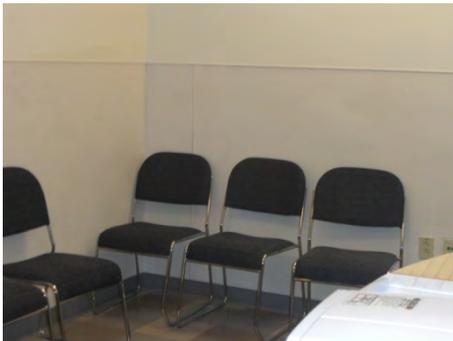
- A larger Patrol Briefing Room is needed.

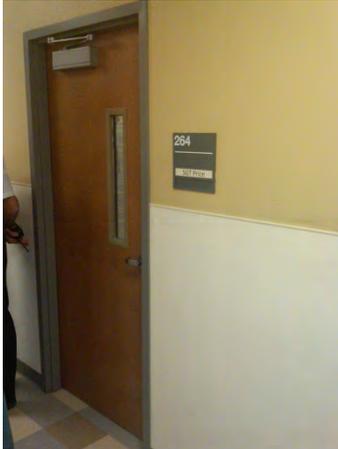
- The designer needs to add more offices for Patrol Officers.
- The Fire Department Headquarters should be a central hub. It should not be located in the corner of the building.
- Provide durable and cleanable wall surfaces in MP and guard area. They have put a FRG wainscot in these hallways to protect the walls.

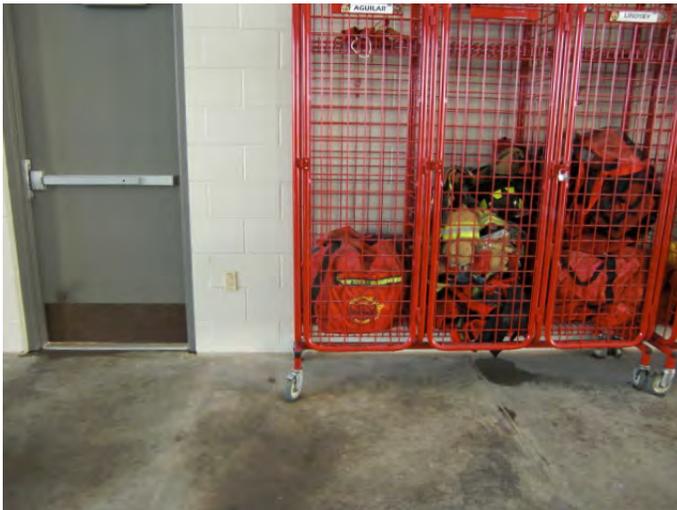
- Firefighters gear should not be stored in the Apparatus Bay due to exhaust fumes. Personnel Protective Equipment should be stored in a dedicated room.

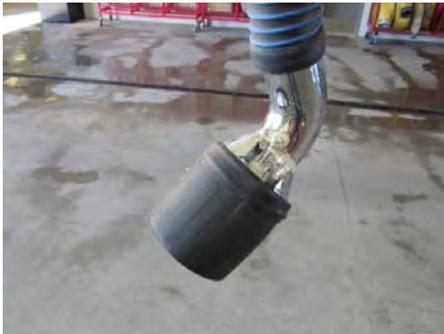
- HVAC System consists of a chilled water and hot water system serving a VAV system and multiple fan coil units. Gas-fired infrared heat is used for the Apparatus Bay.
- Individual, dedicated fan coil units provided for each dorm room.
- Tailpipe exhaust system in the Apparatus Bay is not working properly. The exhaust hose tailpipe adapter does not fit the fire truck exhaust tailpipe. A new adaptor fitting has been ordered.

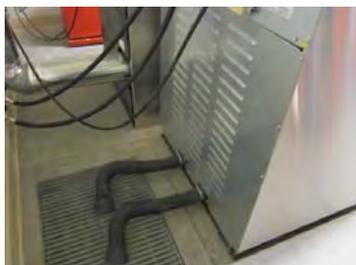
- Commercial duty washing machine drains into floor trench.

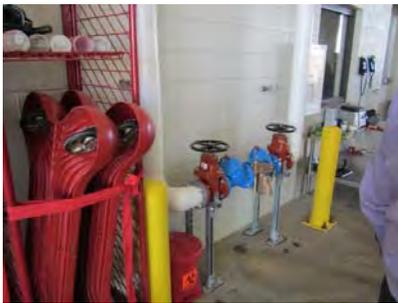
- Low flow shower heads and lavatories were provided.
- Waterless urinals were provided.
- Apparatus fill line was provided in Apparatus Bay.
- Stainless steel security plumbing fixtures provided in Detention Area.
- Backflow preventer located in Apparatus Bay consumes valuable space and is subject to damage. Due to ready access requirements for annual inspection and testing, it could not be raised.

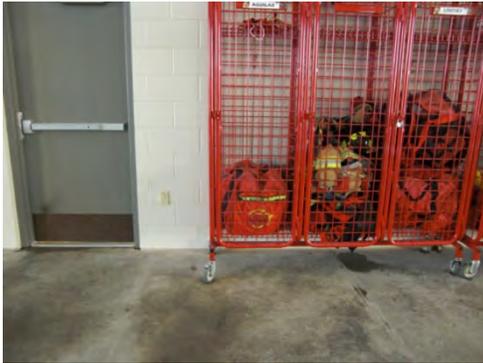
- The Apparatus Bay does not have functioning Red/Green signaling system mounted 6' AFF for each door to indicate whether the bay door is fully raised.
- The Apparatus Bay Hose Drying Rack does have dedicated outlets to support drying equipment.

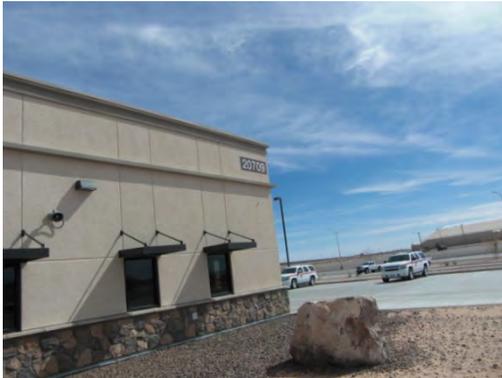
- The occupant is not satisfied with parking design. The Parking lot curve cuts need to be wider for oversized trucks.

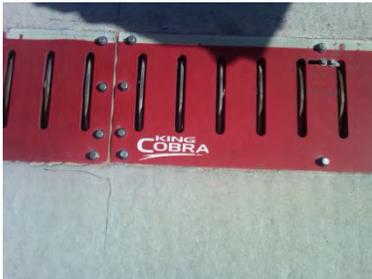
- Tiger Teeth does not work properly. They are chewing up the sides of the tires on the fire trucks.
