**U.S. Army Corps  
of Engineers**  
Engineering and Support  
Center, Huntsville

## **FIRE STATION # 5**

**Building 2620  
Fort Riley, KS**

**POTR – Phase 1  
Project No 17322**

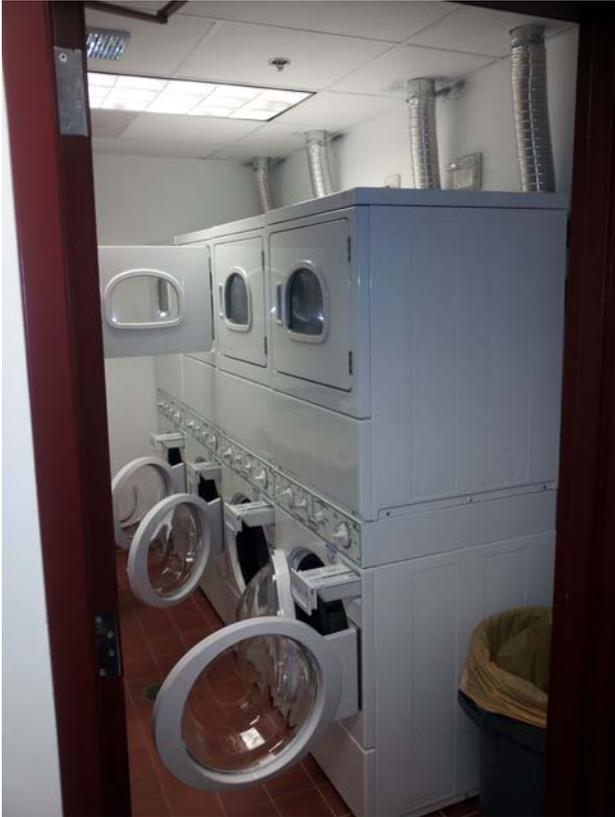
- Apparatus Bay. The floor was initially constructed with a slope of 1" per foot which too much of a slope. The floor was later removed and sloped to 1/8" per foot.
- Laundry Room. Vents were added for the dryers and proper outlet connections were installed to support

stackable washer/dryer units.

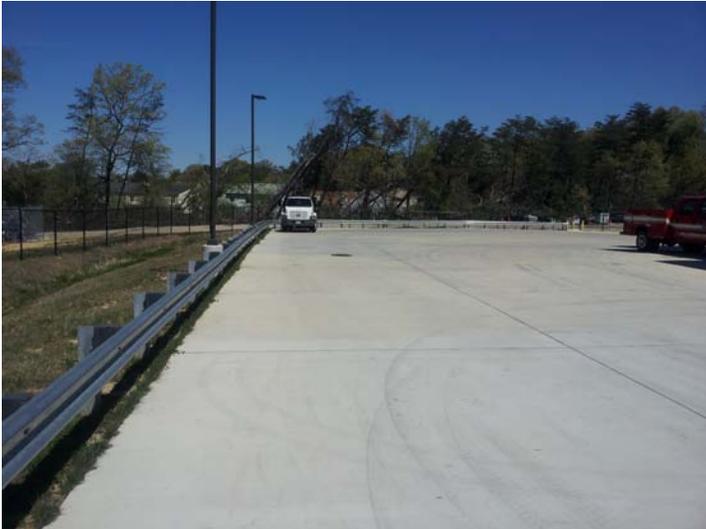
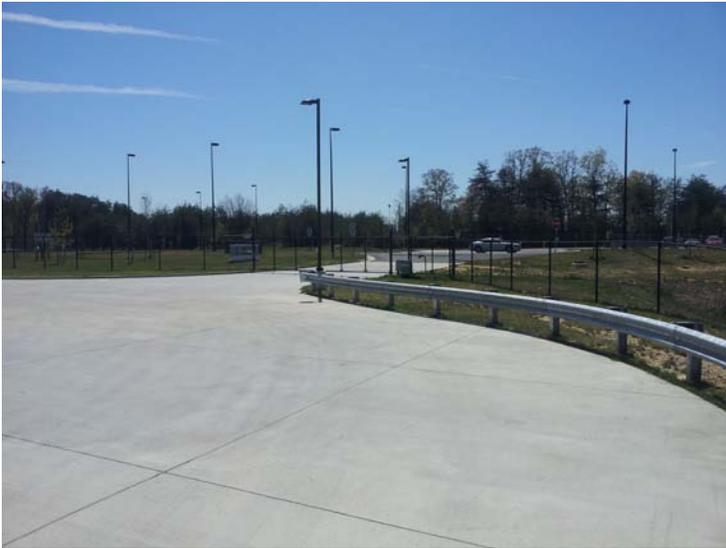
- Guardrails were installed at the vehicle apron to prevent vehicular rollover into the easements.

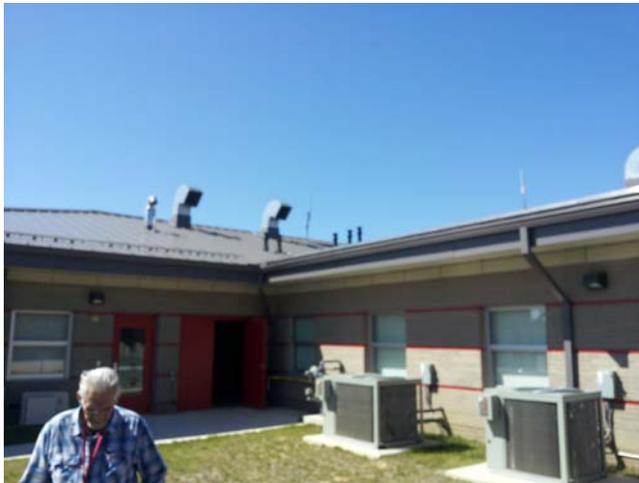
- Kitchen. Residential grade appliances were provided and counter/cabinet spaces were provided to support a residential request. Commercial grade appliances and commercial counter/cabinet spacing was needed to support a Fire Station/ Emergency Services work environment.
- Dorm Rooms. Vision panels were provided on the Dorm Room doors. This should not have happened. The vision panels had to be tinted to provide privacy.
- HVAC System. On-going balancing issues throughout the facility. Heating units had to be installed to compensate for overcooling.
- There are continued roof leaks at roof curbs.

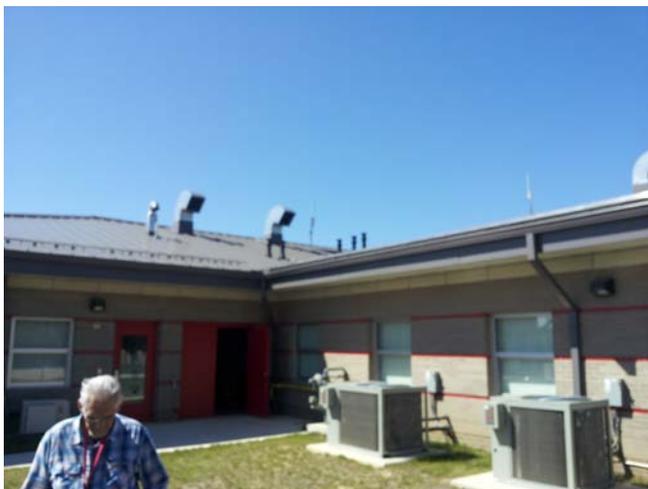
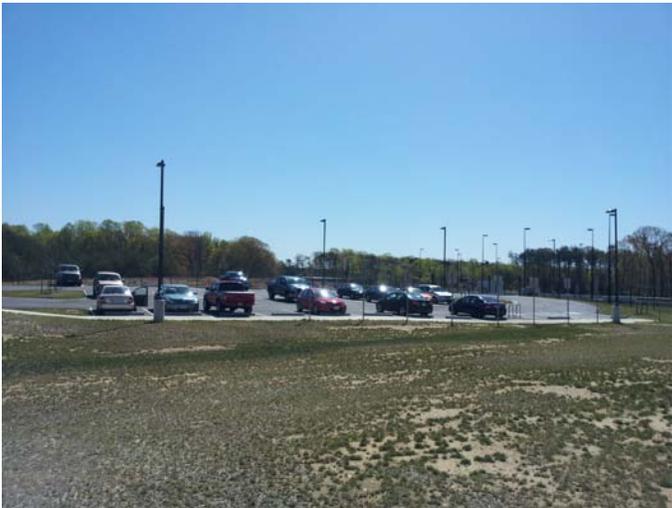
- Roof gutters and downspouts are undersized to support the rain discharge of the roof. Overflow at gutters causes landscape damage.

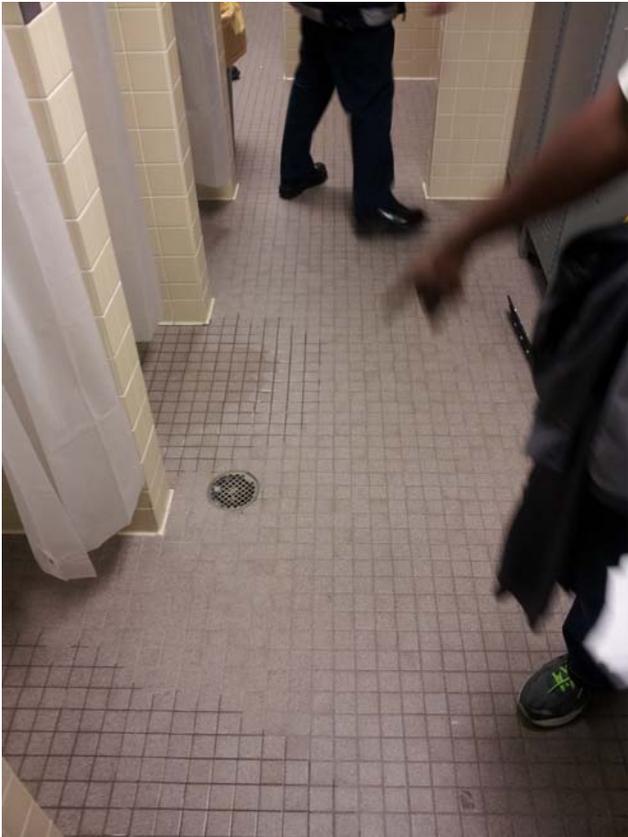
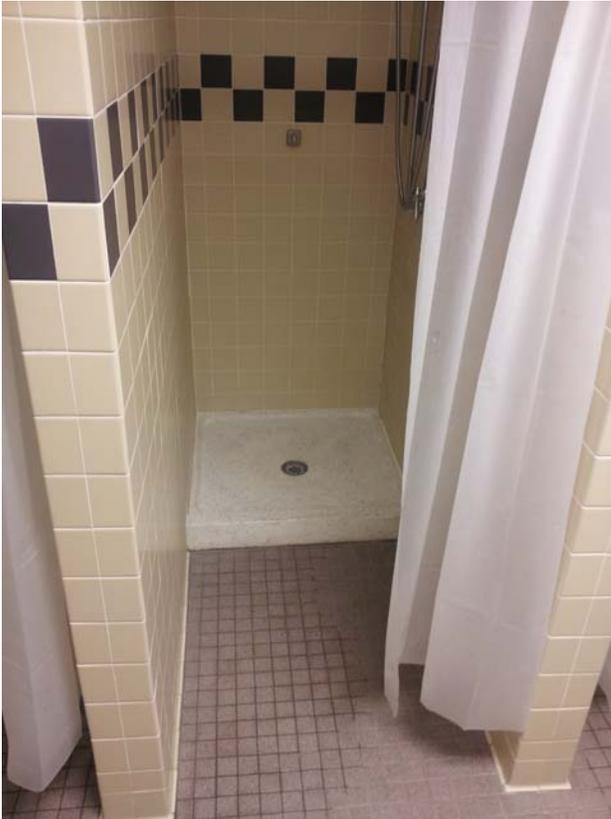
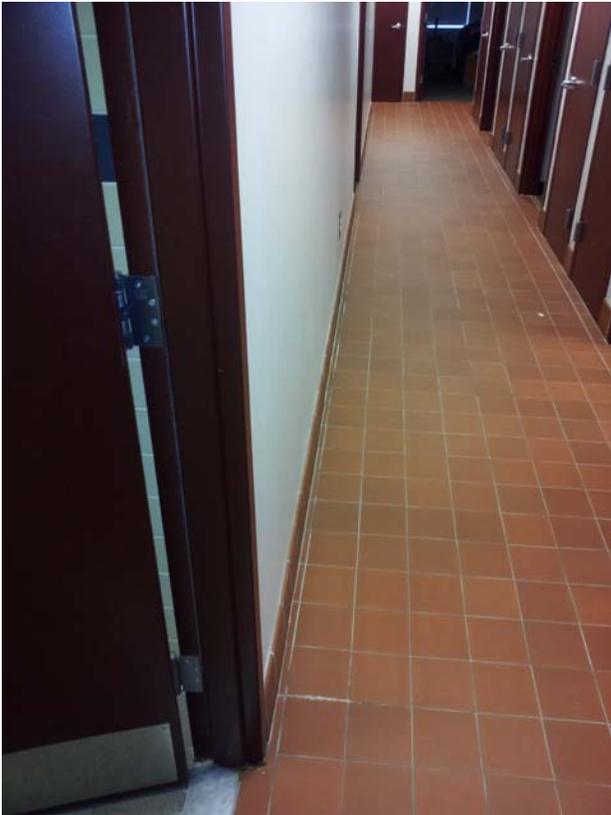
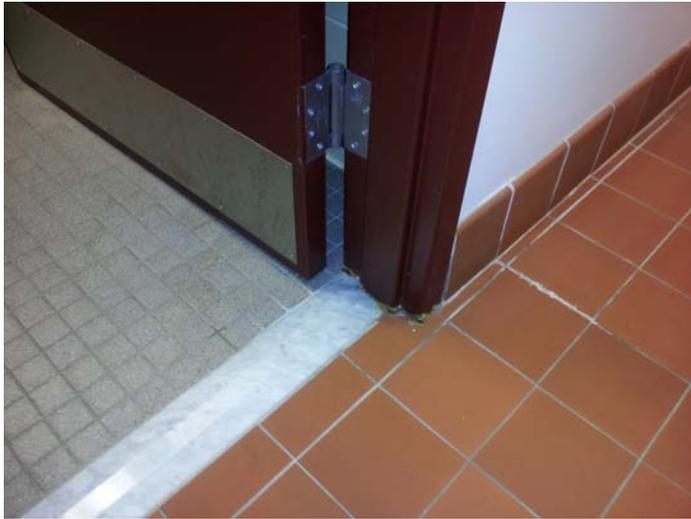
- Rest Rooms. Severe drainage issues. Floors are not sloping to drains, therefore causing flooding, wall damage, tile staining, and rusting at the foot of door jambs.

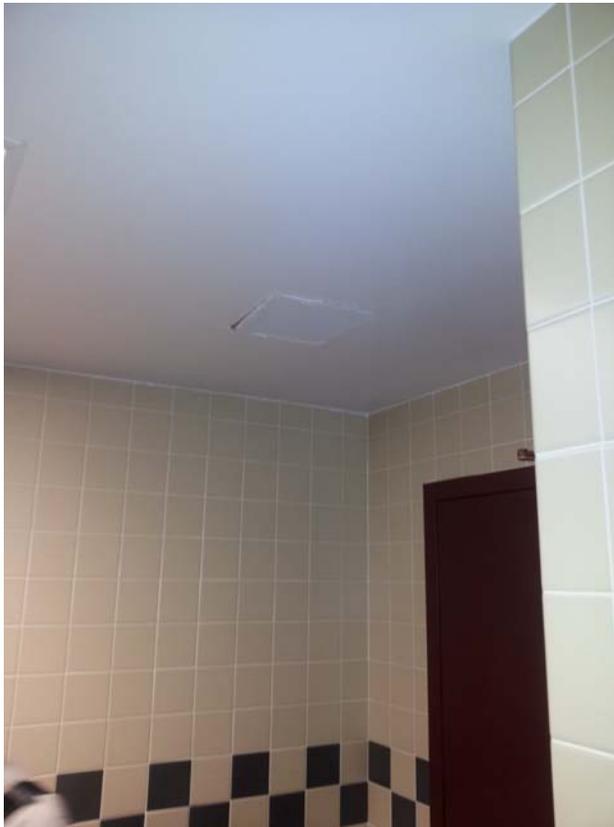
- Rest Rooms. Exhaust for moisture was not installed. A grill was placed in the restroom to conceal the fact.

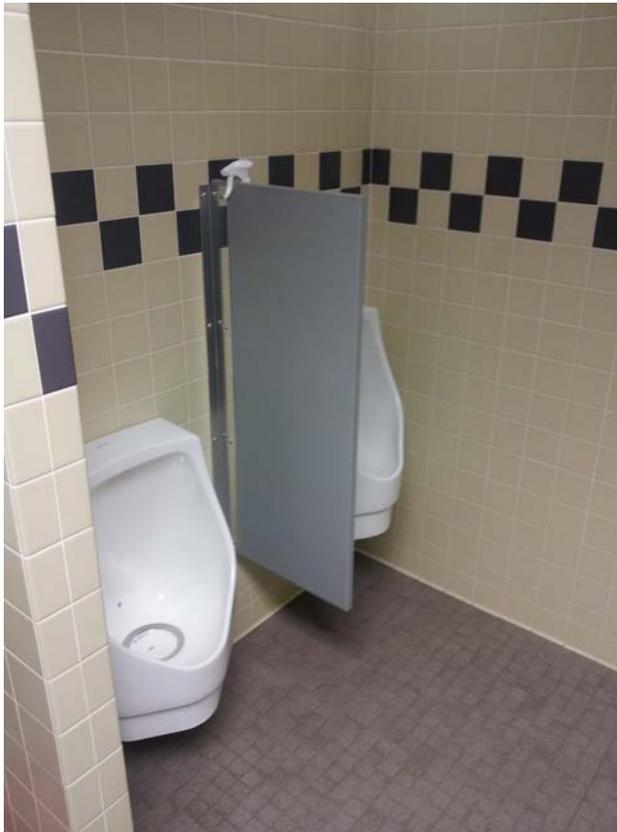
- Rest Rooms. Waterless urinals installed.

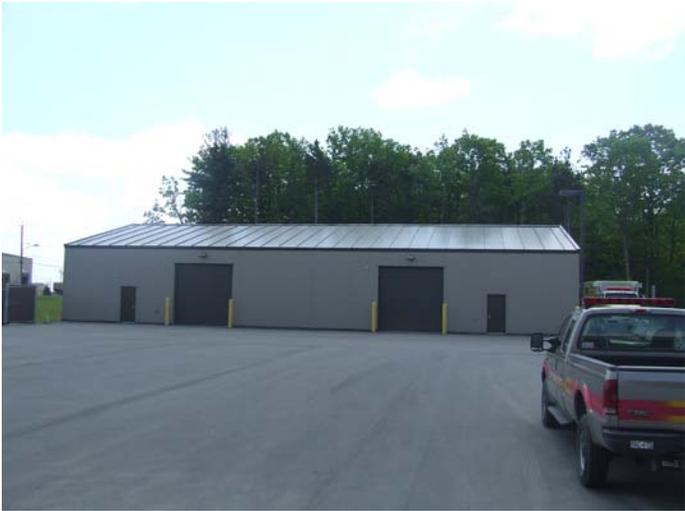
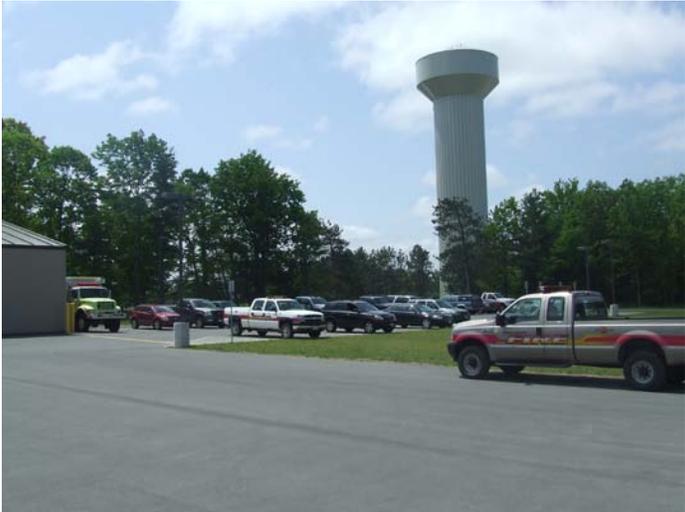
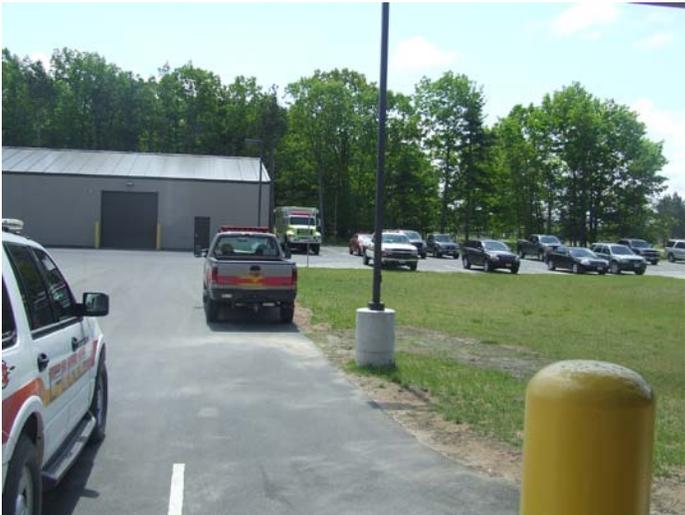
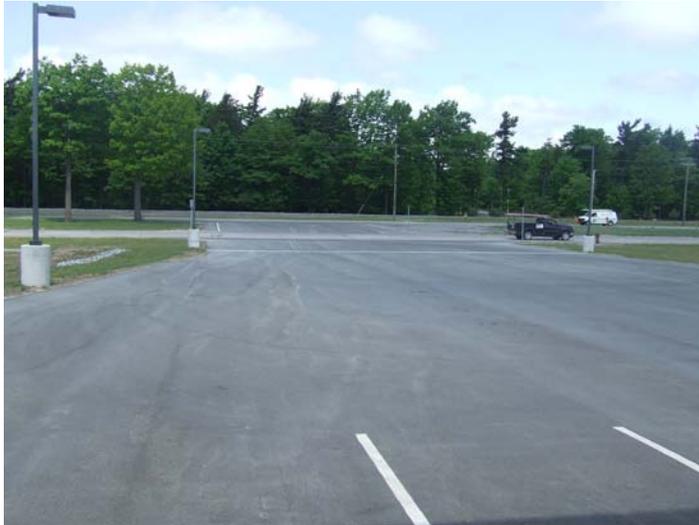
- Apparatus Bay. Because of the configuration of the hose system vehicle exhaust removal system the Apparatus Bay could not be constructed as a drive-thru Apparatus Bay.
- An asphalt based emergency vehicles apron was used instead of a concrete based application because of budgetary constraints.

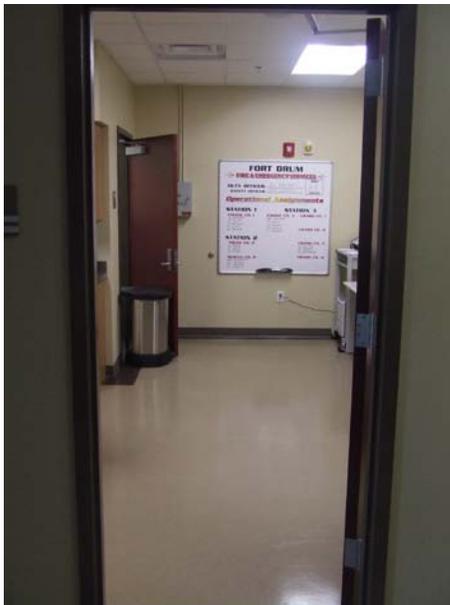
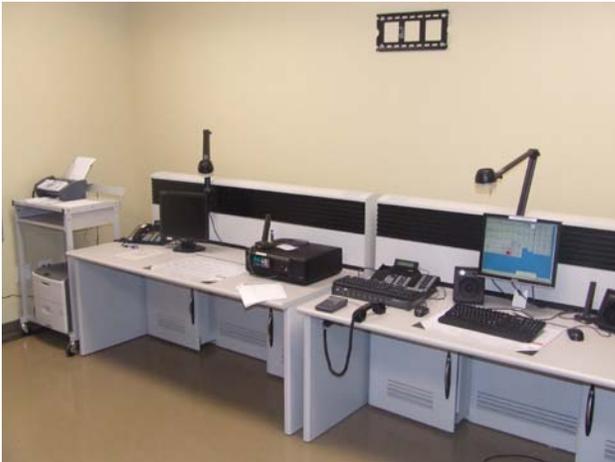
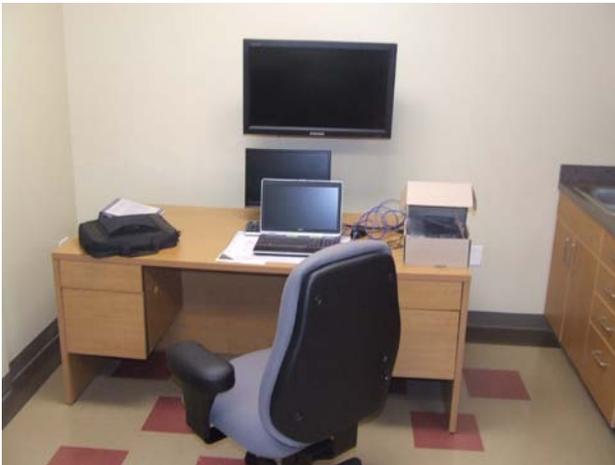
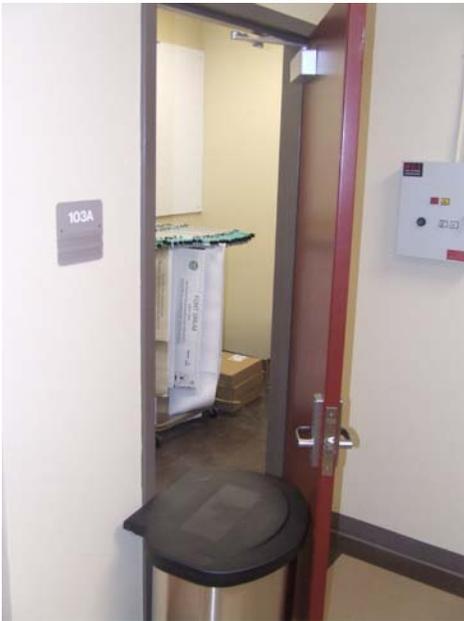
- The SCBA Compressor and Maintenance Rooms. These rooms were reconfigured to support the space requirements of the SCBA Compressor.
- Alternate 911 Center. The dispatch suite was converted into this room. A separate Telecommunications Room was required for the room and reconfiguring of the Dispatch Suite was performed.

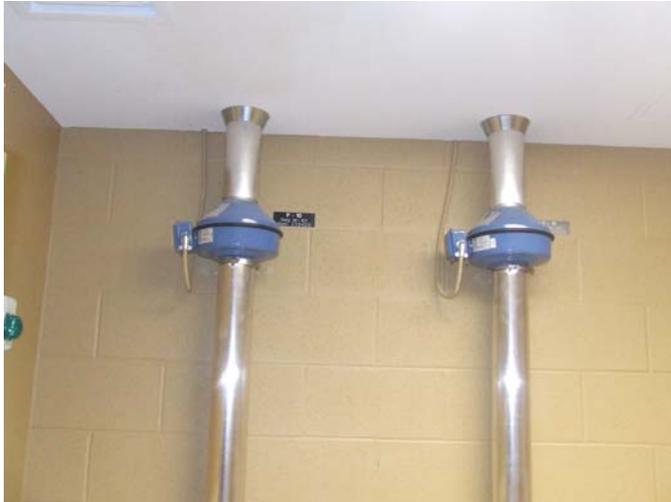
- In the Laundry Room, relays had to be attached to the dryer vents to assist in lint removal since the Laundry Room is expected to be located on an exterior wall.
