**U.S. Army Corps  
of Engineers**  
Engineering and Support  
Center, Huntsville

## **Fire Station #2**

**Building 68328  
Fort Huachuca, AZ**

**POTR – Phase 1  
Project No 60550**

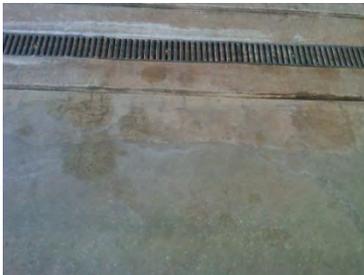
- The day room door is a maintenance issue due to the heavy use. Due to its proximity to the parking area, this is the primary door used by the users.
- Exterior LED lights are flickering.
- All exterior doors except for one has issues regarding the panic hardware and CAC reader.
- Water pump that sends recycled water (captured rain water) to hose bib for washing trucks is not working.
- Apparatus bay flooring is not resisting oil stains. Seems coating is allowing the oil to penetrate. May need to look at RFP working to be more prescriptive.

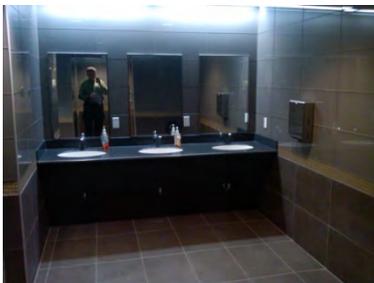
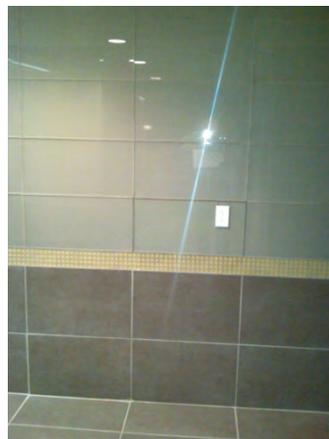
- Glass tile in the restrooms are cracking in some areas. The glass tile is more fragile than ceramic tile.

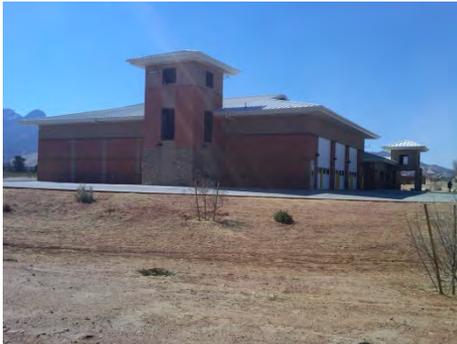
- The computer training room is now the Inspector Office
- Recycling Room has been converted to an office
- Hose drying tower was added. Made an agreement with HNC to add this during the RFP preparation.

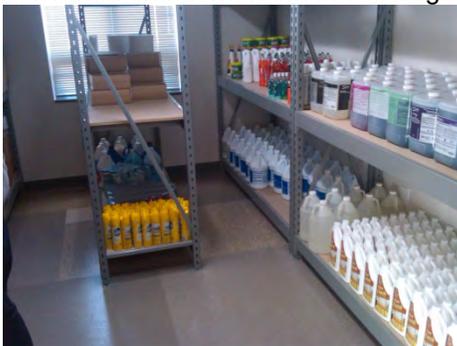
- OSHA says PPE must be in a separate room due to vehicle exhaust. Users insisted in dedicated room. Right now problem is fumes are being sucked into the PPE storage room by the ventilation system. The fumes then go through a filter and sent back into the apparatus bay.
- General storage room (room 112) is used as an office.
- SCBA Compressor Room and Maintenance Room have been combined into one larger room. They said the compressor would not have fit in the room allowed in the standard.
- Converted one dorm room into storage.

- A disadvantage of the Apparatus Bay general exhaust system is that exhaust fumes travel through the PPE Storage Room and leave residual contaminants on and in the PPE. A tailpipe source capture type exhaust system would eliminate this problem.

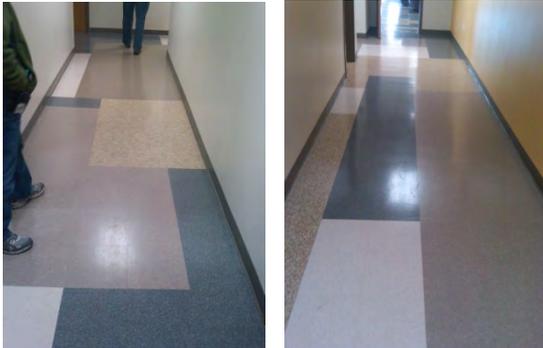
- Would prefer stained concrete floor to the VCT. The VCT pattern in this facility is very “unique”, and takes some getting used to. On the other hand, it appears that the pattern and texture would allow for repairs to be done to the VCT when required without being as apparent as on a solid single-color VCT floor.

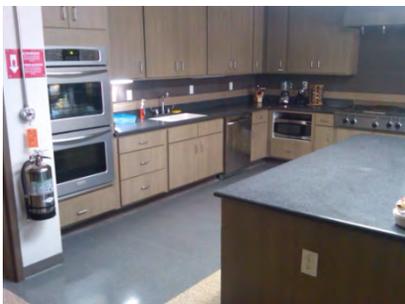
- Need a larger kitchen sink with a high gooseneck faucet.

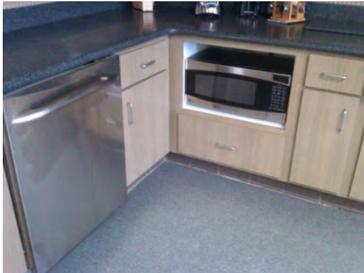
- Not able to shave due to the water saving faucets. Can't plug sink. Metered and pre-mixed water. Cannot get enough hot water. Have to wait in between pushes of faucet for water to come back on. Needs to be a residential style faucet.
- Individual room sheets in the standard indicate only data in the training room, which conflicts with I3A which requires voice as well.
- Need stripes on the apparatus bay floor for a guide when pulling into the bays.
- Facility needs more storage.
- Need to locate the microwaves either on or above the counters as opposed to below the counters. They are too low.

- Where natural gas is supplied to the building, provide natural gas line with capped and valved outlet for gas grille by others in the courtyard area outside.
- Do not provide metering lavatory faucets in Men's Toilet.

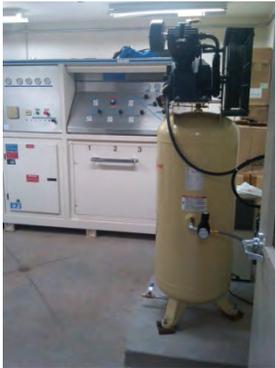
- They need a work bench area in the SCBA room.

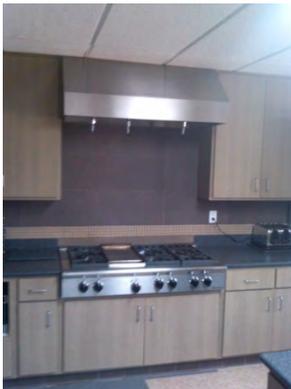
- Need better guidance on what kitchen equipment is to be provided as part of construction. Some issues regarding items such as built-in ovens and ranges (i.e. drop-in range) and dishwasher. Needs to be clarified in the RFP and criteria. Dishwasher was delivered, but not installed. Fire fighters had to install.

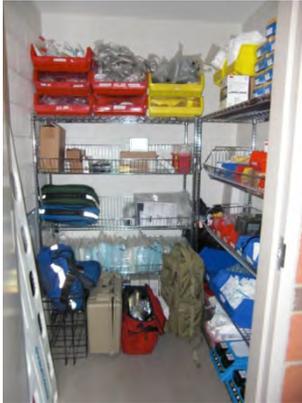
- The medical supply storage needs to be larger.

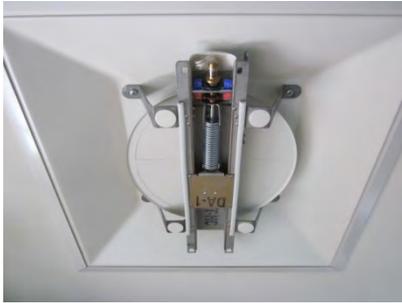
- Self-powered VAV supply diffusers with individual thermostats are used in the Dorm Rooms for individual temperature control. There does not appear to be any bypass duct to maintain minimum airflow. One of the refrigerant lines frosted up when the system was first operated and has been corrected. Running the unit below minimum supply air requirements could be problematic over time.

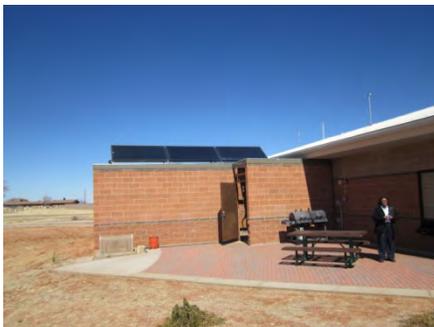
- Rainwater collection system for washing fire trucks was provided. System worked when building turned over but the pump is not working.
- Waterless urinals and metering lavatory faucets provided. Metering lavatory faucets in Men's Toilet are problematic when men are trying to shave.
- Water softener was added due to high mineral content of potable water.
- Solar hot water system provided and is working.

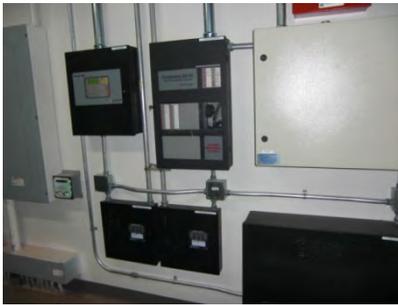
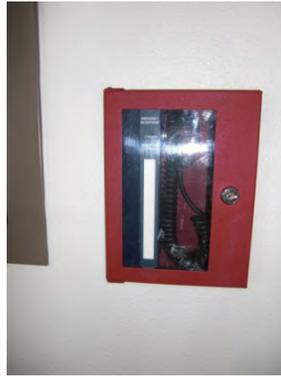
- The Mass Notification System is not coordinated and it does not work as designed. It will be repaired in March. The Fire Alert System was hard to understand.

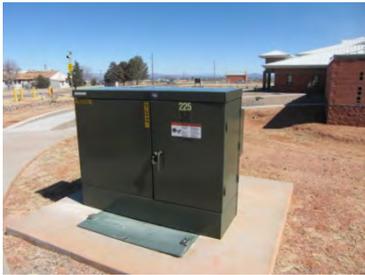
- The transformer is not metered.
