## **4<sup>th</sup> IBCT Physical Fitness Facility**

**Building 8437  
Fort Stewart, GA**

**POTR – Phase 1  
Project No 71152**

**DATE: October 17, 2012**

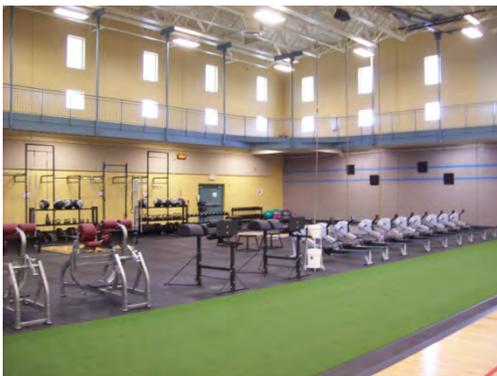
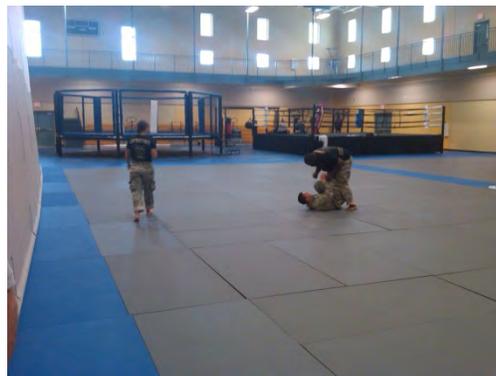
- Per command decision, one basketball court has been taken over by a cross fit area, and another has been turned into a combatives area. Only the middle basketball court remains. The cross-court tournament court is unusable. Serious concern that the wood floor under the cross fit area will be ruined with the cross fit is removed.

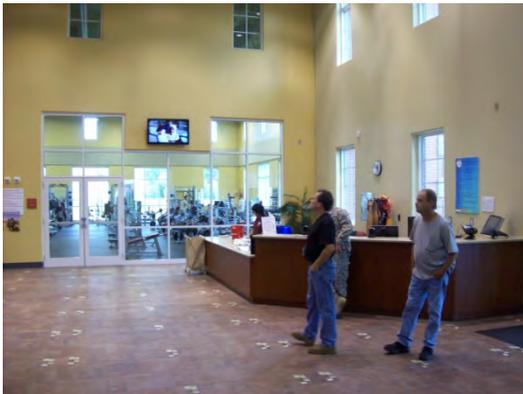
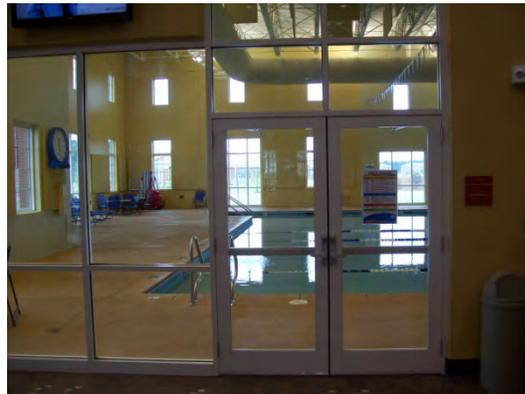
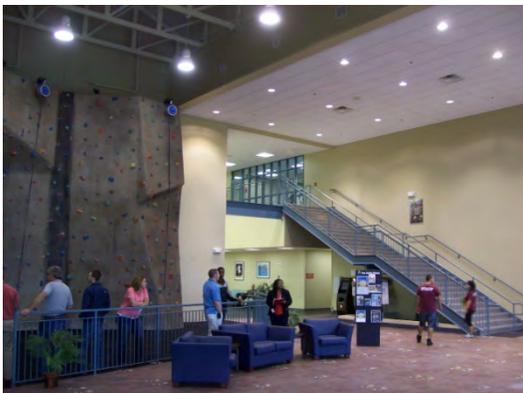
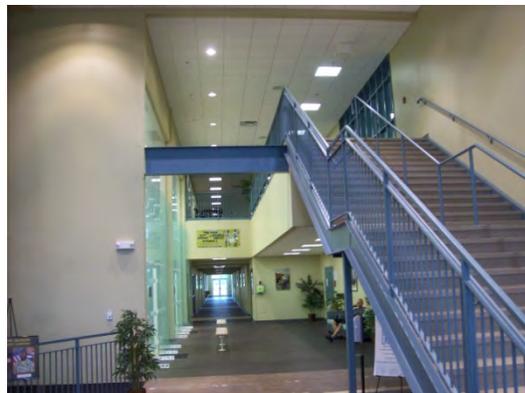
- They really like the cubbies in the various spaces around the facility.
- There were no ceiling fans in the facility.
- The control desk is located on the exterior wall to the right of the main entrance when you walk in. It has direct view into the fitness module through a glass wall, has direct view into pool area and racquetball courts. It also has direct vision of the climbing wall. A small storage room would be very beneficial. More data and power is required at the desk. Need at least 3 drops.

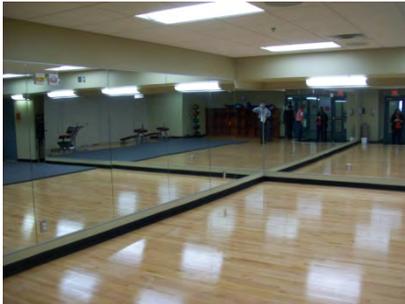
- The group exercise room is on the second floor. It is divisible; however, the door is bowed at the bottom. The ceiling is very low; approximately 8'-6". There is a small storage room that flows through from one side to the other.

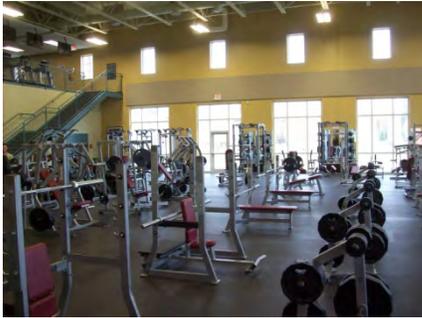
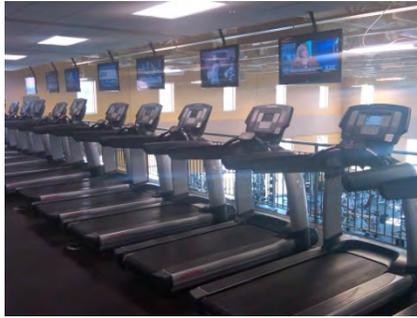
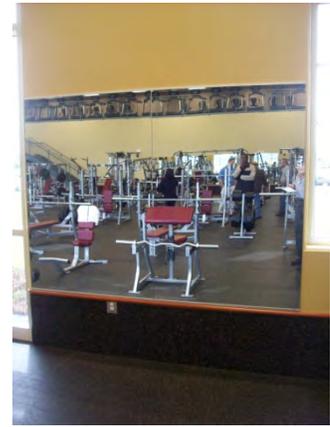
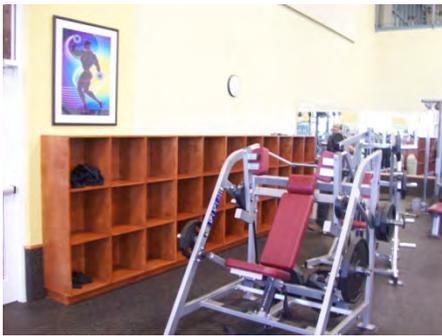
- The fitness module is a two story open space. There is a bank of cubbies as you walk into the space. The windows on the west face of the building cause heat gain in the fitness area. The floor is rubber tile. There are mirrors between the windows and on solid wall areas. The lighting is direct lighting. They like the wainscot of the flooring material with the wood trim on top. It is protecting the walls from damage. There is a cardio balcony overlooking the large space on the first floor.

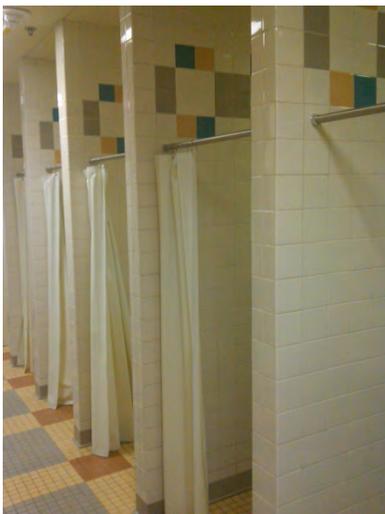
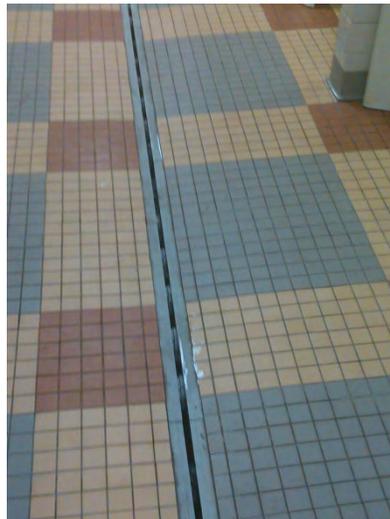
- The facility is provided with individual shower stalls with full-height ceramic tile walls. There is not really a separate drying stall (there is no separating curtain), but the shower stall is long enough to provide a drying area. The flooring is ceramic tile, and the ceiling is plaster. Originally, the floor in the shower room was not draining, so they had to come back and put a trench drain down the middle of the floor. The shower heads are on the sides of the stalls, which is preferred.

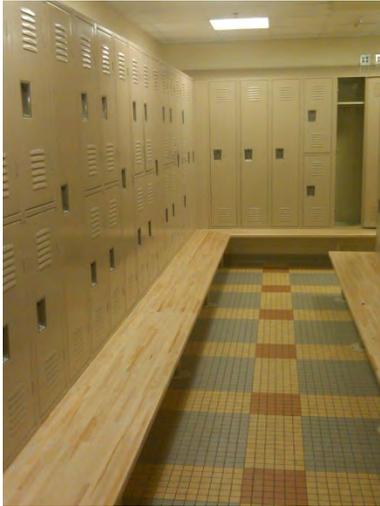
- There are enough lockers, but the number of showers is tight during PT. Lockers are NOT "Z-lockers",

and the users hate the “Z-lockers”. They are full-height and half-height metal lockers. This was a change after design since it’s a deviation from the criteria. The benches function as integral benches, but they are actually separate benches that are secured up against the lockers. The floor in the locker area is ceramic tile, and the ceiling is acoustical tile.

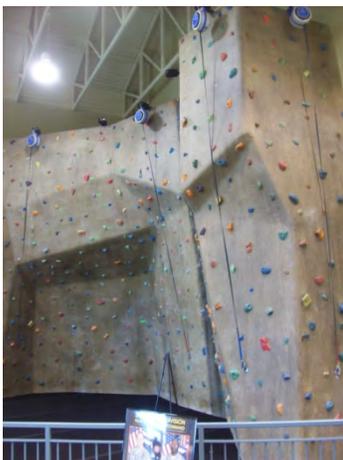
- The climbing wall is off of the lobby. It would be good to have a stair or ladder behind the climbing wall to access and change the lines.

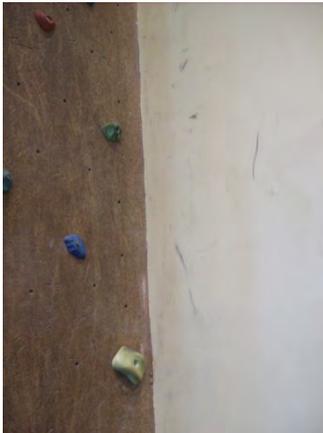
- Provide a data drop in the lobby area for a display board.
- On climbing wall, continue the wall finish onto the adjacent walls to protect them from damage and scuffing.

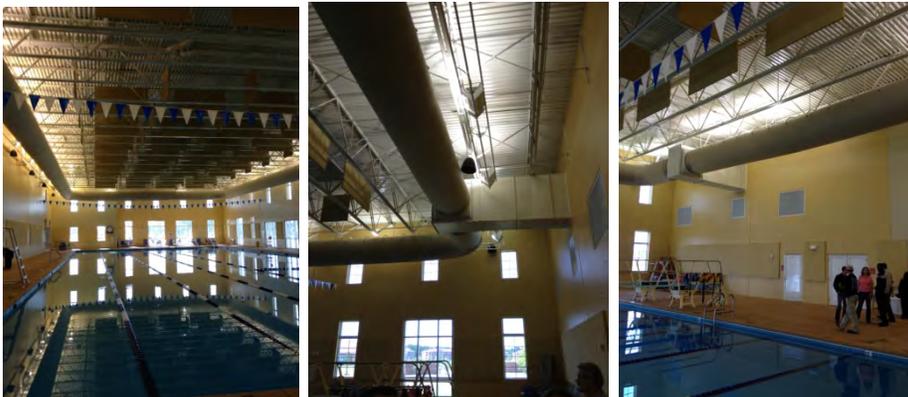
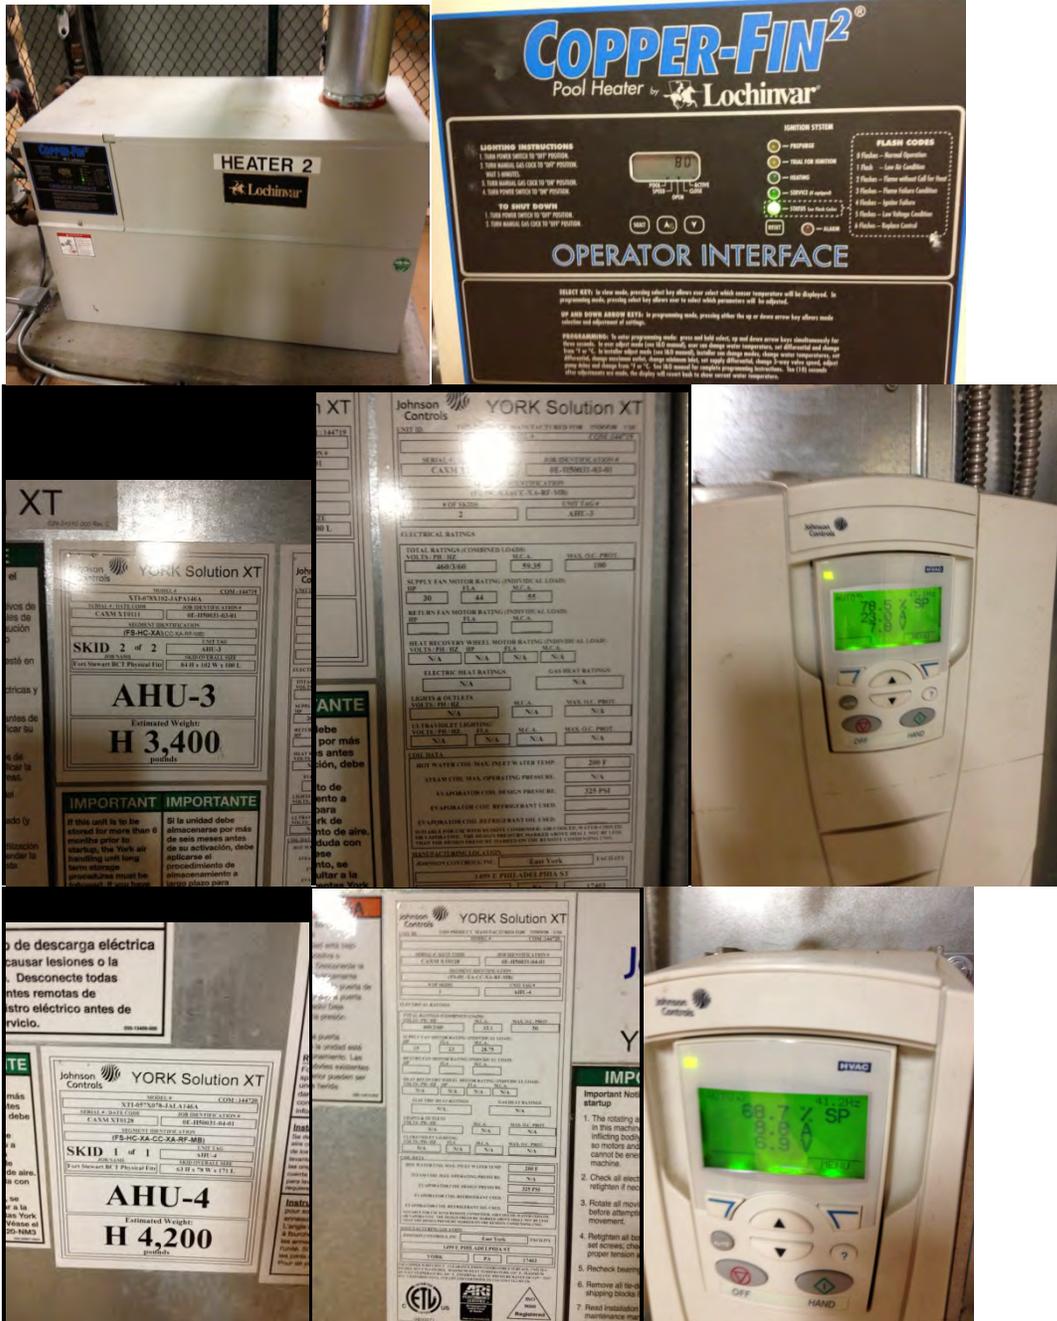
- The user, maintenance personnel and facility engineers indicated that there are issues with the high humidity levels and temperature in the pool area. When walking through the pool area, the water temperature was 80 degrees F and the environment was very warm and humid. The facility maintenance personnel and engineers indicated that the problem was created by the heat valves of air handling units 3 and 4 not being fed. The maintenance personnel indicated that they were trying to address the issues by adjusting the controls associated with these units.

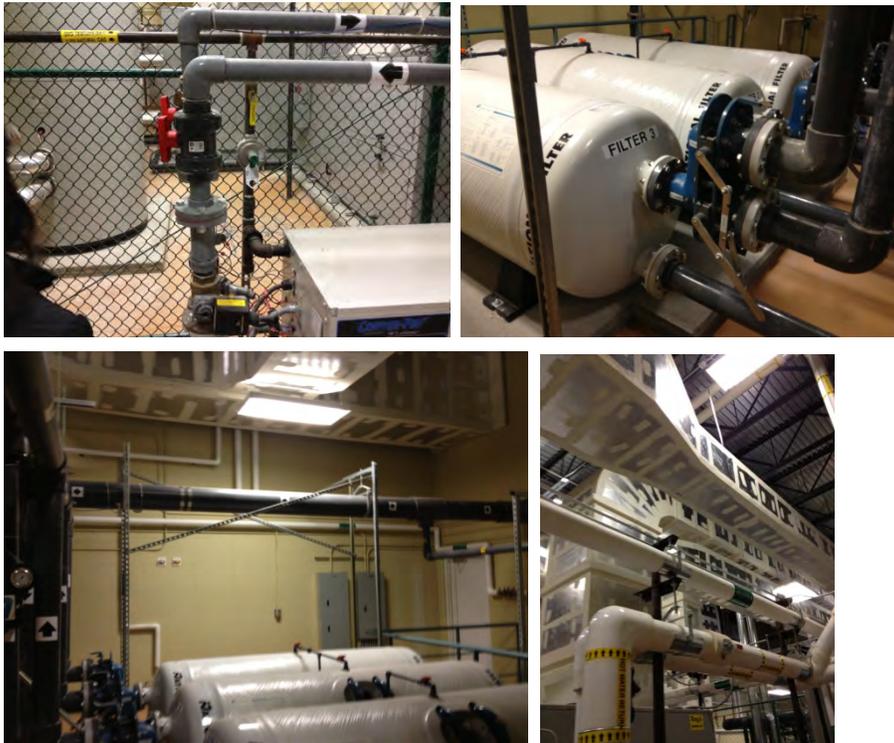
- The mechanical room for the facility seemed to be of an adequate size. One issue that was noticed

was that it is going to be very difficult to change the light bulbs out in the mechanical room. The fixtures are set high in the area and mechanical equipment was placed directly under the fixtures. If the need arises to change out the bulbs, a man lift or ladders cannot be utilized due to the location of the equipment and space constraints. However, the facility engineers and maintenance personnel had no complaints with the spaces allocated with the mechanical room or the pump control room.

- Suggest adding a timer switch to the steam rooms in the locker room areas that controls the on/off function of the steam system. For example, after the desired time expires, the power to the steam system shuts off. This would limit the systems run time to only activate when someone is utilizing the steam room and therefore significantly reduce the scale build-up in the system.
- The humidity and temperature issues need to be addressed in the pool area.
- The issues with the chiller need to be corrected so that it functions properly.
- Consideration for changing lights and fixtures in the mechanical room need to be addressed in future equipment or electrical lighting lay outs.

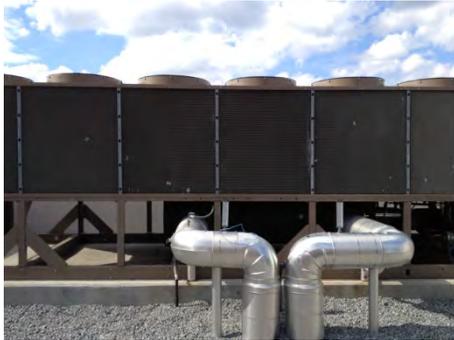
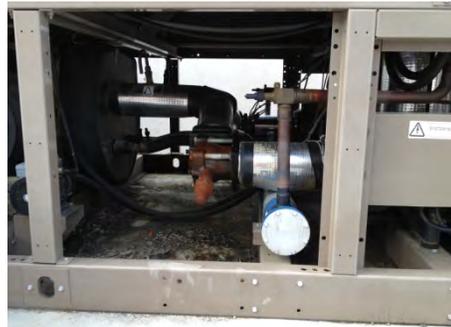
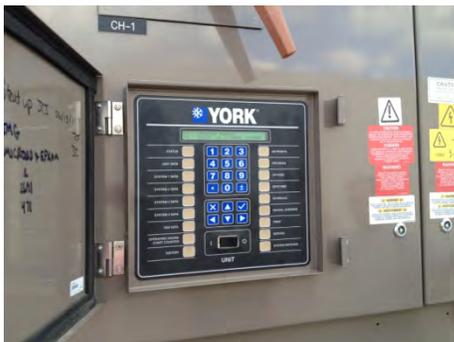
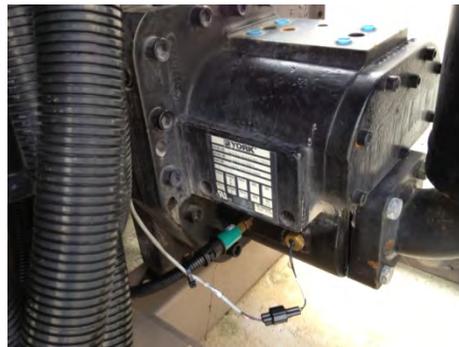
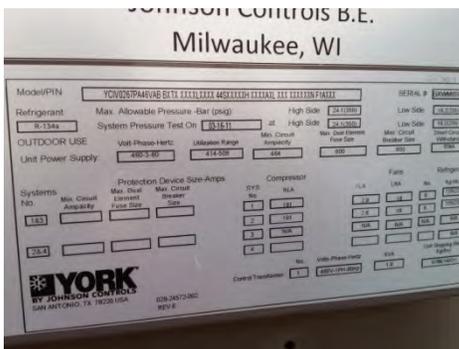
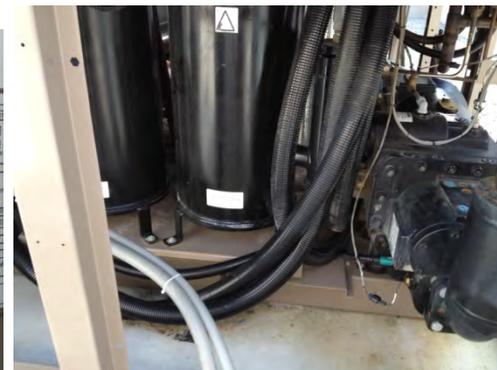
- The maintenance personnel indicated that they were having multiple warranty issues with the chiller. They currently have a bad condenser fan and either a drain valve or flash tank entry valve not operating properly. They are waiting on the warranty repair, but are worried because the warranty expires in November 2012.

- All warranty repair issues need to be quickly resolved at this facility before the warranty runs out. Facility engineers and maintenance personnel indicated that the majority of the warranty issues are created from the scheduling difference between construction completion and the actual occupancy of the facilities. The facilities will be completed and placed into an active status which starts the warranty on the equipment of the facility. Then it may be an extend amount of time before the facility can be occupied. By the time people are able to use the facility and equipment is breaking or not functioning as it should, the warranties are close to expiring. Suggest coordinating construction completion and occupancy schedules so that full use of equipment warranties can be utilized.

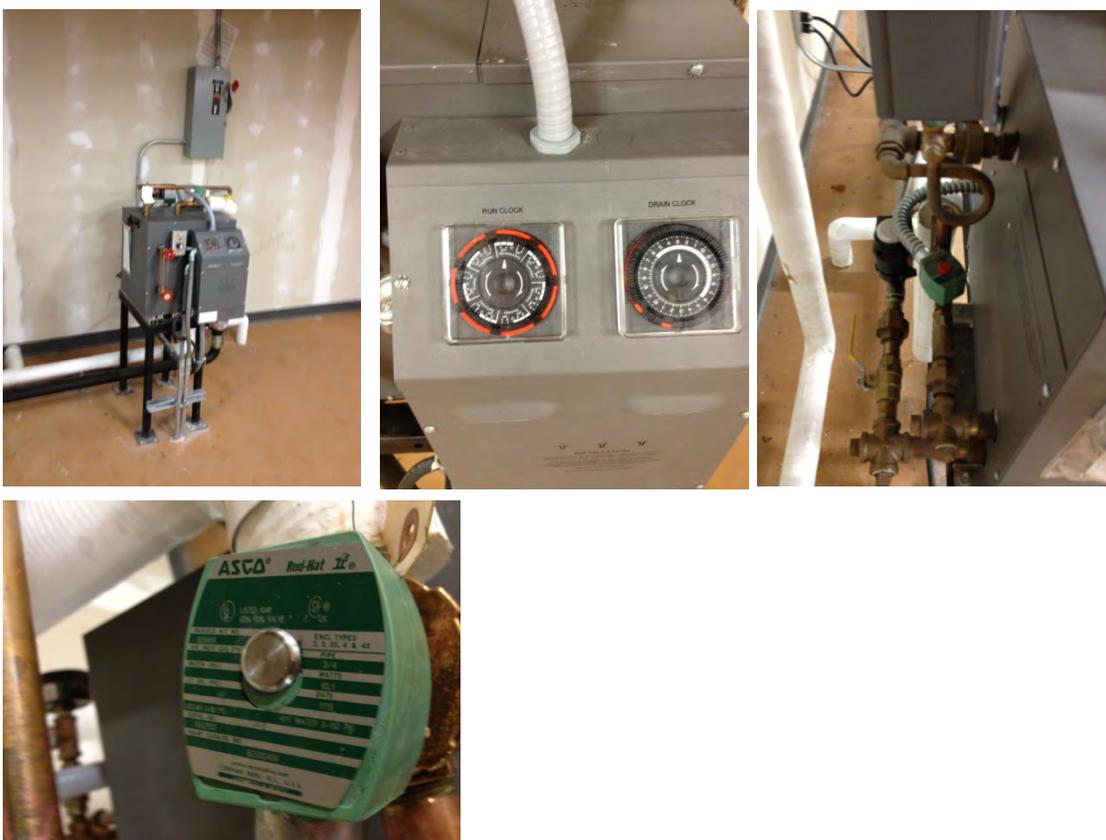
- Facility engineers and maintenance personnel indicated that scheduled maintenance and service for the plumbing equipment was being properly followed.
- The facility engineers and maintenance personnel indicated that there is an issue with scale build-up in the valves and within the steam generating systems for the steam room in the locker rooms. The issue is that there is an “on/off” switch and a timer outside of the steam room. The timer does not shut off the steam once the desired duration has been reached. Therefore the steam system continues to run after the time has expired and has the potential to run all day unless someone turns it off creating an overheating of the system. The scale frequently plugs up the system and requires a thorough cleaning.

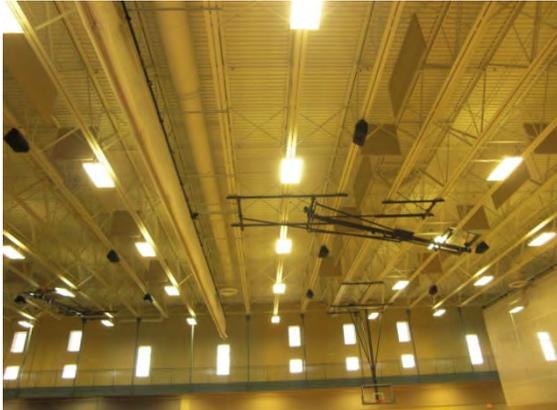
- Document satisfaction with intercom system (announcements understandable). The intercom is not operational. There is no sound from the speakers in the gymnasium.

- The intercom does not work in rooms 207-1 and 207-2. The User had an XM Radio installed after the building was turned over. This could have caused speakers in the in the gymnasium to not work. The contractor has not been notified about this issue. There may be a warranty issue with this sound system.

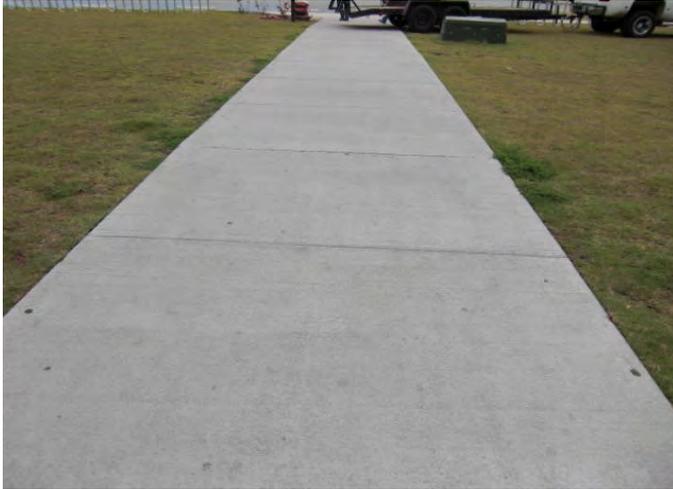
- The entrance sidewalk is really too narrow for the size of facility.
