**U.S. Army Corps
of Engineers**
Engineering and Support
Center, Huntsville

Ft. Leonard Wood Child Development Center (6-10);

**ESTR – Phase 1
Project No 54914**

February, 2011

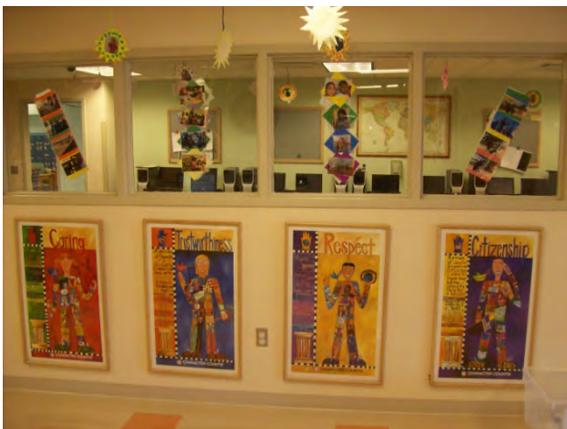
- There is no desire for TV in the activity room(s).
- Assistant director and Maintenance person are using the training room as well as the trainer.
- Like the 4 windows side by side into the computer lab. However, due to accreditation requirements, there needs to be a lot of space for announcements on that wall.

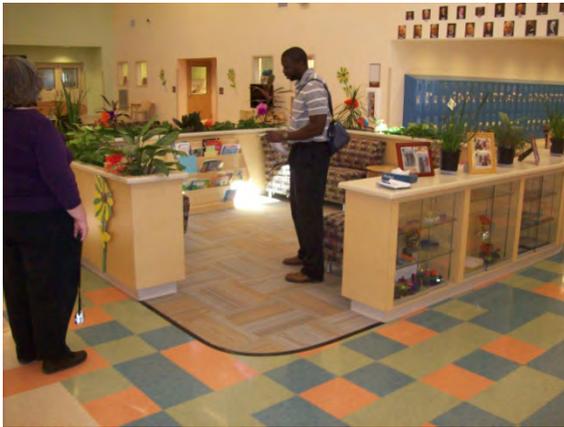
- Like the carpet in the waiting area. In this facility this area is used for parents waiting.

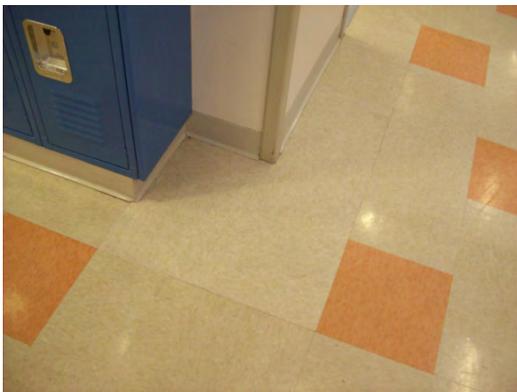
- There has been a lot of settling; they have had to replace VCT at corners, and have had to repair gyp. bd. cracks as well. Now you can see raised area in floor in cafeteria wing. Also led to cracks in the Ceramic Tile floors.

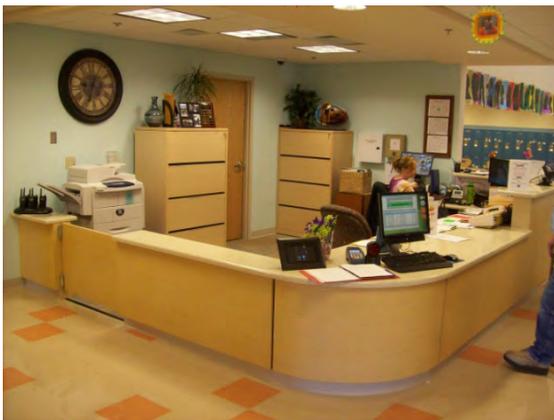
- It would be better if the window in the Director's Office was on the wall next to the door so they could watch the reception counter.
- Needs to be a cable TV outlet in the break room.
- FFE – need to change to wall mounted flat screen TV in lounge to maximize the space in the room.
- Storage in training room needs to have adjustable shelves.
- Don't need the swinging gate into the counter area.
- Flip the reception counter so that the high area is on the corner by the front door.

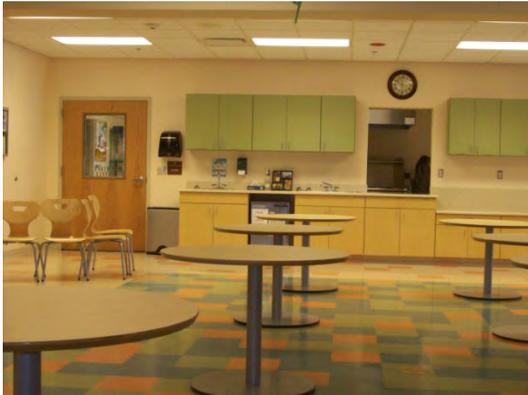
- Accountability boards not in a good location in the cafeteria. Not easily accessible to parents. Maybe should be on wall under comp lab window across from parent waiting.
- Has 4' wide door from the cafeteria area into the kitchen which is too wide, too heavy, and unnecessary. It does not have self closer, and therefore they get written up for it not being self closing.

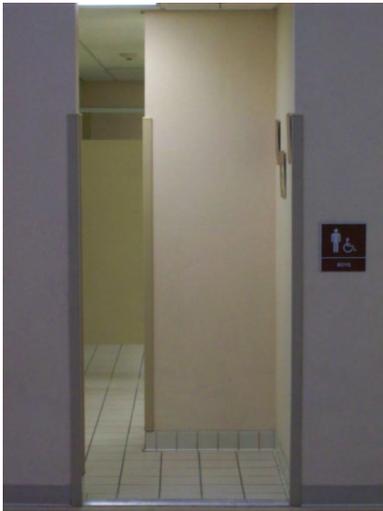
- Sinks in counter in cafeteria area need to be for hand washing for the children before they prepare their food. Need to relook at this area to provide a low and high hand washing sink at the left end of the counter, with demo kitchen type sinks towards the right.
- Question the need for refrigerator in the demo kitchen.
- Need hand washing sink as you enter into the kitchen.
- Could use a bigger freezer and dry storage area.
- Could use a steamer in the kitchen.
- There is a line of sight issue with the main restrooms. The wing walls are not long enough to block views into the stalls.

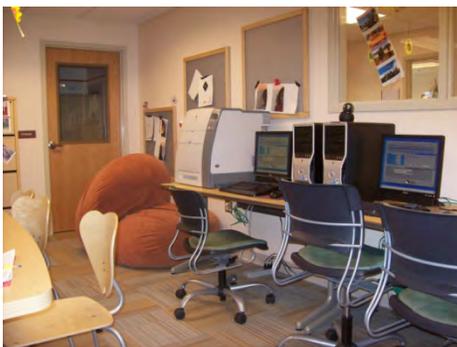
- Built in shelving would be good in the storage area off of the multi-purpose room.
- Need ability to lock multi-purpose room off from rest of building.
- There is a door between the multi-purpose room and the corridor with the restrooms. This would allow people using outdoor fields to have access to restrooms without having the center open.
- Glare from window in exterior door of computer lab affects viewing of computers.
- Would like half wall between computer lab and homework room; then 1 staff person could monitor both.
- Computer lab is too small since for accreditation each area needs to provide a “soft” area.

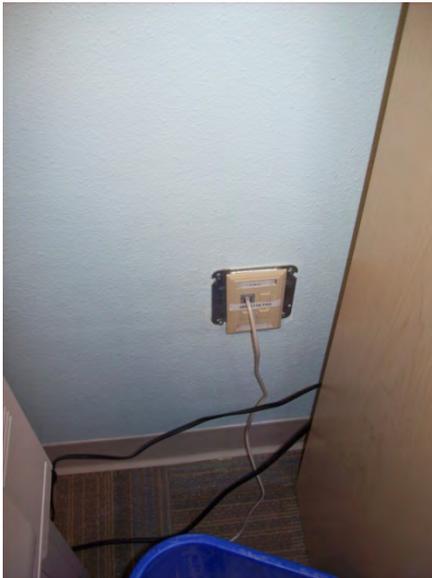
- Need to provide adequate data lines in reception desk area, to include where printer is located.

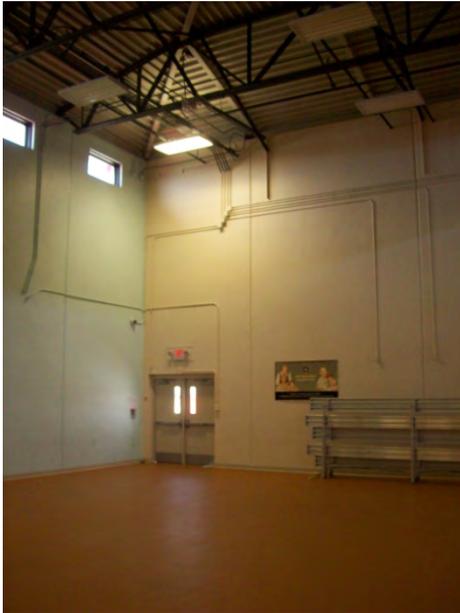
- Since the building construction of the multi-purpose room was precast panels, all the conduit was surface mounted, which looks bad.

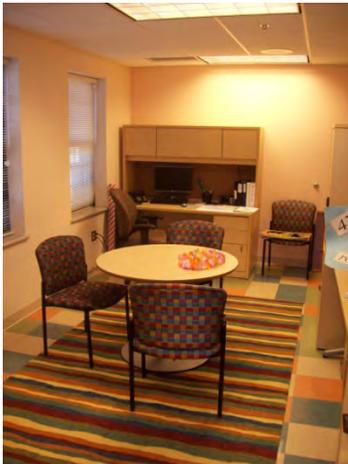
- This facility had a smell when it opened, but they think it was from the p-traps.
- No shading on windows. Needs to be provided where it is very bright and hot. Standard should address shading.
- Relocating school liaison to the training room and moving the IT/Maintenance to better support the parents.
- Using the director's office for small training or computer room if training whole staff. Training Room is being used as offices.

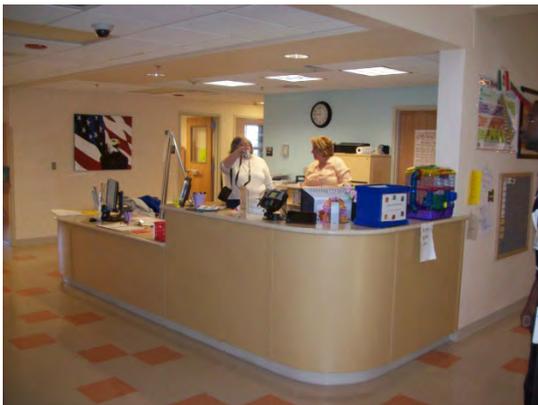
- A redundant air conditioning system would be great. Right now when the system goes down, it takes several weeks to fix, which means no cooling.
- Break room closet is not as important as training room closet.
- There is no dishwasher in the break room, and there really isn't a need for one.
- No furr-down and accent lighting was provided over the reception counter. There are some can lights that actually are located over the chairs behind the counter.

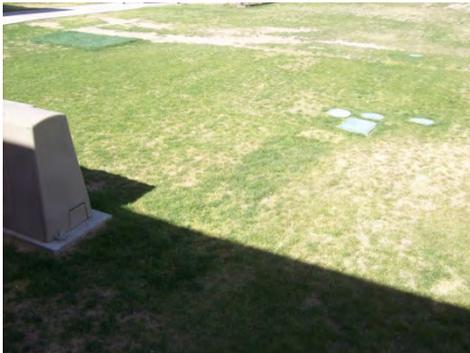
- The roll-down door on the pass-through window in the kitchen is manual operated.
- Ice cream maker was not installed because there is no water line available, and a water line is required.
- Recycling room is now being used by IT, but will be the maintenance office.
- Front desk person is responsible for monitoring a sick child.
- Heater at door next to kitchen to the outside is not needed.
- Playground area surfacing is supposed to be poured in place instead of loose rubber.
- Ft. Bliss removes the shade structure covering in times of high winds.
- Playground area has irrigation meter, manholes, and various other covers (at least 10 items) that are a hazard and should not be in the playground area.

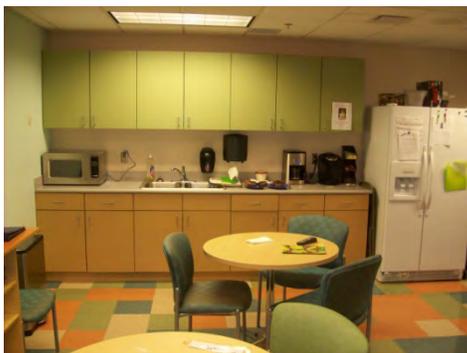
- It would be better if the window in the Director's Office was on the wall next to the door so they could watch the reception counter.
- Shelves are required in the training room storage room.
- Break room is very tight when not in swing shift. Could look at moving lockers to enlarge. Lockers could be on end wall or on wall by the door.
- Needs to be a cable TV outlet in the break room.
- In the break room, raise the microwave off of the counter and provide more counter space. The cabinets are overkill.

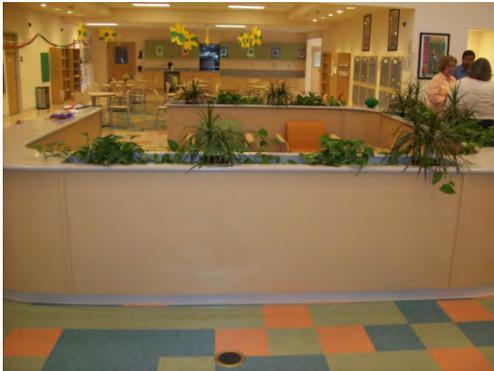
- Needs more storage at the control desk.
- Need more data drops at the control desk. Six would be ideal and make sure to have one on the wall where the copier/printer is located.
- Electrical outlets in floor need to be inside waiting area, not outside.

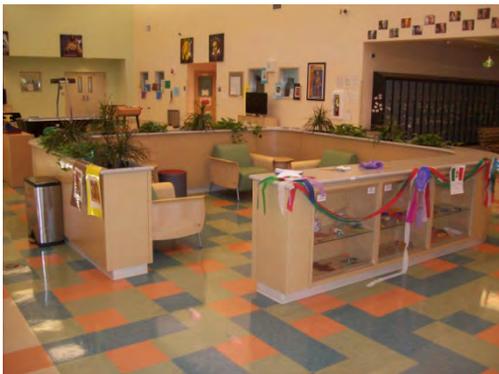
- Cabinetry around waiting area needs to be permanent with outlets in the cabinetry.
- Design the cabinetry around the waiting area with some shelving opening to the inside for games, etc. Also, provide the plant cut-outs at the corners so shelves and display cases can be put in the straight areas of the cabinetry.

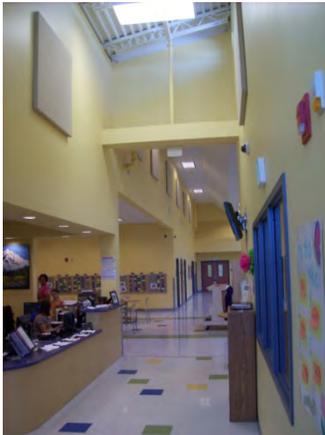
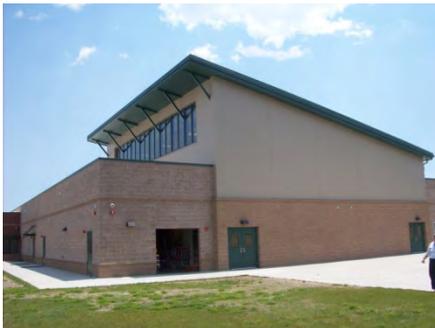
- Doors are not closing all the way. This is a function of the hardware more than an issue with the HVAC. Hardware has been a problem on this facility.
- There is a problem with a smell throughout the building. Can smell it inside and outside the building.
- There was a bad leak in the storage room. They think it might have been up from the ground.
- Computer lab was overheating, but something was wrong with the system, and it has been corrected.
- Has a refrigerator in the Director's office for medication.
- The outside of the facility is a departure from the look of the standard design. However, building is very attractive, and the design included a full length clerestory window above the atrium and above the multi-purpose rooms which provided more natural light. Also provided higher ceiling and natural light in entry corridor at reception desk.

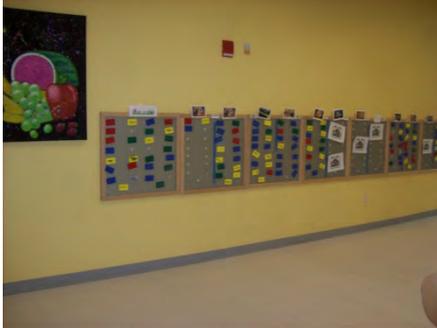
- Accountability is on 1 main board that is broken into individual spaces. The children have 1 card they put on that board to show their location.

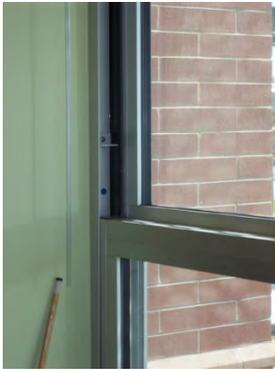
- In winter there is a serious draft through the windows in the training room.
- Windows – top sash fully operable; bottom sash can open about 6-8 inches.

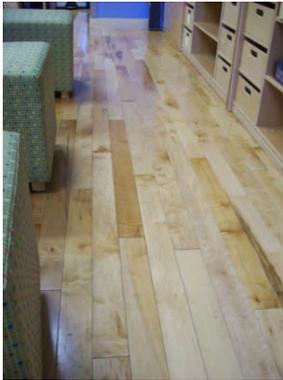
- Intercom system does not work, so the desk won't respond. There is no intercom provided in the computer lab.
- Have waterless urinals in boy's restroom.
- Dryers are not on the exterior wall, they are ducted up through the ceiling.
- Drama room has wood floor and no dance bar.

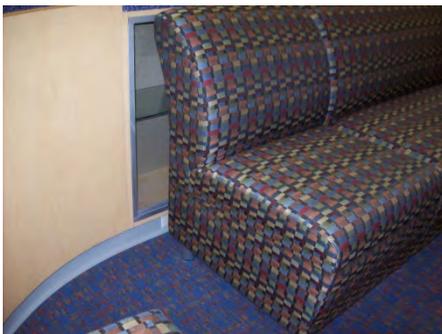
- There had been a glass mirror in the multi-purpose room. A child ran into it and got glass in their head. They replaced the mirror with a plastic mirror.
- Fenced area does not include all activity room doors.
- The waiting area is used for parents and kids. Glass display cases open into the waiting area, which causes a problem with furniture placement.

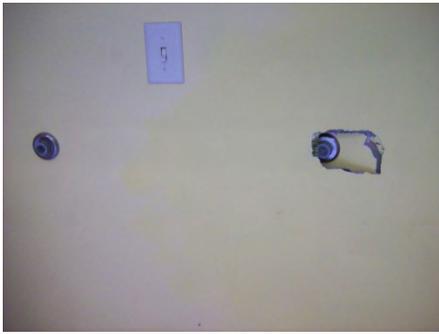
- Have a roll up door into the large storage room.
- Some areas have damage from where the door has been opened too hard and has punched a hole in the gypsum wall.

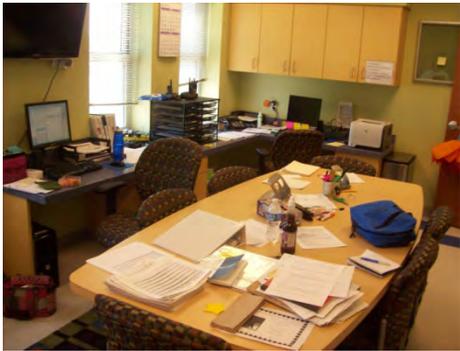
- Closet in training room needs shelving.
- Conference table is too large for the size of the training room.

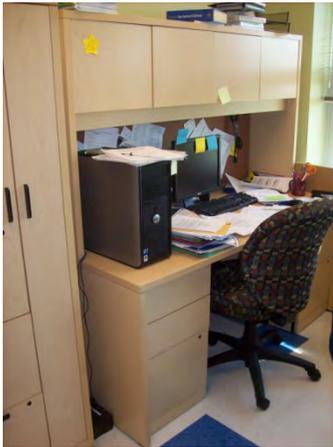
- Training room TV is mounted on opposite wall from data port and white board. Have to run cords under the table. Should provide data/CATV/receptacles on both walls.
- Training Room furniture needs more filing. Multi-use storage unit not overly useful. They can hang coat in locker in lounge.
- In training room, not enough space for tower for computer in the furniture arrangement; it must sit on the desk. Storage unit won't allow room door to fully open.

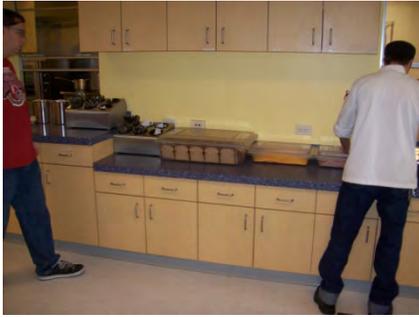
- Training kitchen does not really function for training. Really just an area to put the prepared food on at meal time. The director wants to get warmers to put in the training kitchen to allow the children to heat their own meals.

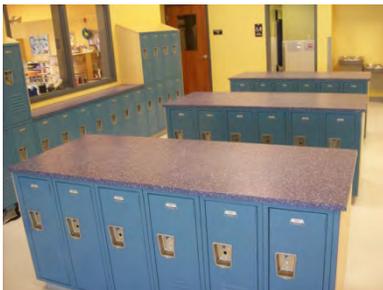
- Surprised there is no walk-in freezer, only a walk-in refrigerator. Needs more food storage in the kitchen, especially since this is a large facility.
- Don't really need a 3-compartment sink except at high end restaurant.
- Only need 1 hand washing sink.
- Ice cream machine cannot be used because it needs water, power, and a drain.
- Due to a lack of space elsewhere, the desk in the kitchen was placed in the dry storage room, and the room was retrofit with data.
- Not enough child lockers for the capacity of the facility.
