**U.S. Army Corps
of Engineers**
Engineering and Support
Center, Huntsville

School Age Center

**Building 7160
Fort Stewart, GA**

**POTR – Phase 1
Project No 71177**

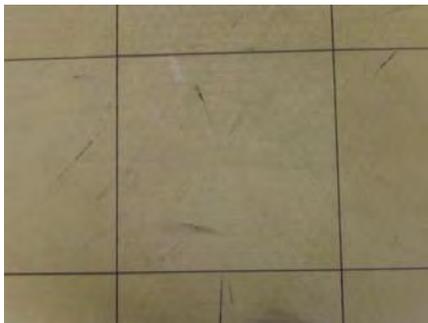
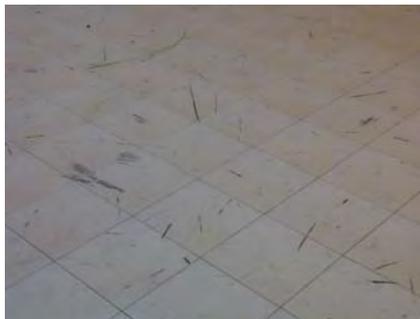
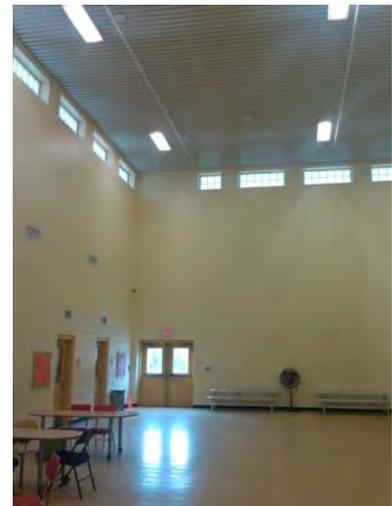
- Floor in the multi-purpose room is bad. It is a tile system that lays on the floor. The tiles are 1' x 1' and snap together. They are difficult to clean, there is concern with sanitation with all the joints, and black marks are evident across the entire floor. The COS recommended the installation follow up with getting this changed since the RFP requirements state "minimal seams" for this floor. The system installed provides the MAXIMUM seams possible. The team was asked to contact Brian Mock regarding the floor concerns. Richard.B.Mock@usace.army.mil.

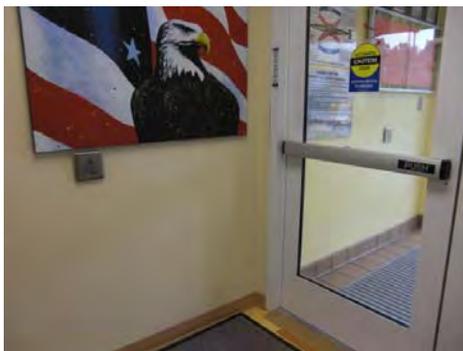
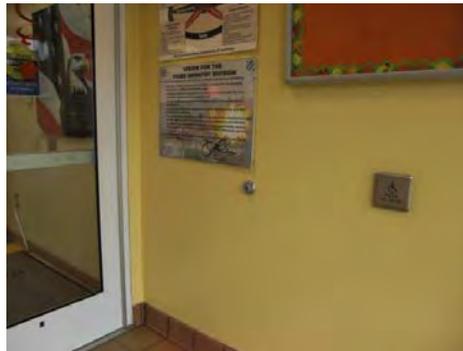
- There is an issue with the handicap push buttons for the doors. There is a button located outside of the facility to open the outer door. There is a button located inside the vestibule to open the outer door. There is a button located in the waiting area to open the inner door. What is missing is a button in the vestibule to open the inner door. The installation is researching this issue.

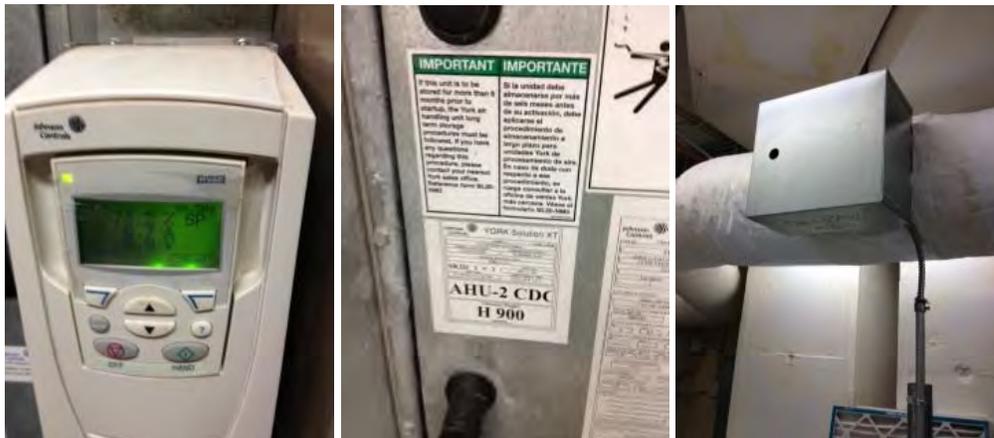
- Overall the user and the facility engineers indicated that the HVAC system installed provides a comfortable environment with exception to the common area in which the children play indoors. The common area was very humid. The user had also indicated that the temperatures seem to fluctuate throughout the facility. The facility engineer indicated that the humidity problem is created from AHU-2 being a constant volume unit and not having the ability to control the outside air. Maintenance personnel and facility engineers indicated that they were going to correct this problem, first by adjusting the controls, and if that doesn't correct the problem, then adding additional VAVs to the AHU-2 system and possibly a heating coil to control the humidity.

- The humidity and temperature issue with the air handling unit supporting the common area of the facility need to be resolved so that the children have a comfortable environment to play in doors.

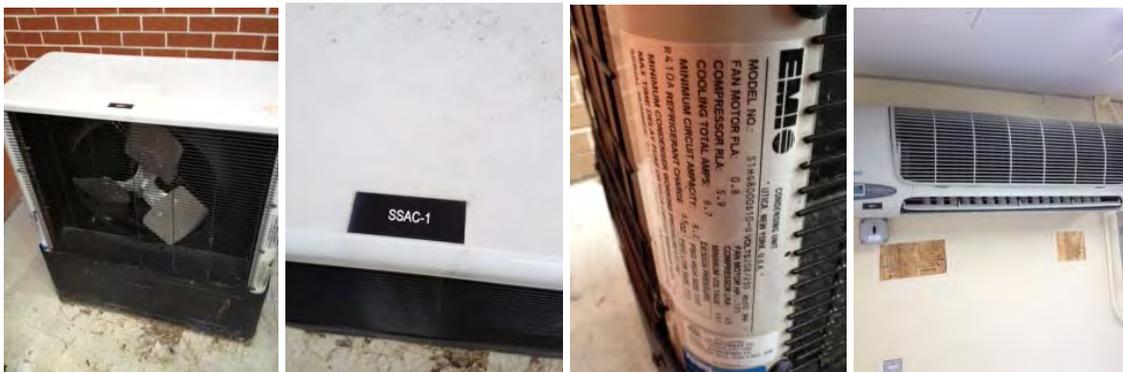
- The split system unit SSAC-1 which provides heating and cooling for the communications room was not working during the walk through. There was a ticket logged prior to the walk through and the issue was being resolved during the POTR.

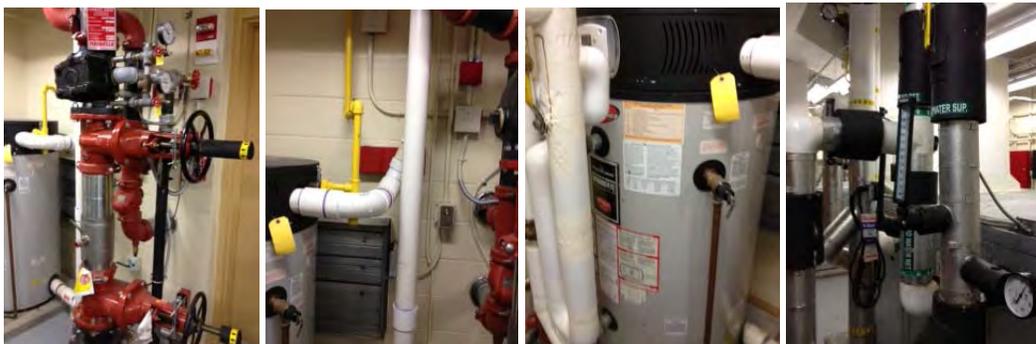
- The mechanical room was very small and cramped with 2 air handling units, an energy recovery system, boiler, fire sprinkler risers, water pumps and piping, etc.

- The mechanical room is very small with the amount of equipment necessary for a functioning facility. Suggest either expanding the footprint of the mechanical room so that mechanical equipment and controls can be properly placed, duct work can be run properly, and major pieces of equipment can be easily removed and installed to and from the room when replacement is necessary. Another suggestion for space savings might be installing a larger unit with VAVs to control the different zones instead of having an air handling unit for each zone.

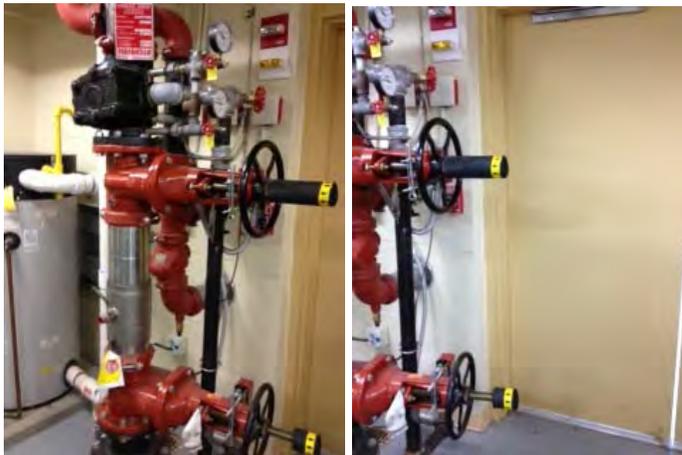
- All equipment seemed to be easily accessible for minor maintenance.
- The fire sprinkler riser shut off valve stems projected into the main entry way of the mechanical room making pass through difficult and will be even more difficult when moving equipment in and out.

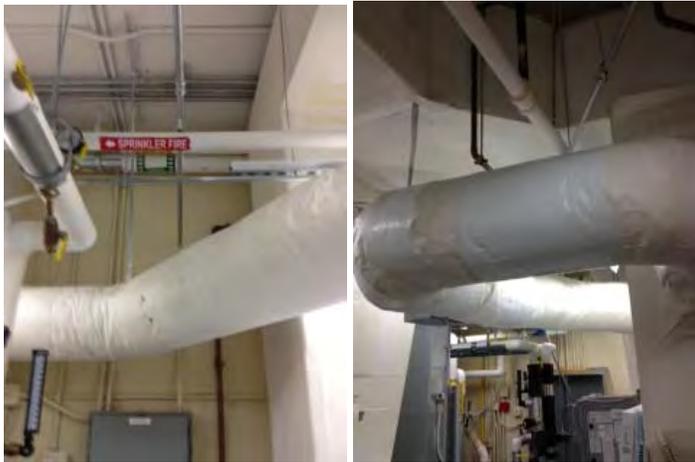
- The lack of space in the mechanical room is going to make it very difficult to replace major components of the mechanical systems, such as a coil replacement.
- No straight duct could be run in the mechanical room due to the lack of space which created issues with the airflow sensors.

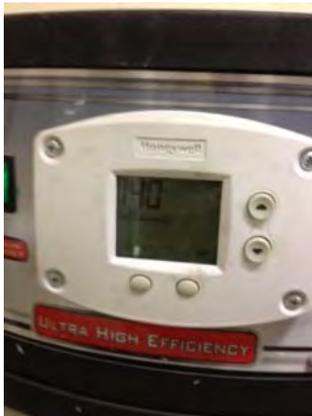
- All plumbing fixtures throughout the facility worked properly and the user had no complaints.
- The water fountain outside of the boys and girls bathroom had a leak. A ticket had been submitted to correct this issue.
- The user and facility engineers indicated that they were pleased with the overall plumbing system.
- The hot water in the boiler was being stored at 140 degrees F.

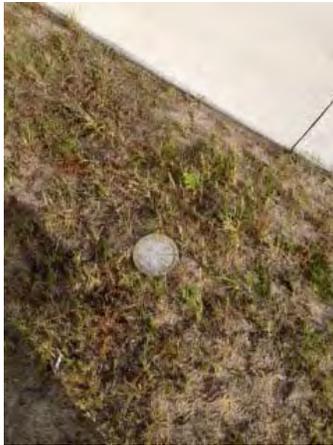
- There is a clean out in the yard to the left of the facility that needs a concrete collar. The clean out could get lost in the grass and become a mowing or tripping hazard.

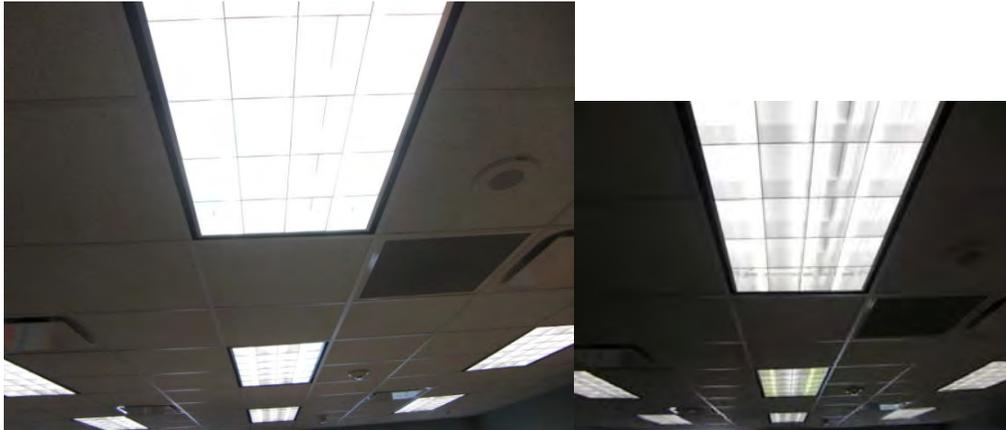
- In the Computer Room, when the lights are dimmed, they flicker.

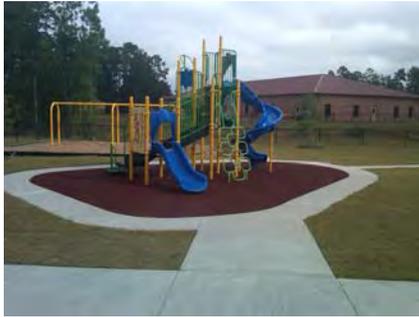
- Playground structure is inadequate. It is too small and is boring. They are getting more playground equipment themselves.

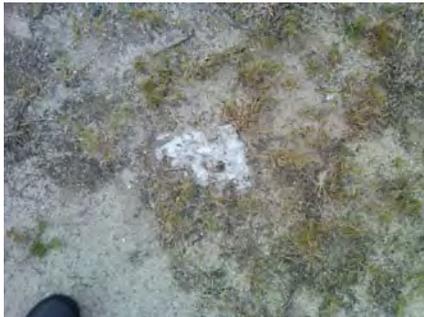
- SAC soccer field is basically all dirt. There are also large rocks in the area. Fortunately they are located next to an installation soccer field.

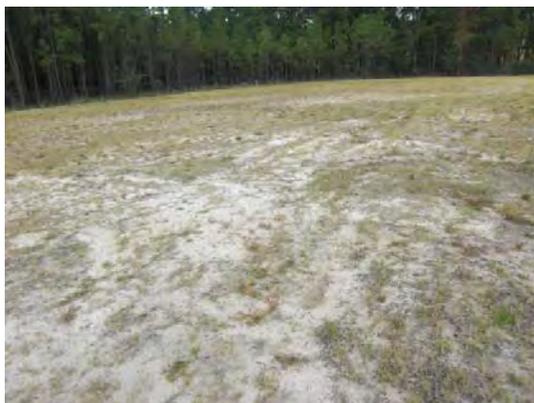
- Document overall site conditions. The grass in the playground does not cover the whole yard. It is patchy.

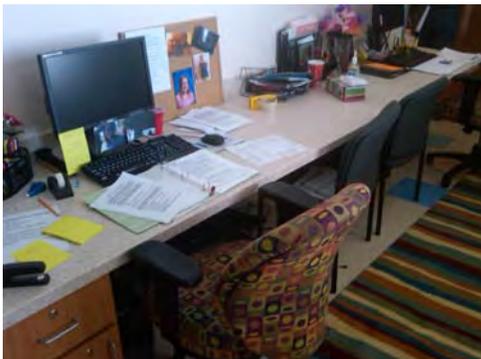
- Training room was provided with a built-in desk/counter which takes a lot of space, and does not allow the use of the table which was provided for this space. In addition, the training room is too small for a facility of this size. There is no way to train more than 6-8 staff at one time in this space.

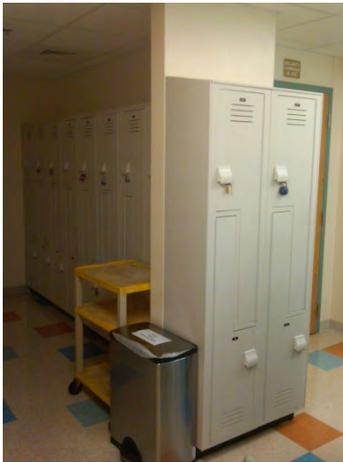
- The Assistant Director needs an office. There is inadequate staff space in this facility.
- The staff lounge is too small for this facility. Some lockers were provided around the corner which impacted usable space. The space in front of the lockers seems too large and wasted as there is nothing you can do with that space.

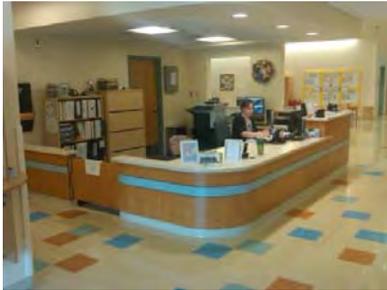
- Swing gate into reception counter has been an issue, and the replacement one is now hitting the counter again. The top hinge appears to be loose, although there is no visible way to tighten it.

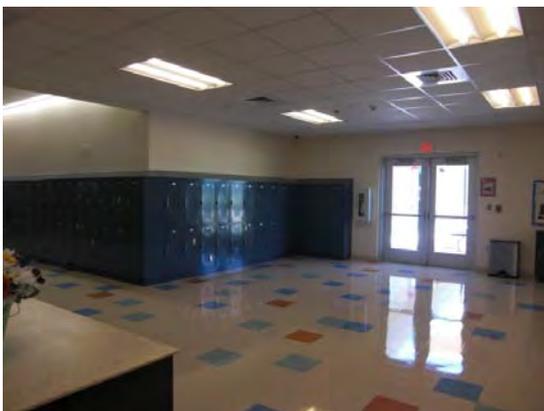
- Lockers in blind corner of atrium, by door to playground, are not ideal. Things can happen there, and have. Try to eliminate the "nook" as well.

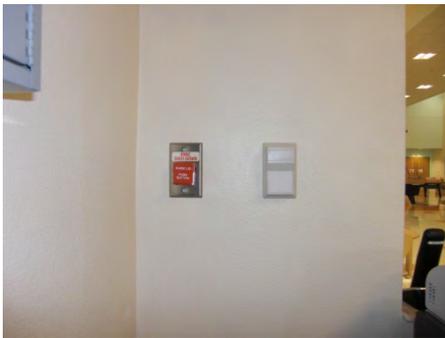
- The HVAC would shut off daily. They found that the flow sensor was bad in the chiller. Had to go directly to sub to get it fixed. AMC kept messing around and not responding. During the POTR it was found that the unit that serves the admin and computer lab and other activity rooms on the front is having a faulty reading regarding drainage, thereby shutting down that system. It was being worked.
- There is a HVAC Emergency Shut-off switch.

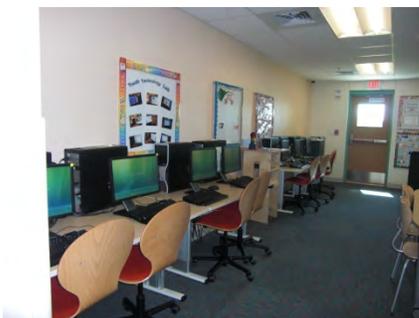
- The Computer Room is too warm.

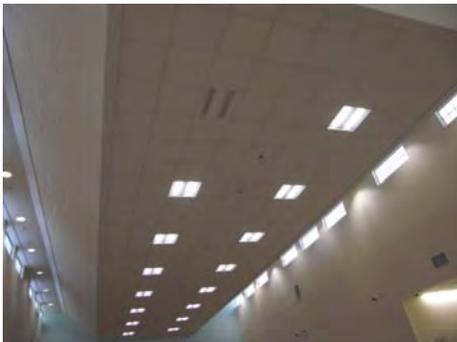
- Fire alarm - every time a power hit or spike the fire alarm would go off. They traced it and believe it was an issue with the reset in the kitchen hood. They has not been a recent variation in power to tell if the problem has been fixed.
- Had issues with smoke detectors. Had to add/relocate due to variations in ceiling heights. Detectors had to be relocated/added in the atrium areas.

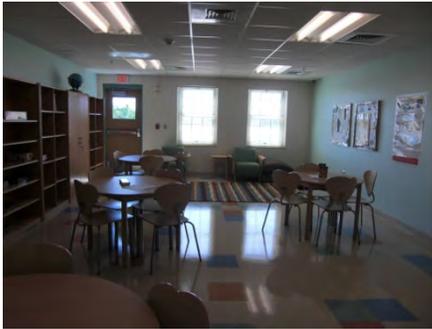
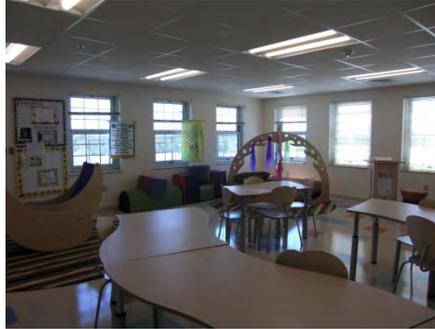
- Lights are starting to have ballast problems. Due to construction delays, the lights were burning for 2 years before the facility even opened.
- Inadequate number of data ports for the facility. The switch will only allow for 24. Need at least 36.
- The lamps in child accessible areas are enclosed by lens/shields

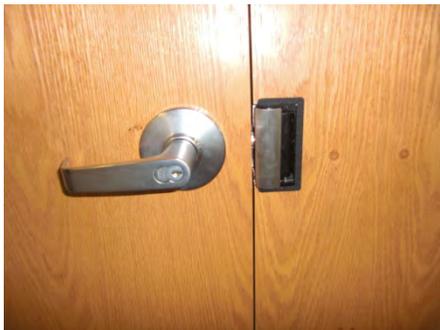
- Storage Room 127 is not secure. The lock is easy to open with a card.

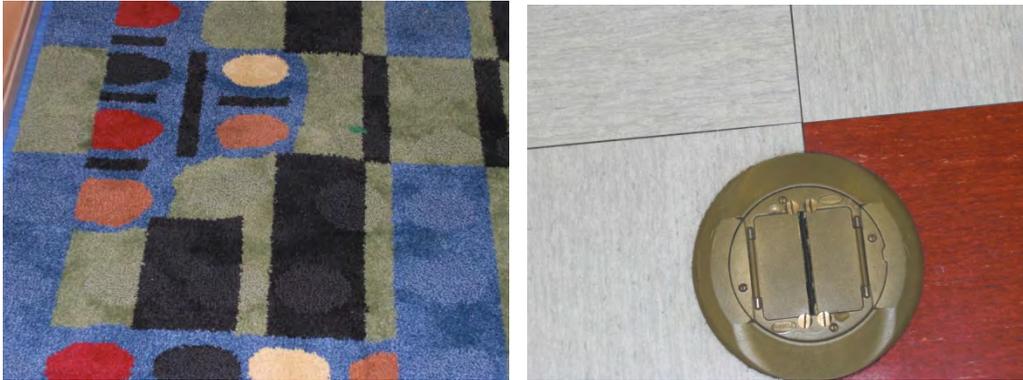
- The floor outlets covered with a rug are a trip hazard.

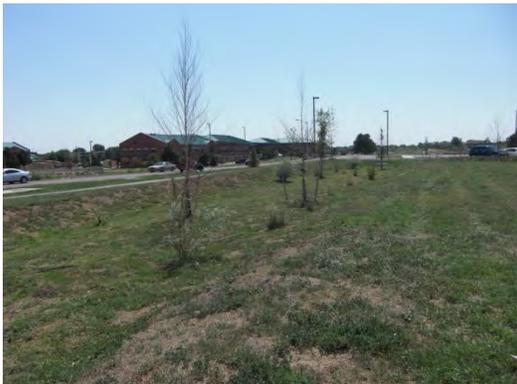
- All of the dead trees have not yet been replaced.

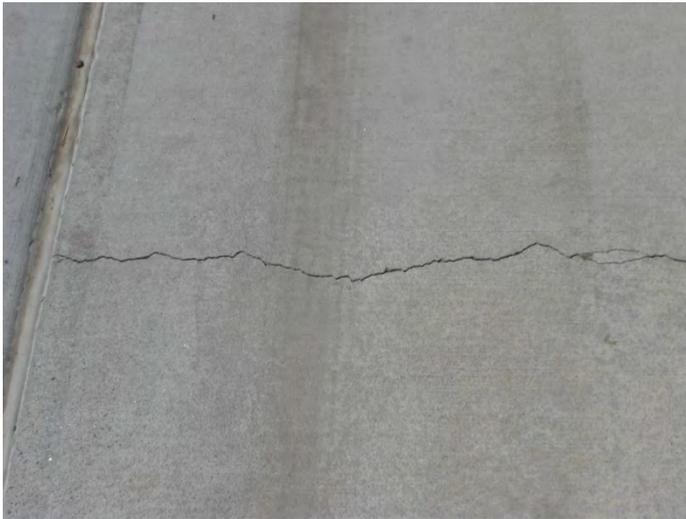
- There is a crack in the concrete at the entrance of the building.

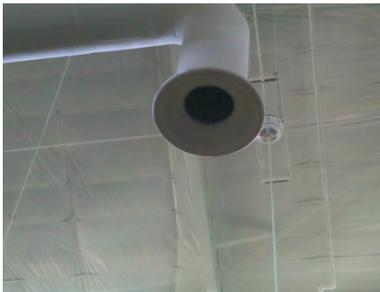
- The return grill in the multi-purpose room has been knocked in by balls. It was not heavy duty to withstand the function of the space.
