**U.S. Army Corps  
of Engineers**  
Engineering and Support  
Center, Huntsville

## **Replica SAC**

**Building 5037  
Fort Bliss, TX**

**POTR – Phase 1  
Project No 74516**

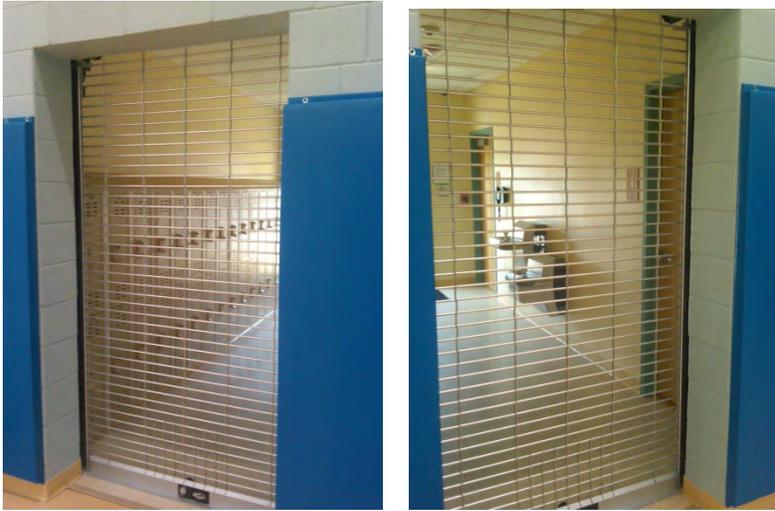
- Added a roll-up security door to corridor from Multi-Purpose Room to the restrooms and outside in order to allow outdoor events to utilize the restrooms.

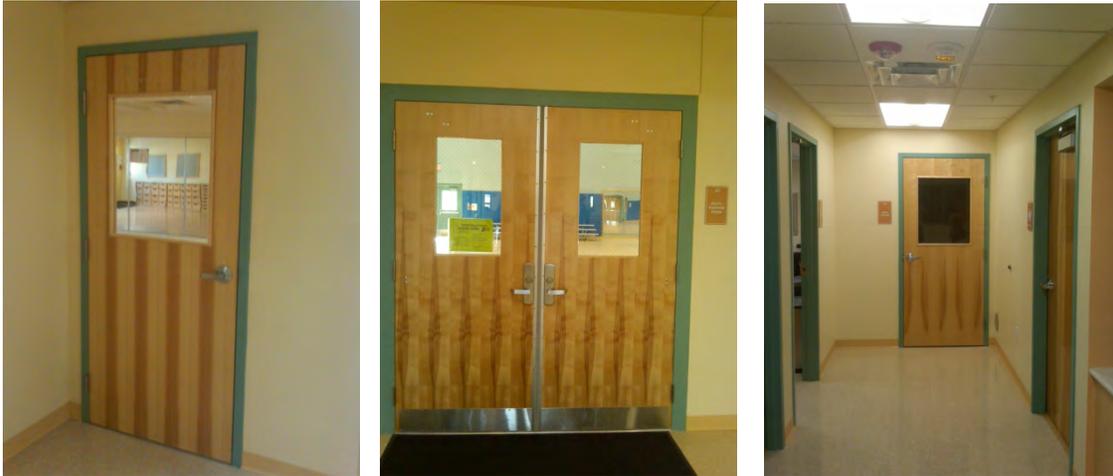
- About half a dozen of the exterior lights are out.
- Ice maker needs repair.
- The veneer on some of the doors is very odd. The overall appearance of the doors varies greatly.

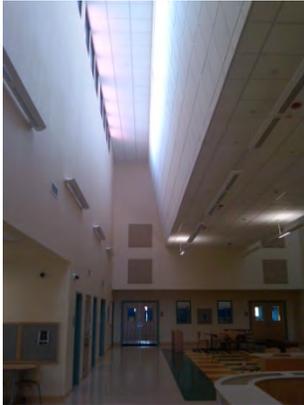
- The atrium has clerestories, but they are higher than normal due to the roof slope that was most likely driven by Architectural design requirements since the facility is located near the historic area of post. The nearly vertical walls of the drop down over the atrium were done with acoustical ceiling tiles in the standard grid. This is not the ideal solution, and I can see these tiles being knocked out over time.

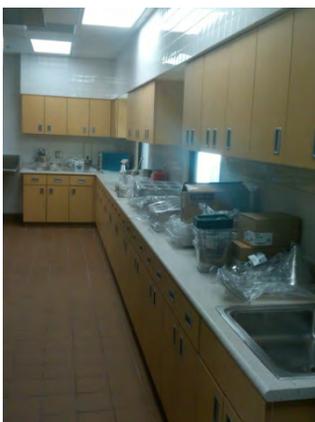
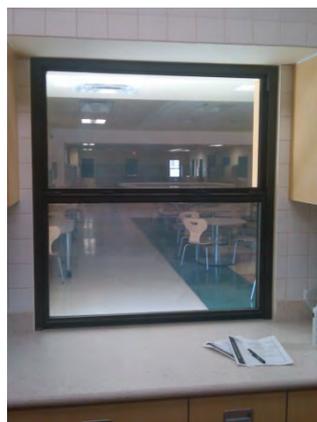
- The Kitchen has full height ceramic tile walls. Stainless steel counters were not provided along the wall with the pass-throughs. The pass-throughs have been provided with single hung windows.

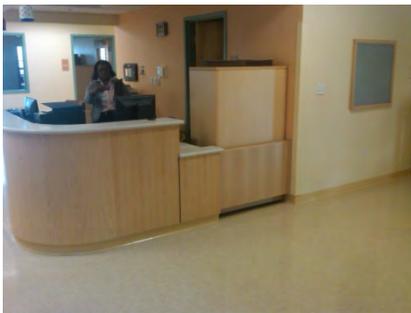
- Do not remove the Training Room closet to use as an electrical room. The Training Room needs storage!
- They feel the reception desk is way too small. There is not enough space for the mandatory files and records.
- Do not provide a gate from the reception desk into the atrium. It reduces counter space too much, and also makes it too inviting for children to come behind the desk.

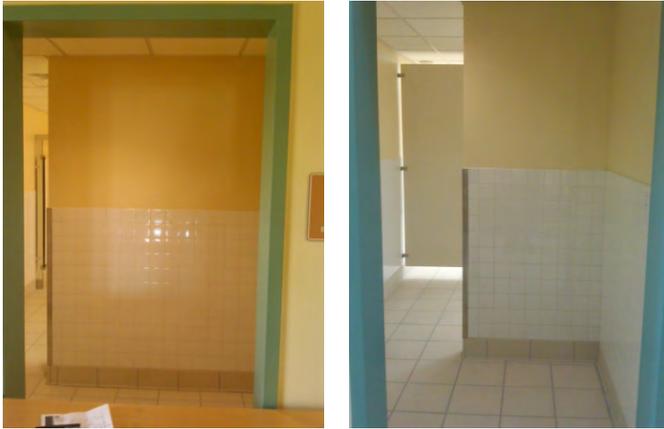
- Video cameras must now be able to monitor the entrances to the staff restrooms. This needs to be updated in the standards and criteria ASAP.
- There are line of sight issues with all of the children restrooms. The 2 remote restrooms are much better (picture below left). The primary restrooms had to have screens added (picture below right, showing the screen). This needs to be resolved in the standard designs.

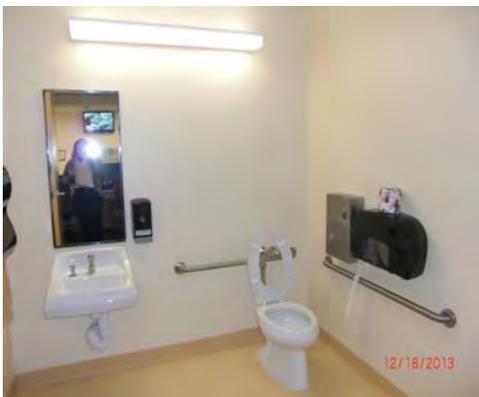
- The toilet automatic flush does not work when the seat is in the up position.

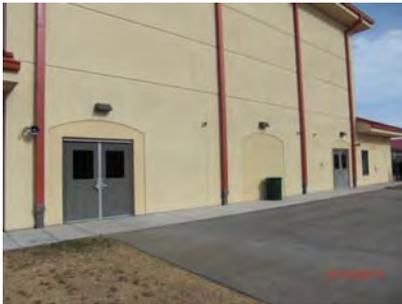
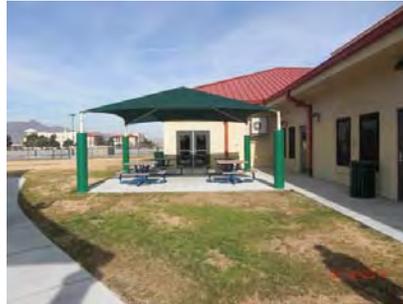
- The location of the exterior cameras does not give a good view of the entire playground area. There are some blind spots.

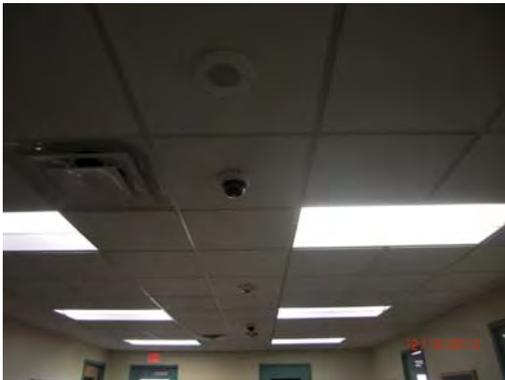
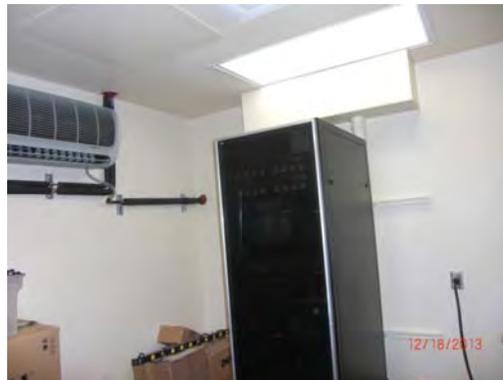
- The video system is not installed correctly. The camera signal from the Computer Lab is not going back to the video room. The cameras in the Computer Lab are not showing up on the DVR.

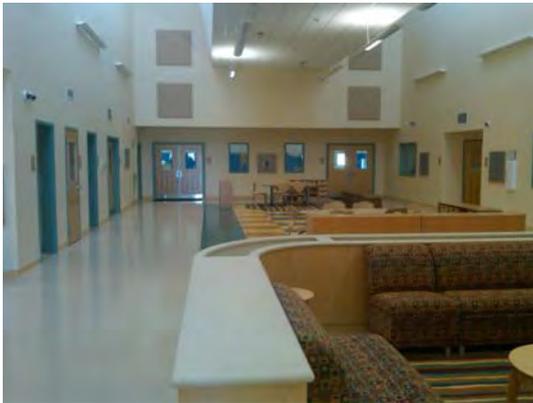
- The video recorder records for less than 30 days.
- The front of the restrooms and hallways are not picked up on the camera. The camera should face the front of the restrooms.

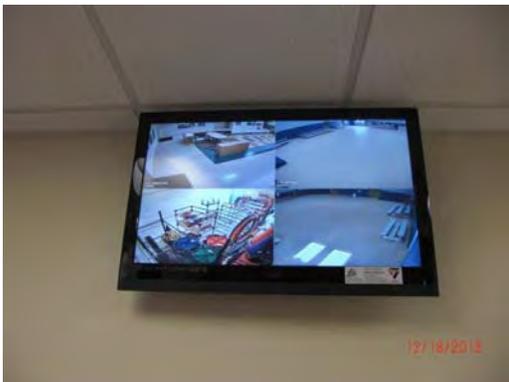
- The video surveillance does not cover the parking lot.

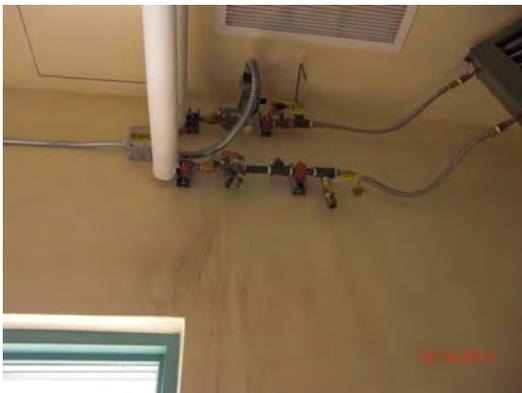
- The exterior Electrical Room wall has water stains.

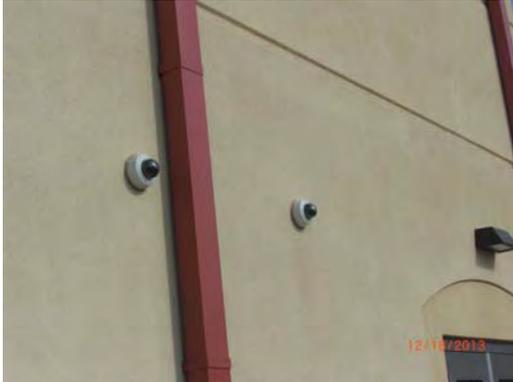
- The SAC needs more cameras.

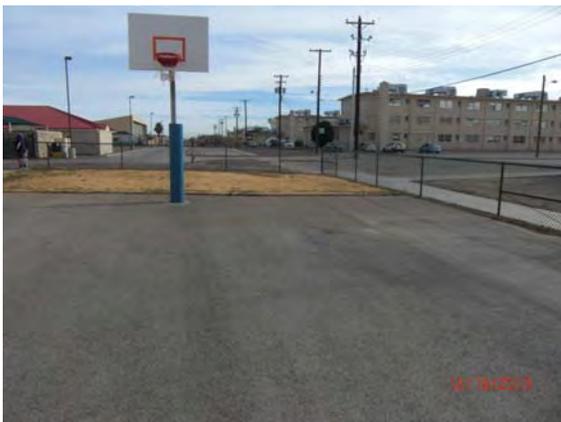
- Water drains into the basketball court.
