## **TRAINING SUPPORT CENTER**

**Building 77680  
Fort Riley, KS**

**POTR – Phase 1  
Project No 19389**

**DATE: 20 March 2012**

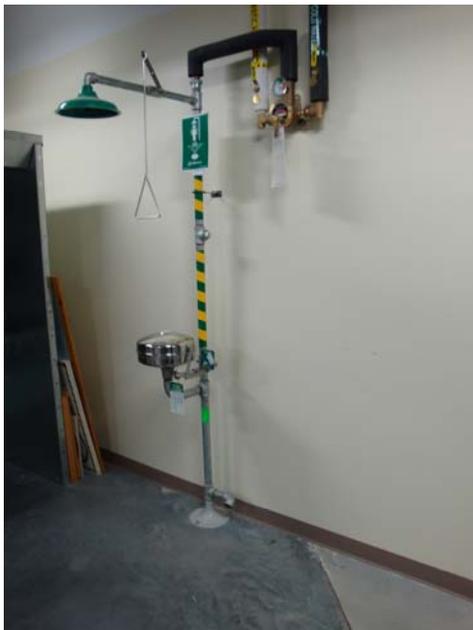
- Downspouts and Splash Blocks. Improper drainage caused by some splash blocks being angled towards the structure and causing pooling and erosion.
- Cracking and displacement of hard tile in the restrooms. The hard tiles in the restrooms are improperly installed and will continuously cause tile cracking and displacement. Especially troublesome is the Warehouse toilet where the tiles are installed at the communion of the Warehouse finished floor and the column floor base.
- Cracking in the walls and ceiling of the Corridors.
- Eye Wash/Shower stations. Floor drains were omitted at all Eye Wash/Shower locations. Proper maintenance and flushing of the stations becomes problematic due to flooding of the floors.

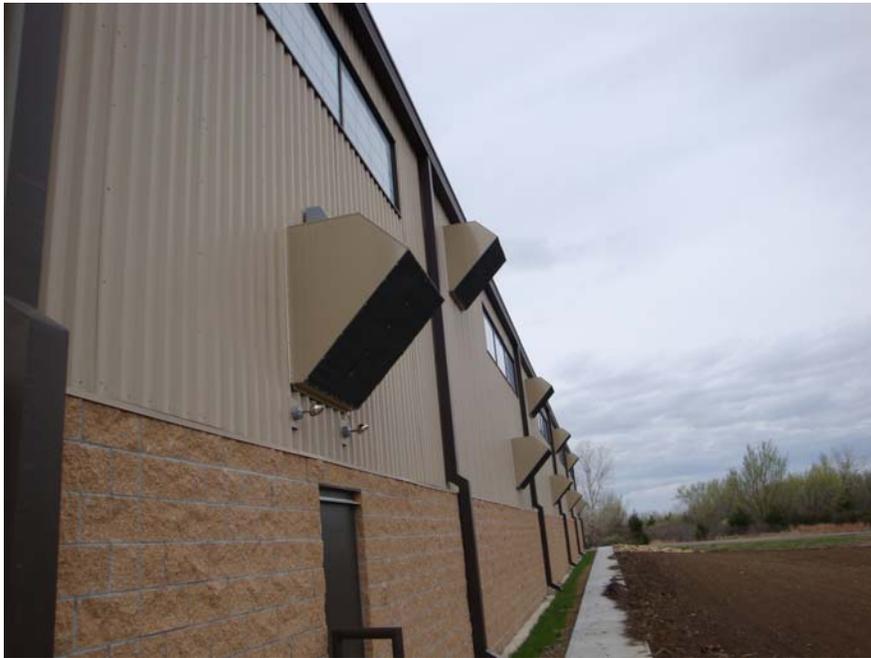
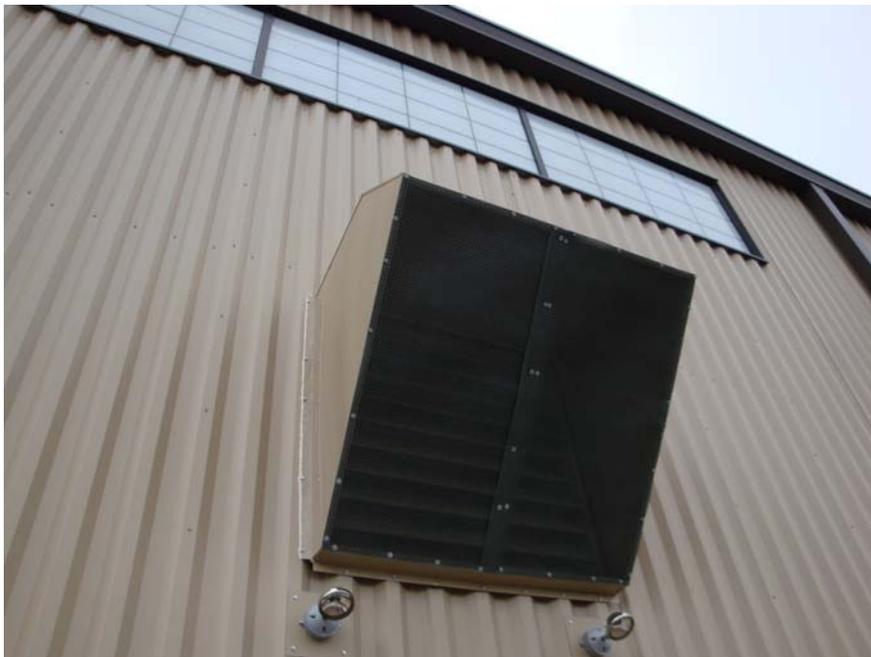
- A door closure device is needed at the interior door of the Customer Service Area. Due to the high traffic at the Customer Service Area and varying heating/cooling loads of the Customer Service Area/Warehouse, automatic door closure is needed. Door framing should be constructed to support the loads of a door closing device.
- Exterior lights are located near the exhaust fans of the Warehouse and attract bugs which are sucked into the Warehouse. Bug excrements cause stains on the Warehouse floor and excessive floor maintenance. Bug screens have been installed on the outside housing of the exhaust fans to remedy the issues.

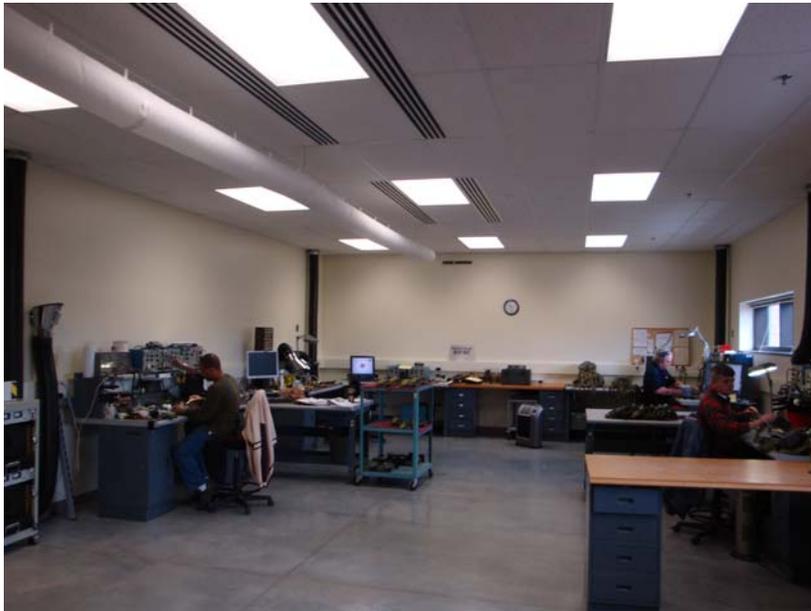
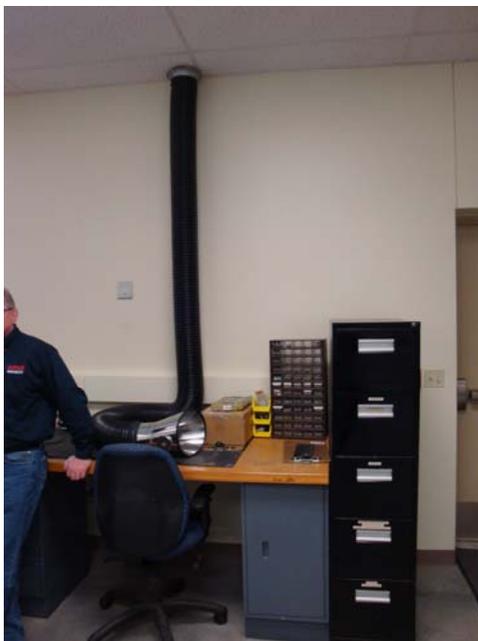
- The outlets in the Retail Sales Room, Conference Room, and some other rooms do not meet the 10 feet rule and causes issues when locating electrically powered equipment.
- In the Device Maintenance Repair Room, all but one of the ventilation hoses work. The one that works is considered to be too loud.

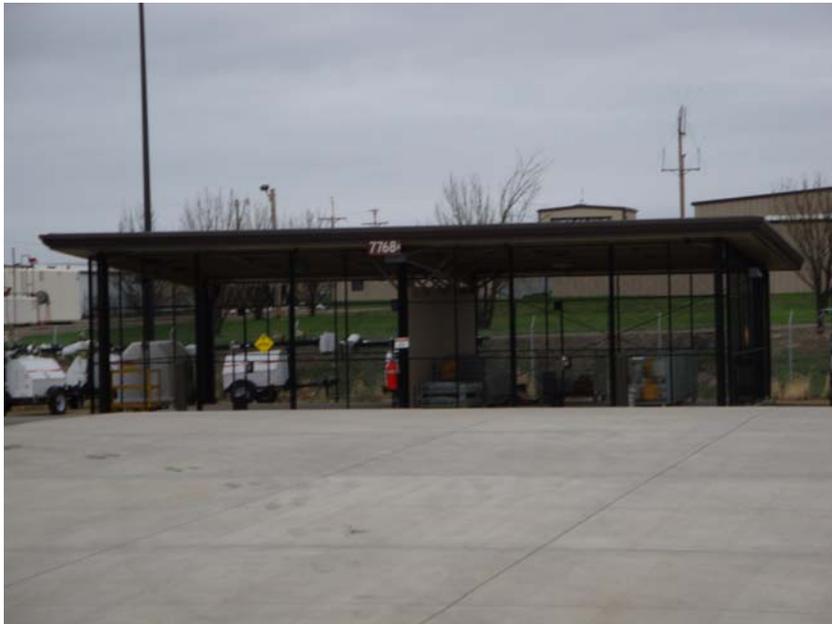
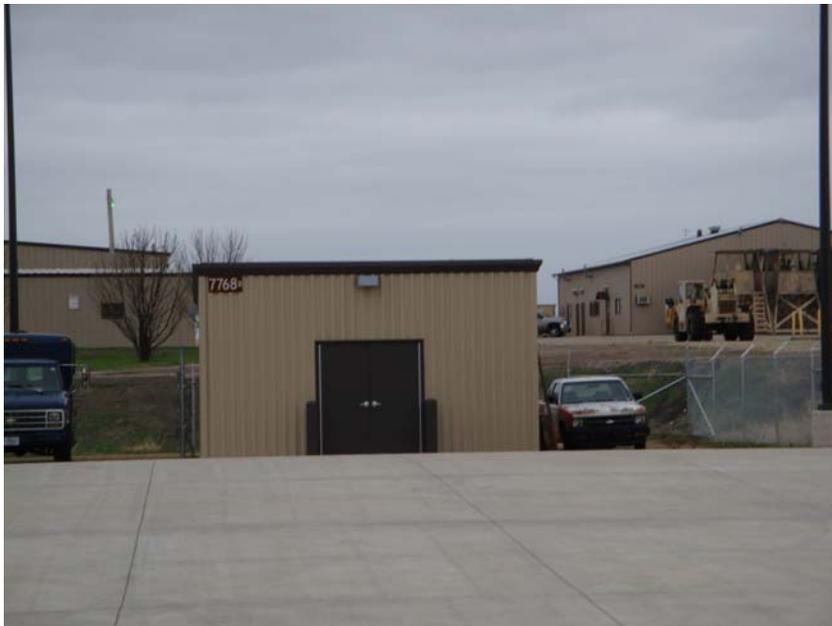
- The facility has two Outside Storage areas. The open storage area is adequate sized: the closed storage is undersized.

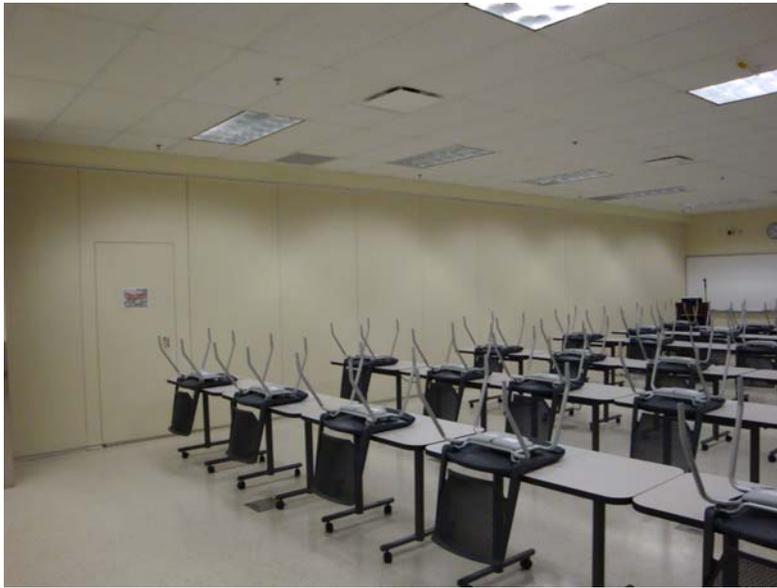
- The staff expressed that they would have preferred the loading dock to be 12 to 24 inches wider than what exists.
- Issues were raised with the manual crank overhead coil door. They wanted to know why the option of an automatic door was not offered commensurate to the other features of the facility.
- 2 X 4 Acoustical Ceiling Tile (ACT) was installed throughout the facility. The preference is for 2 X 2 ACT.

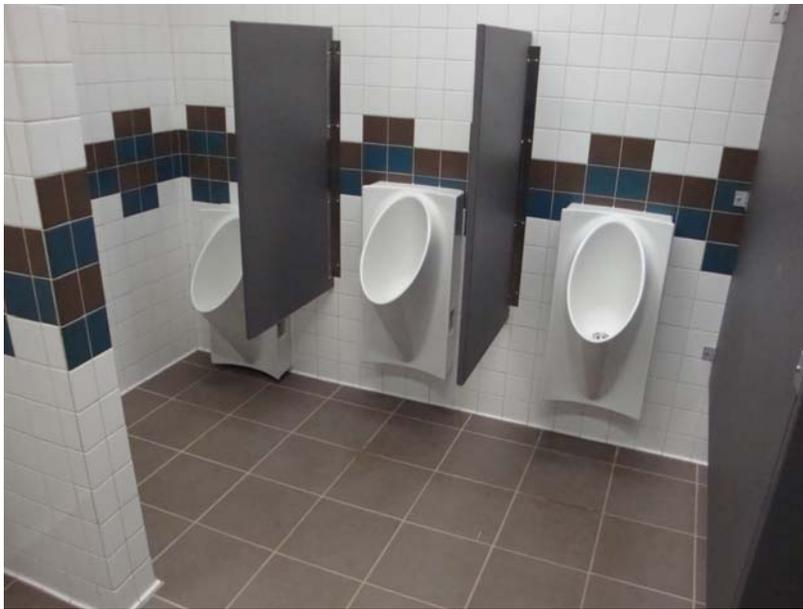
- The facility has waterless urinals installed. The user is responsible for day to day upkeep of the urinals. Waterless Urinals are and will continuously cause maintenance and sanitary issues.

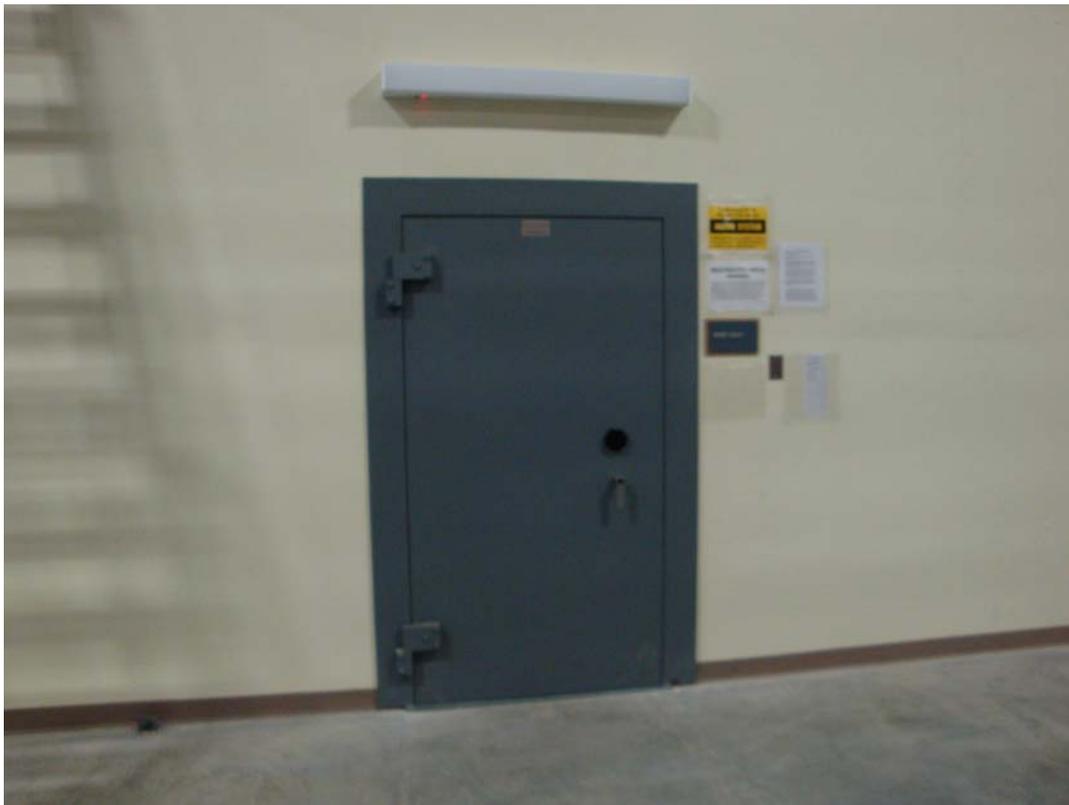
- There appeared to be not enough electrical outlets in several of the rooms and in the corridors. The staff reported difficulties with floor maintenance in the hallways because of the distances between outlets.
- The battery charging stations throughout the Warehouse are inadequate.
- 24 hour lighting of the Vault door is required for visibility from a distance.

- Ensure the requirements for outlet spacing are adhered to. Also ensure all user requirements for outlet spacing are included in the RFP.

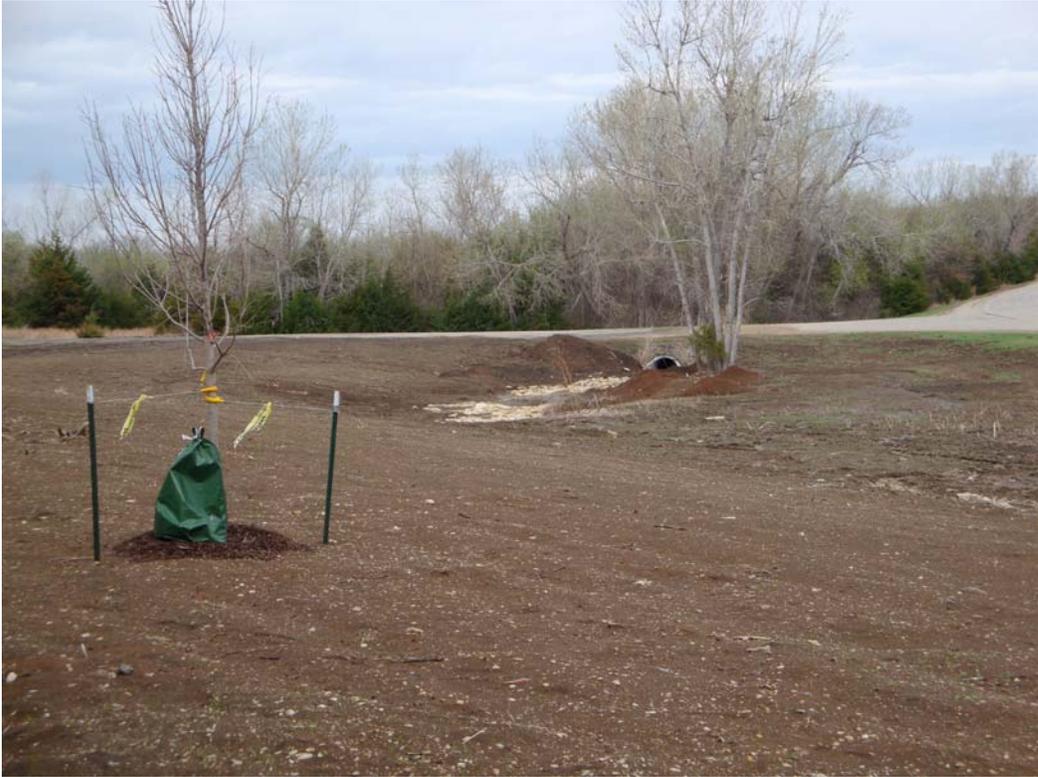
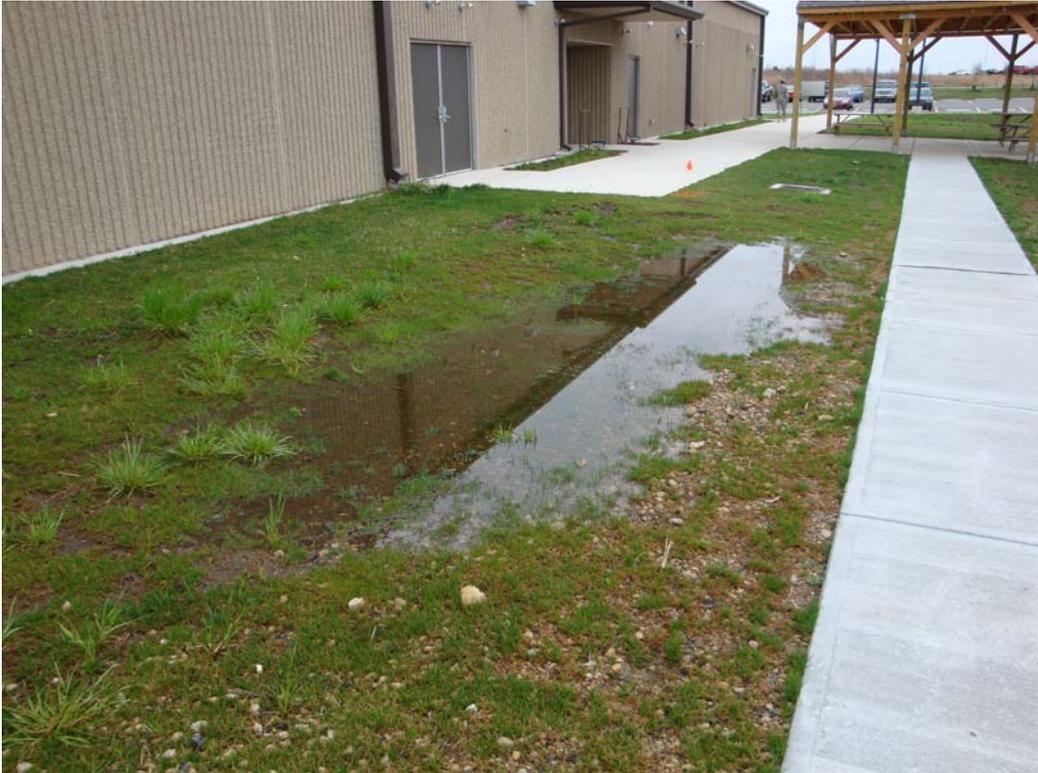
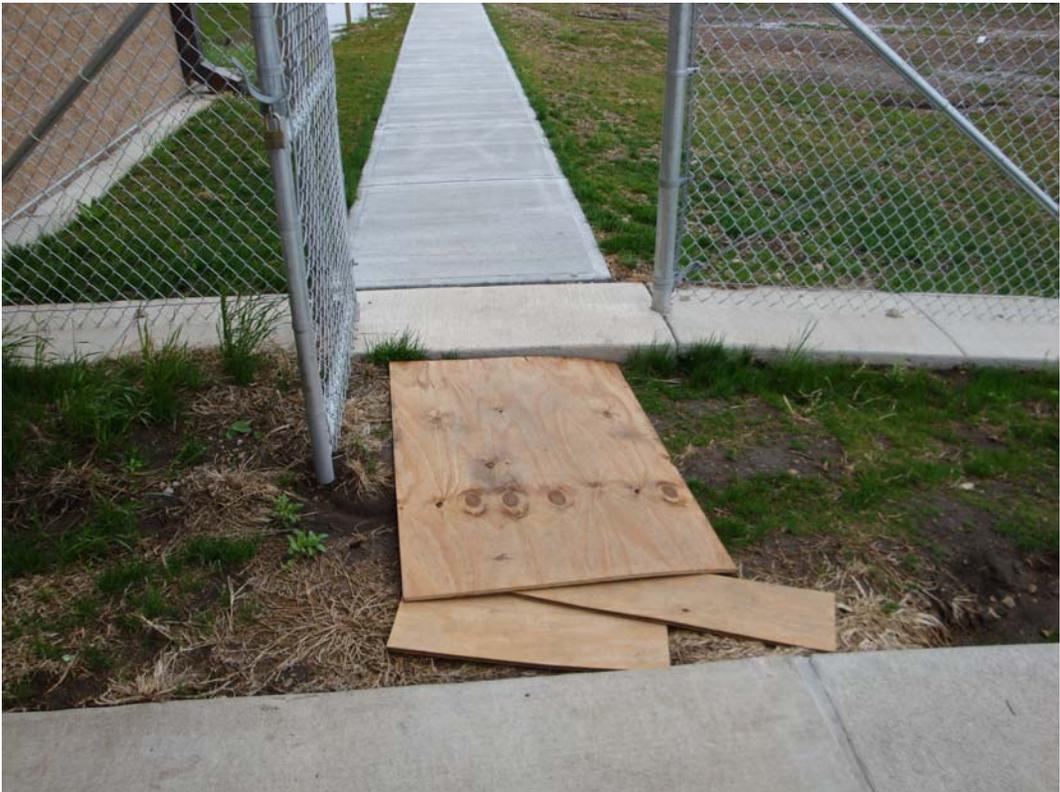
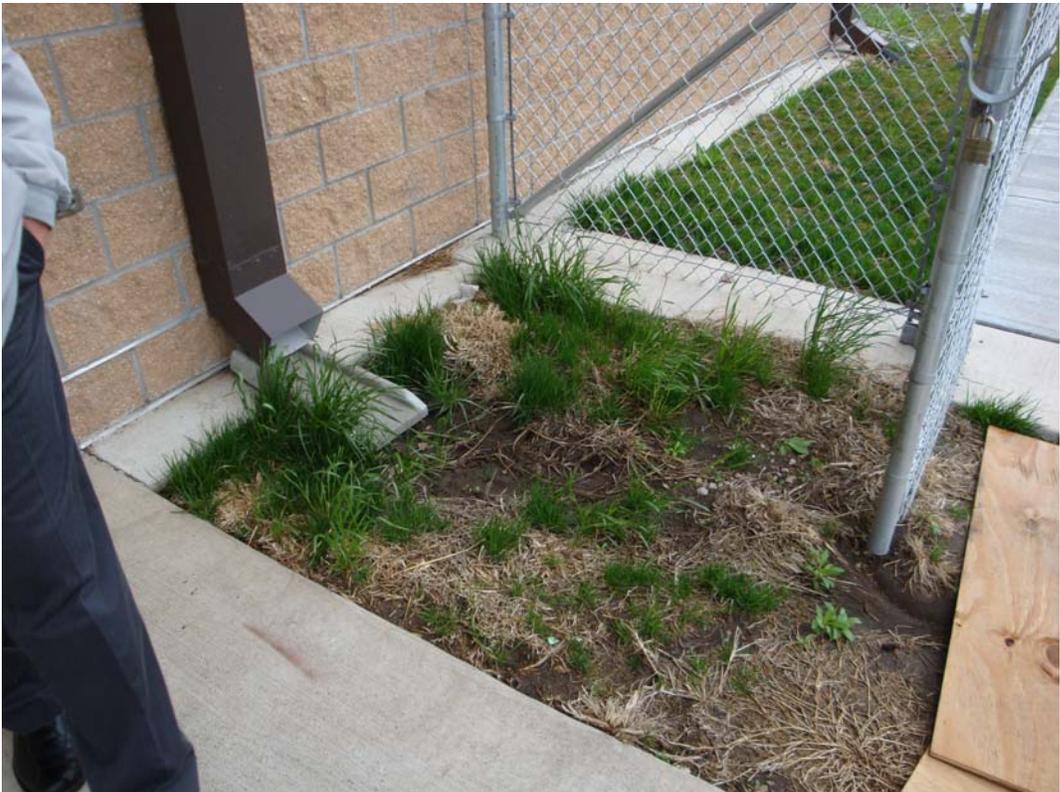
- The asphalt in the parking lot is not supporting the daily loads of vehicular traffic. Issues of deterioration and puncture are visually evident.

- Visual flooding and erosion on the south-side of the facility. Poor drainage throughout the site.

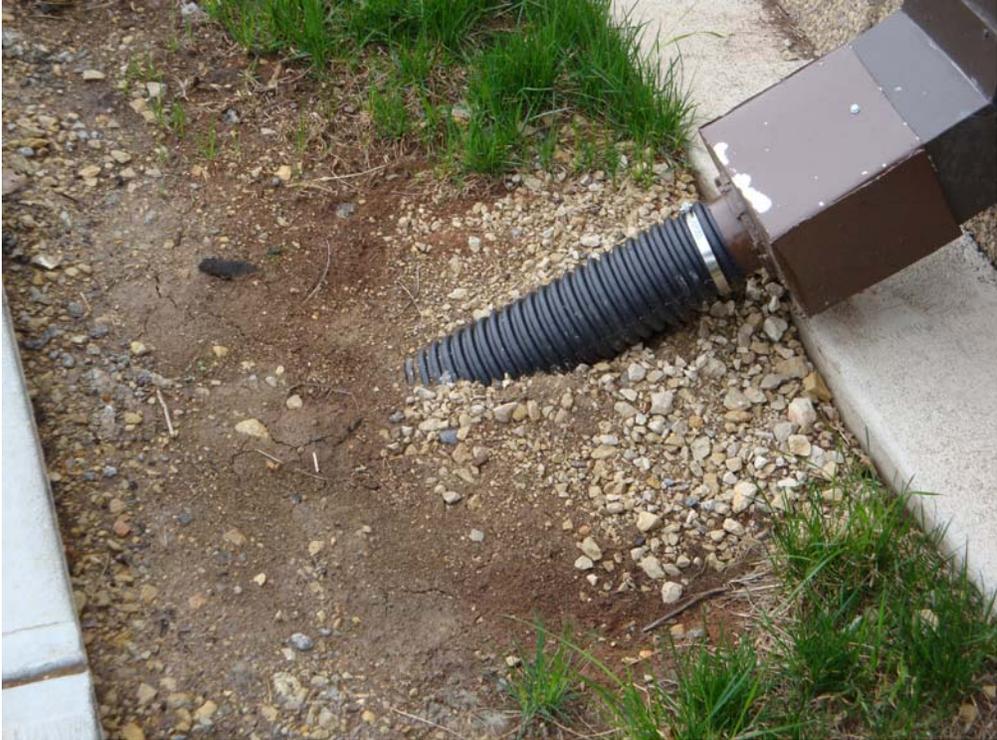
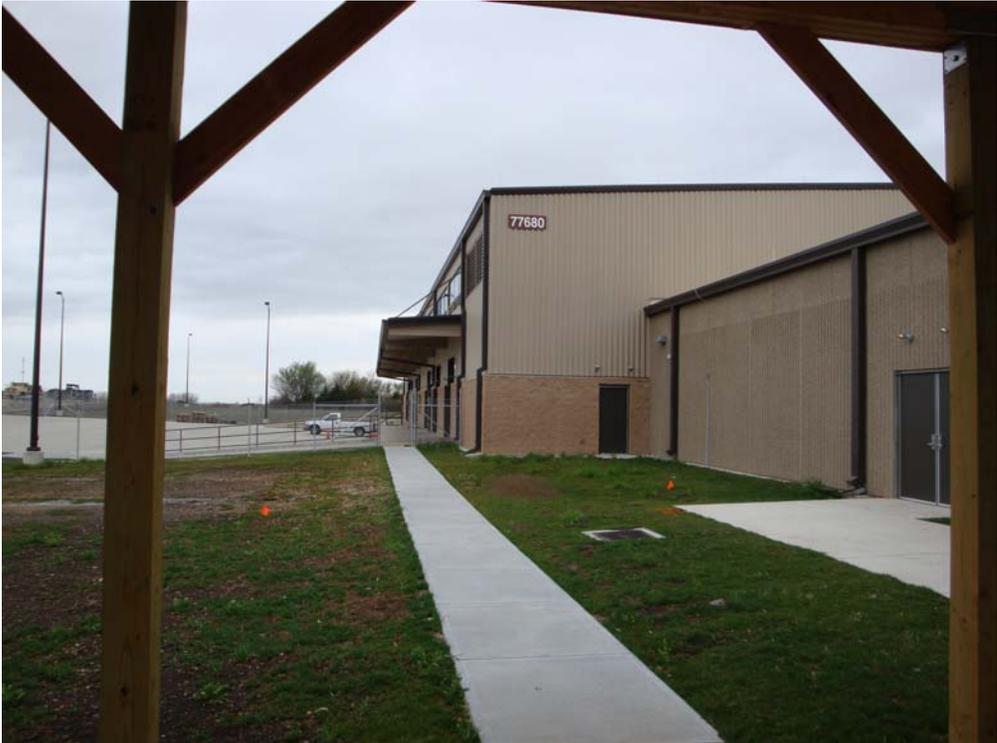
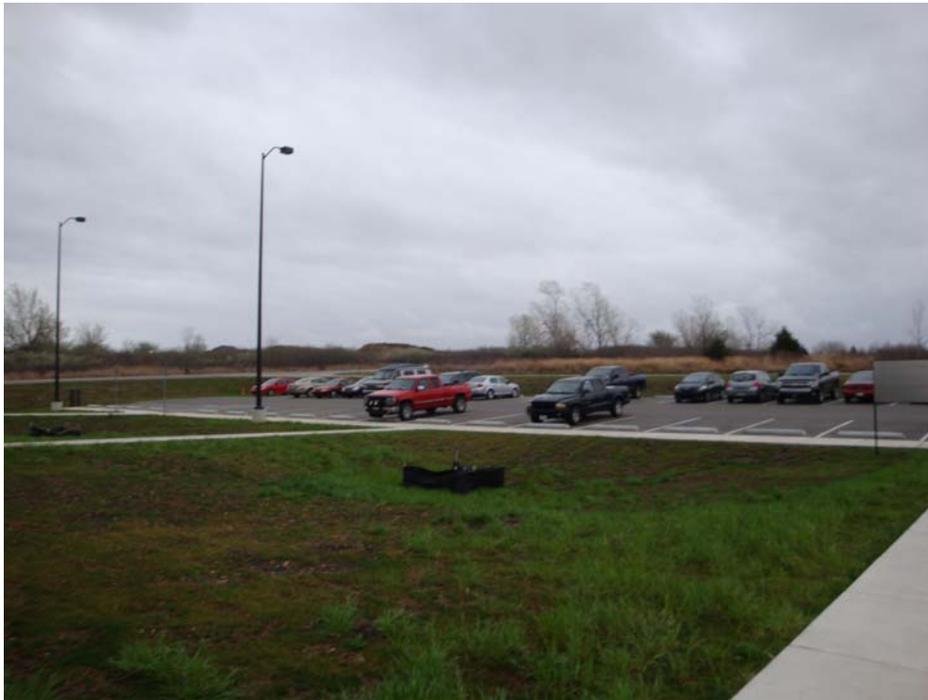
- Large rocks are integrated with the top soil and creating a major hardship in maintaining the landscape. (Above photo and below photo).

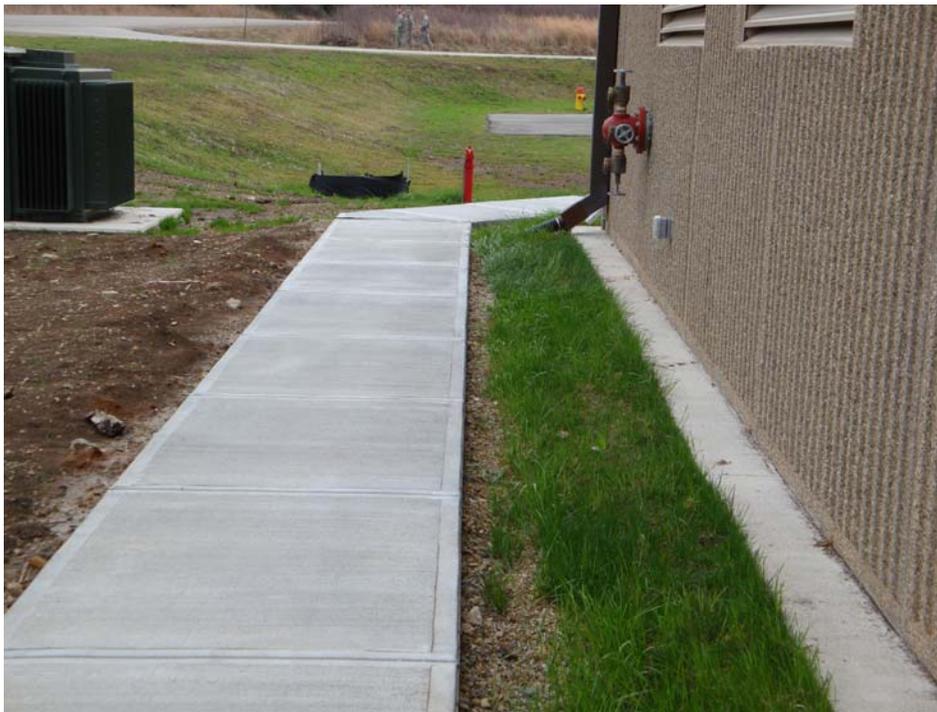
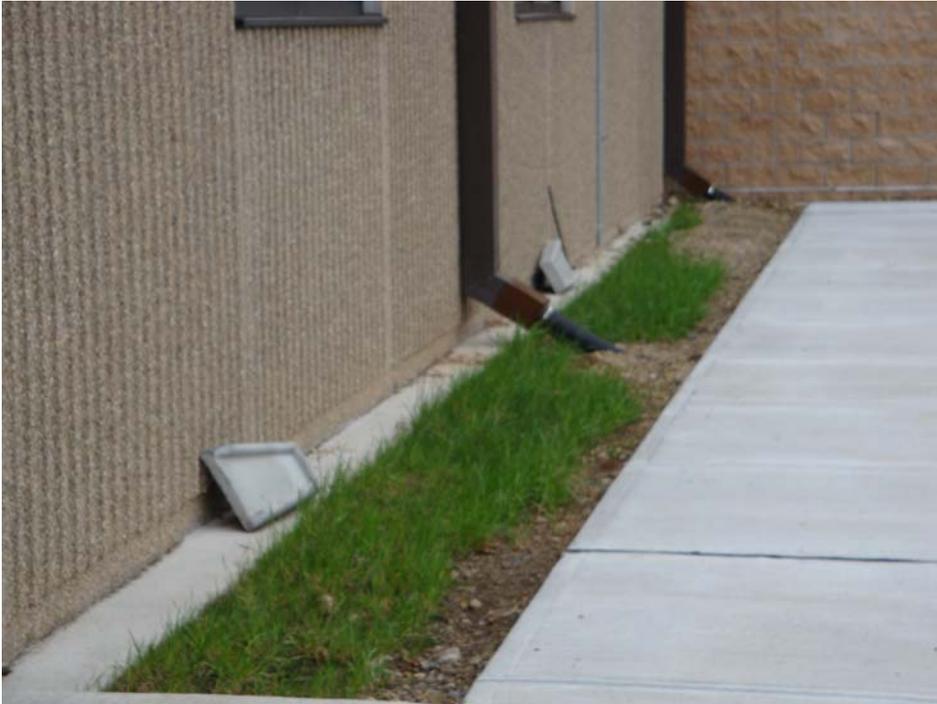
- A sidewalk was later installed around the facility by the 94<sup>th</sup> Engineers located at Fort Riley. The splash blocks at the downspouts were removed. Flexible drainage pipes were attached to the downspouts and run underneath the sidewalks to better enhance drainage.

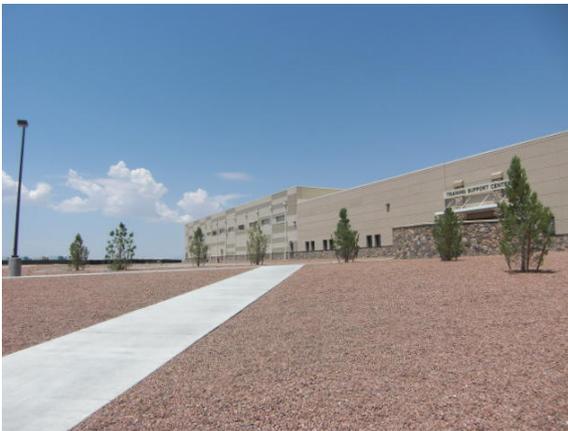
- Main entrance sidewalk did not go directly to the parking lot. Original design had the sidewalk going to the drop off circle then proceeding back to the parking area. Installation has added an extension off the existing sidewalk to go directly to the parking area.

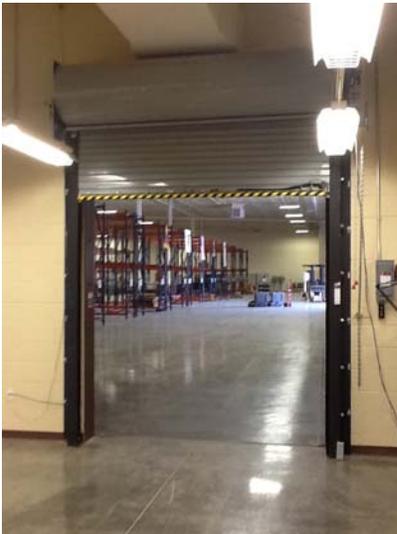
- Roll up door in the Device Fabrication Room off the Warehouse was not connected to a switch.

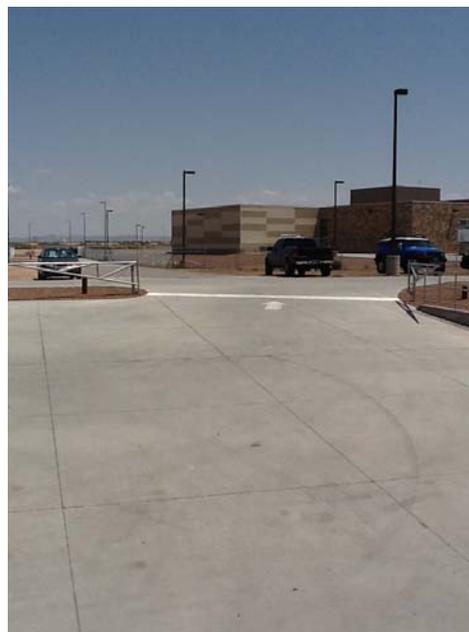
- Loading dock entrance was set up with two entrances with swing arms. Nothing was placed in between the two swing arm entrances to keep anyone out.

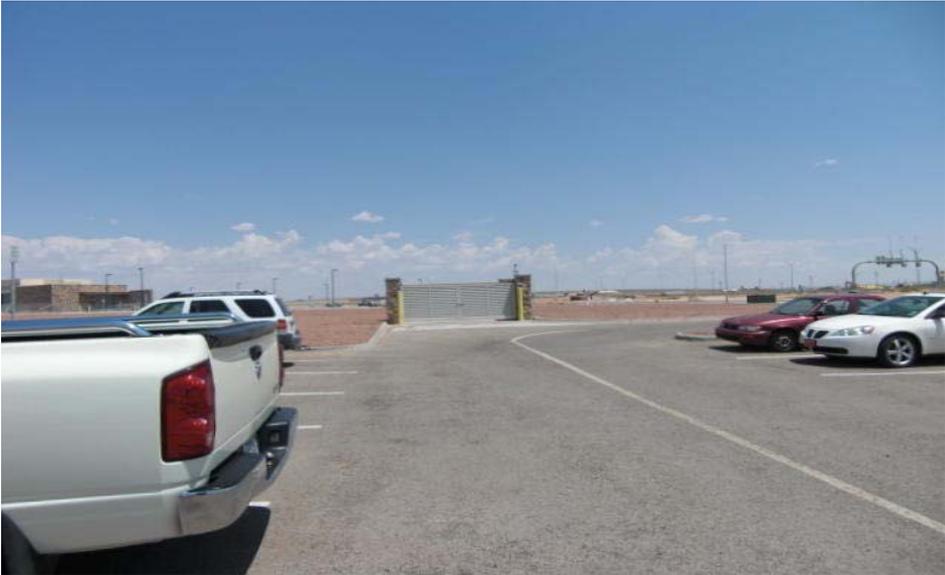
Document satisfaction with dumpster location(s). The dumpster should be located in the back. The trash has to be carried to the front of the building. This is not Convenient for the workers.

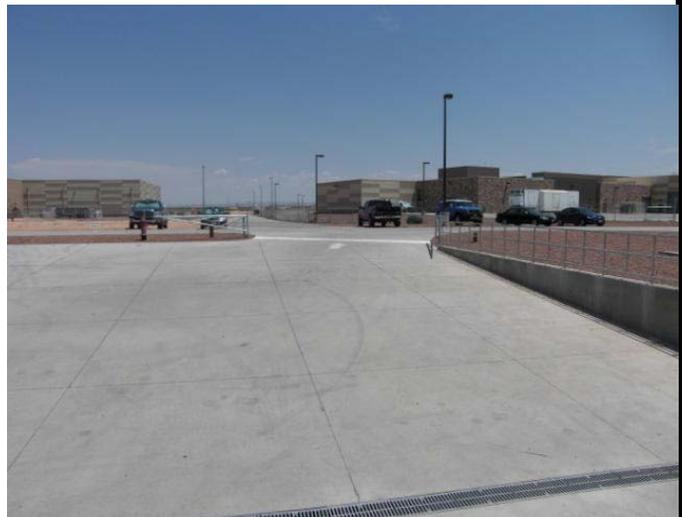
Document any structural related problems/concerns. The loading Dock is too high for 18 wheelers trucks to unload. The loading dock needs an adjustable ramp.

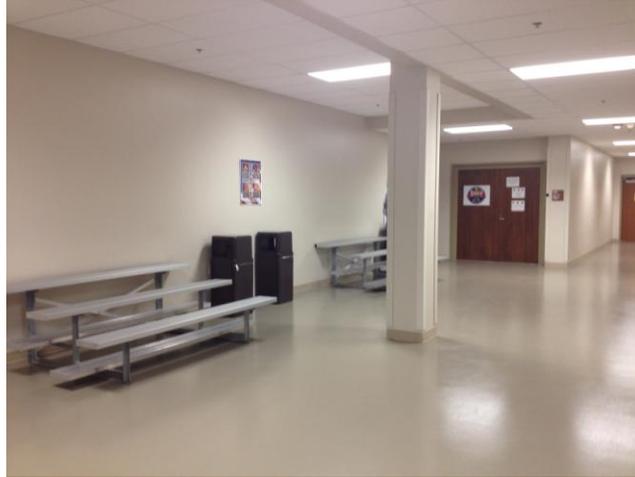
- Waiting Room: There is not enough space for troops waiting to go into classrooms, call room, etc. No sound proofing was installed.

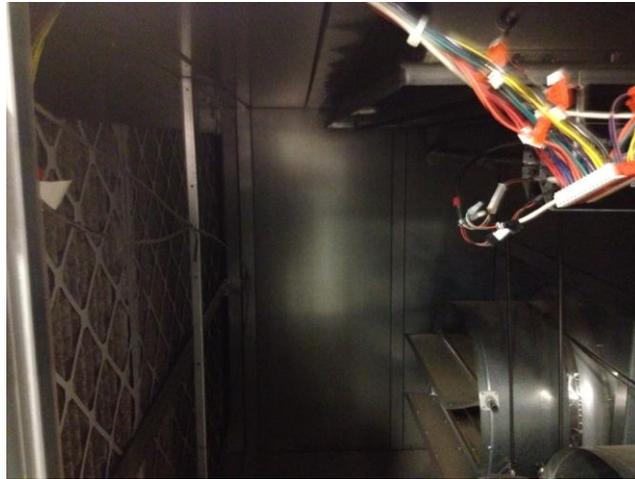
- Maintenance/service schedules of the HVAC system needs to start being properly followed. Currently the air filters are not being replaced as frequently as they should.

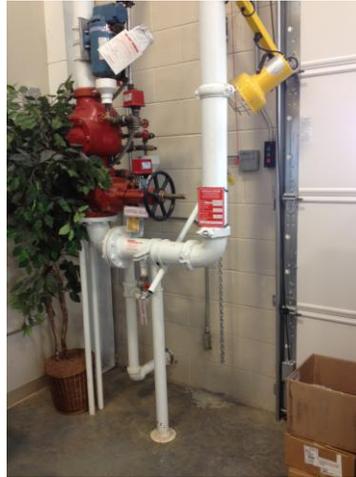
- No one at the facility/installation knows who is supposed to test the fire pump. This needs to be resolved.

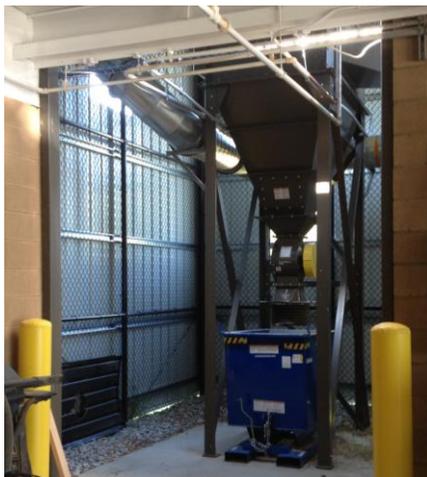
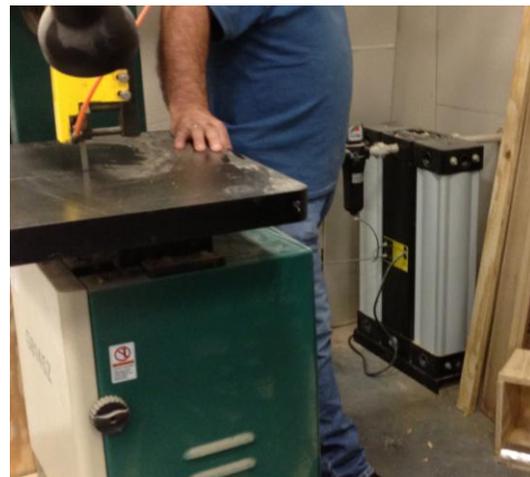
- No Standard Design Impacts identified for this facility mechanically or plumbing related.
- Located inside the Fabrication/Woodworking space is a saw dust dryer/dust collector that randomly makes a loud “compressed air” popping sound. This is a hazard. It’s a hazard because the random sound can startle the employee and therefore cause an accident when working with saws and cutting equipment.

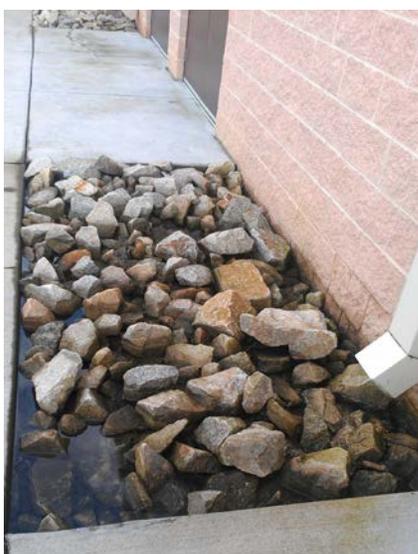
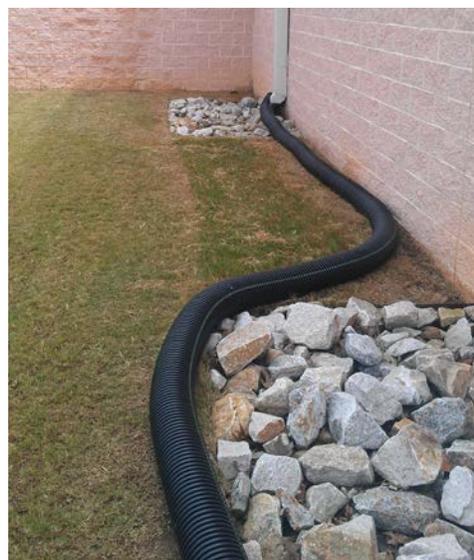
- The drywells continually hold water and the poorly drained water has seeped into the building in several locations. The drywells that retain water are also growing mold and/or algae. To mitigate some of the issues, they have installed piping to divert the water and some are now connecting to the sewer line.

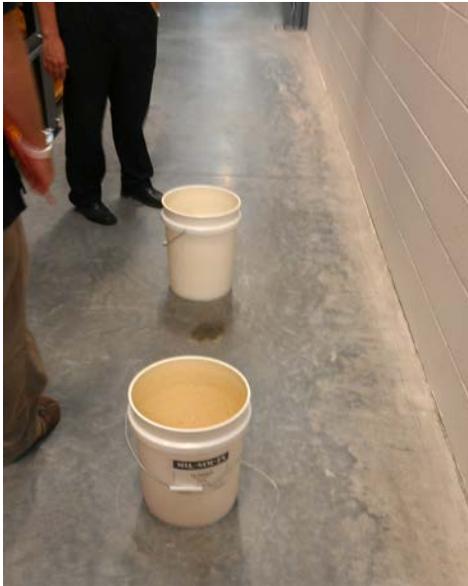
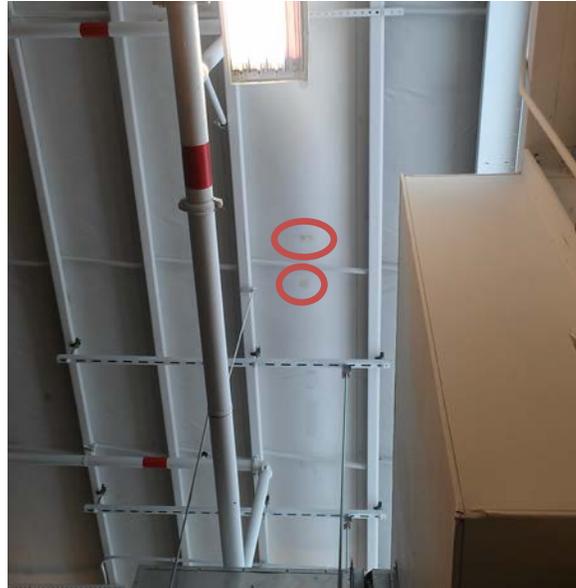
- There is leakage in the warehouse roof which is oftentimes hard to identify and could be a result of a large roof system.
