US Army Corps of Engineers
Norfolk District

Post Occupancy Evaluation

FY09 Ft Benning Armor Officer Basic Course GIB, PN65286, Catcode 17120

POE conducted 9/8/2014

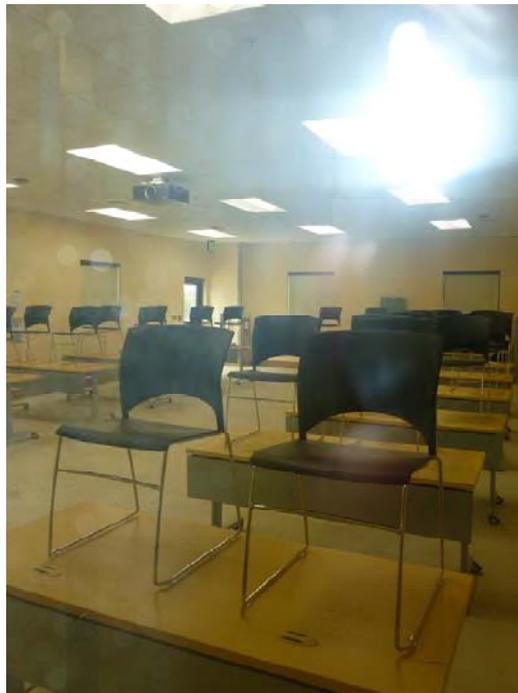
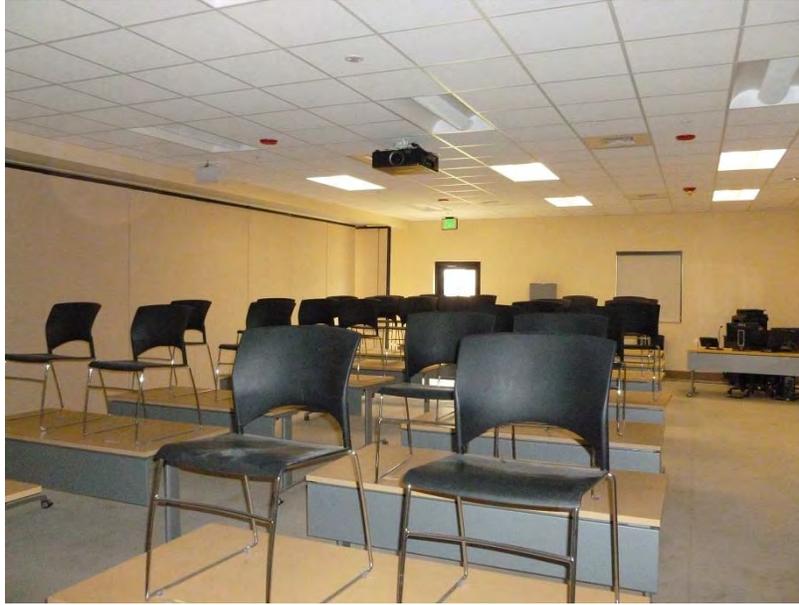
- 2) One of the Large 78 pax classrooms is dividable into 3 smaller classrooms. This has been successful
 - a. Lesson - consider operable partitions to increase utilization (verbiage included in Standard)

Figure 5-one of 2 large dividable classrooms

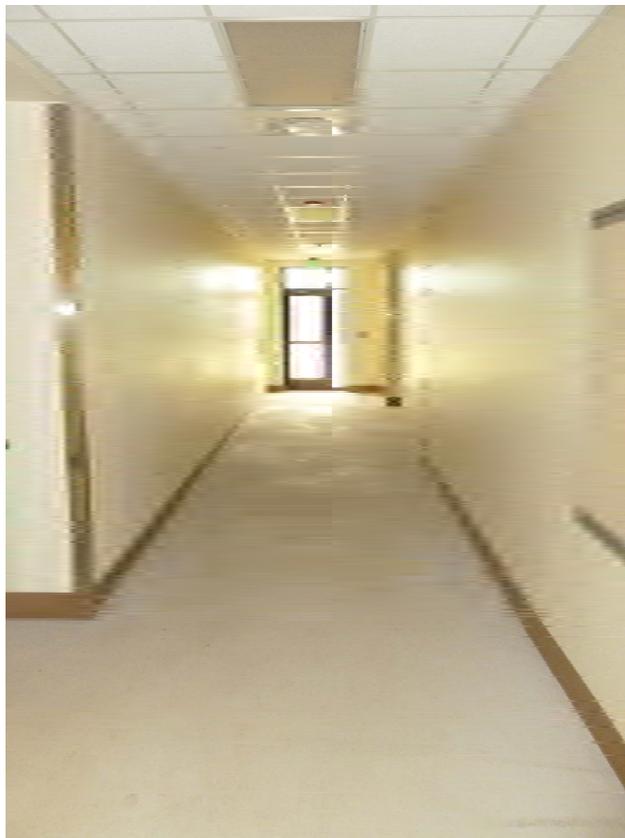
- 1) Post-construction award decision was made to remove the requirement for VTC in the classroom and corridor floor and instead provide a sealed broom finish floor. This has been an unmitigated failure in all traffic areas and ongoing maintenance issues already associated with floor staining and other issues have been a challenge. User is unhappy with this outcome.
 - a. Lesson - need a feedback mechanism to the COS during post-award to preclude poor decisions such as this one. However, it should still not have been allowed to happen; omitting the floor finish system of a building does not provide a "complete and usable facility"
- 2) No loading dock was provided on this 15,000 SF building. This has not been an issue for the User

Figure 7-main corridor; note lack of floor finish. This is unacceptable.

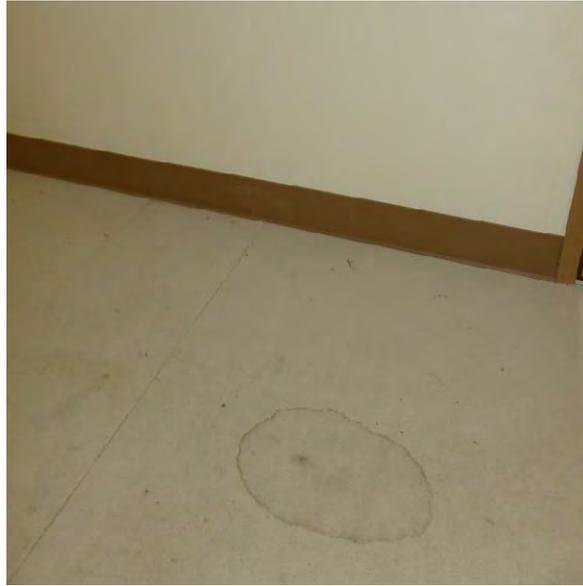
Figure 8 - staining on the corridor floor slab. This slab is not even sealed...

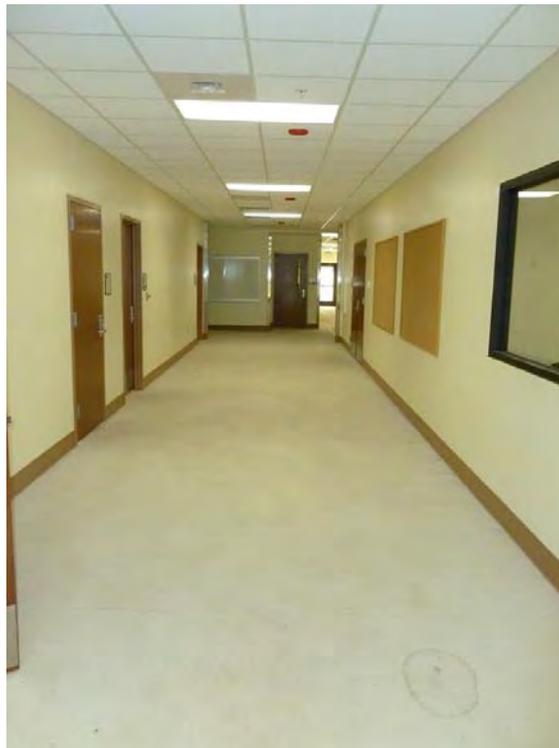
Figure 9 - unsealed concrete slab; even your garage has a better finish!

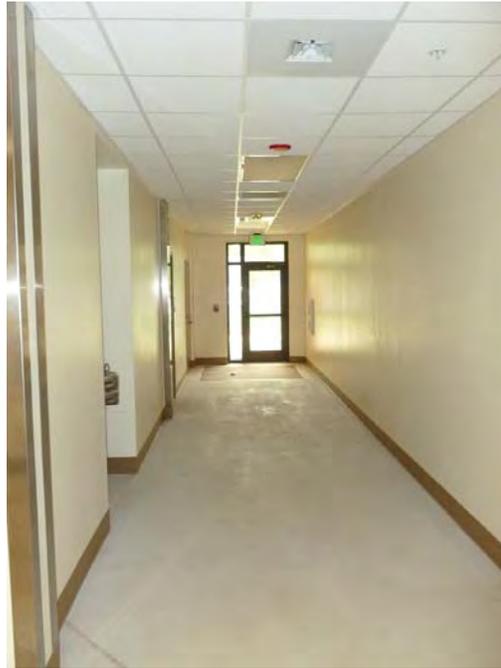
Figure 10 - more unsealed concrete slab; its prevalent throughout the facility.

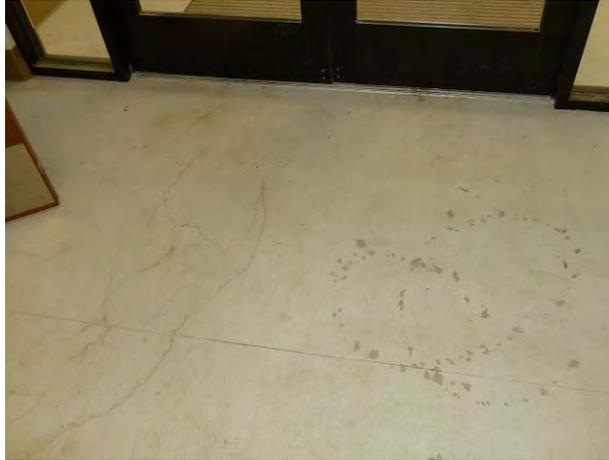
Figure 12 - Yet more floor slab issues

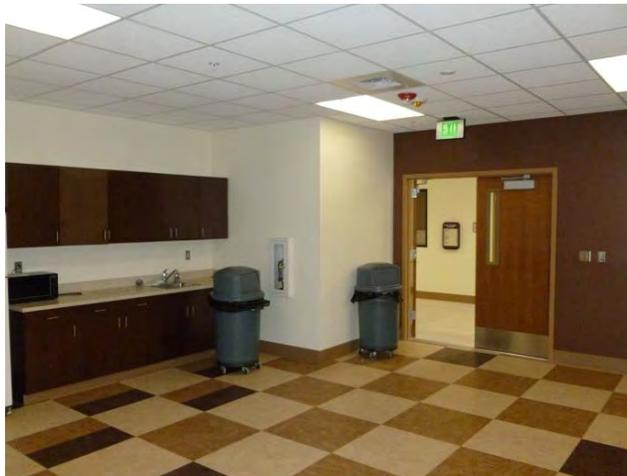
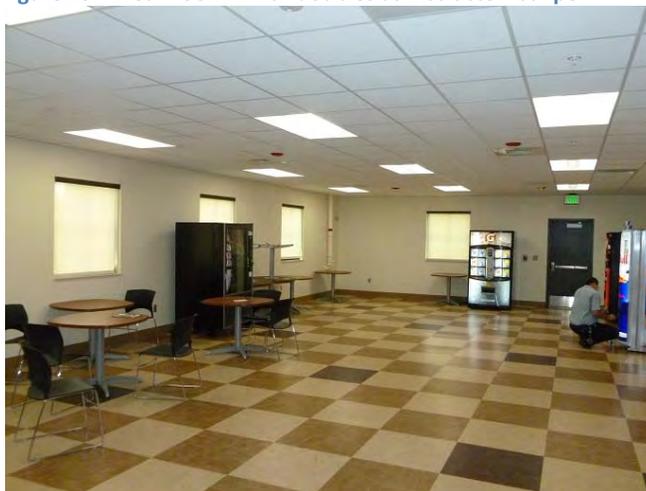
- 1) Offices as programmed appear to have programmed only for a fraction of instructors, with most of the enlisted instructors (about 38) having admin space elsewhere in the complex. However, during certain times in-session a large portion of the break area is re-purposed for desks for instructors, resulting in about 900 SF less space for the break room and leaving about 400 of the 675 allotted student break space (Instructors share this break space with students). Loss of break-room meant that students use outdoors (not so much an issue given the mostly favorable climate)

Figure 13 - Break room which doubles as instructor 'bullpen'

- a. Lesson - Space flexes to meet the need, and this was a mostly successful solution. However, it may have reduced break areas a little bit too much. If doing double duty ensure that both functions can operate simultaneously.
