**U.S. Army Corps  
of Engineers**  
Engineering and Support  
Center, Huntsville

## **Fire Station #5**

**Building 2620  
Fort Riley, KS**

**POTR – Phase 2  
Project No 54914**

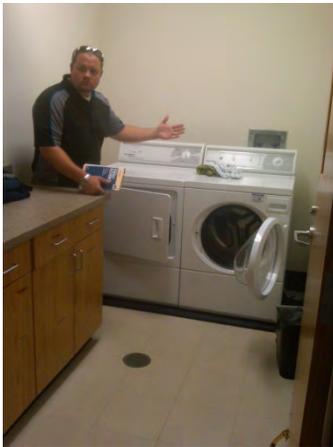
- The cabinet in the laundry room will not allow the dryer door to open fully.

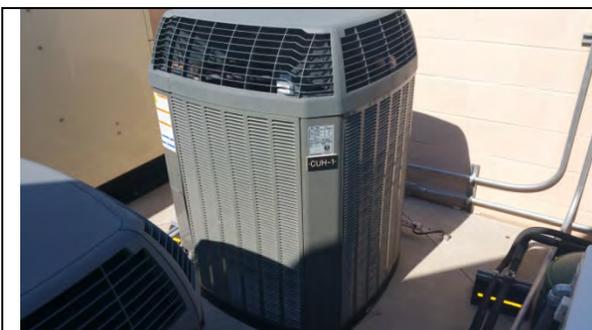
Figure 1 – Condensing Unit 1

- Range Hood – The range hood in the kitchen is improperly configured and allows extreme amounts of infiltration during both the heating and cooling season.
- Cooling/Heating – Facility users reported both cooling and heating issues during the extremes of the season. During peak humidity events, piping above the ceiling begins to sweat and condensation builds up in the light fixtures. The sleeping quarters are provided with independent ductless split systems.

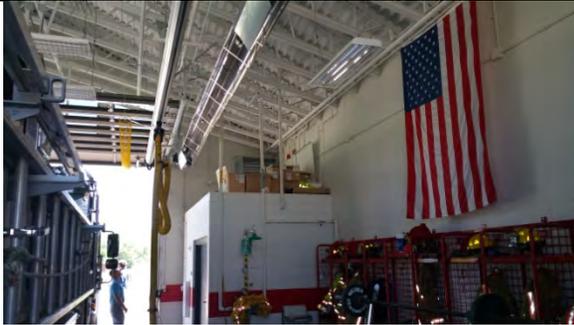
Figure 5 – Outside Air Intake Louver

- Vehicle Bay HVAC – The ventilation system in the vehicle bay is non-operational and the facility users report that it has never operated. The exhaust fan has a disconnect switch that was inaccessible and may just need to be powered on. It was unclear as to what controls the exhaust fan and outside air louver. However, the radiant heat beams seem to function properly. There is no ventilation area provided for soiled firefighter gear.

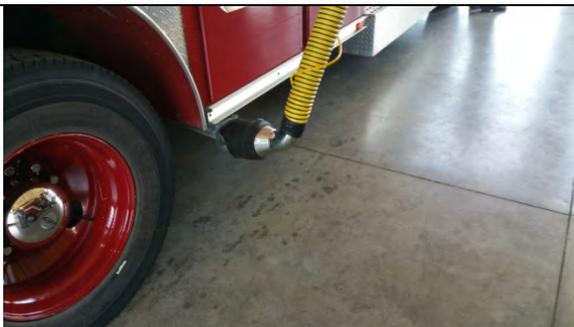
Figure 7 – Vehicle Exhaust Tubing

- Vehicle Exhaust System – The vehicle exhaust system is only partially operational and no longer in compliance with NFPA guidelines.

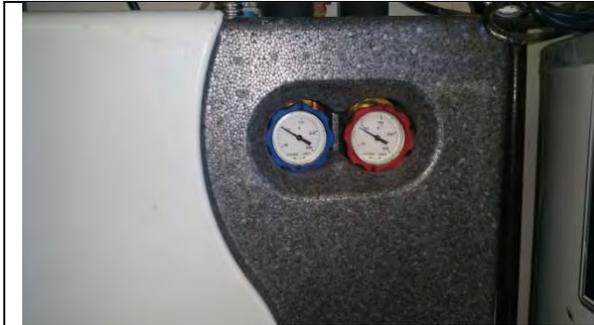
Figure 1 – SHW Temperature Gauges

- Solar Hot Water – It appears the Solar Hot Water (SHW) system was never commissioned and presents a major safety risk. Facility users reported that the domestic cold water at taps throughout the facility was boiling hot along with the domestic hot water at the tap. DPW appears to have tried to correct the situation by partially closing a ball valve in the mechanical room just downstream of the thermostatic mixing valve. DPW's fix has made the situation less dangerous but still needs to be further investigated and resolved. After a brief investigation, it is likely that the piping was incorrectly configured to re-

circulate the hot water into the domestic cold line. In conjunction with the piping error, the system is most likely oversized with no storage capacity and continually heats the re-circulated water.

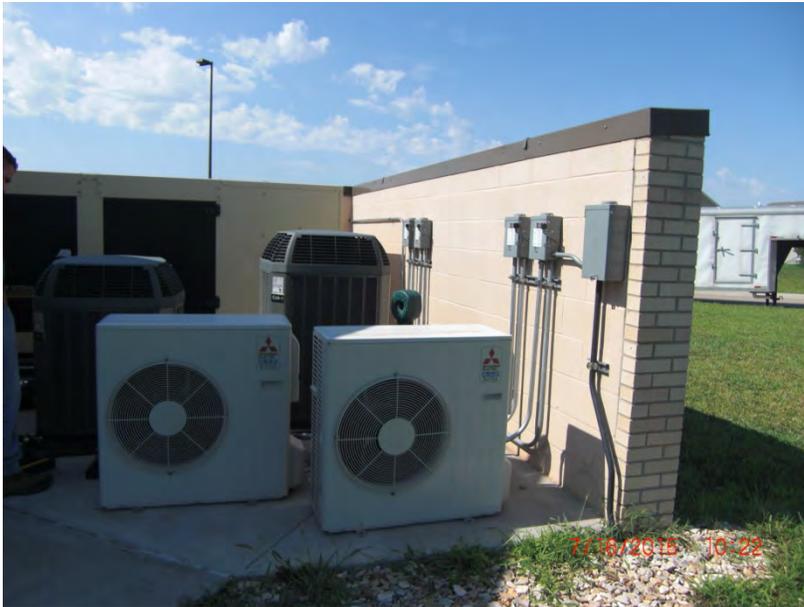
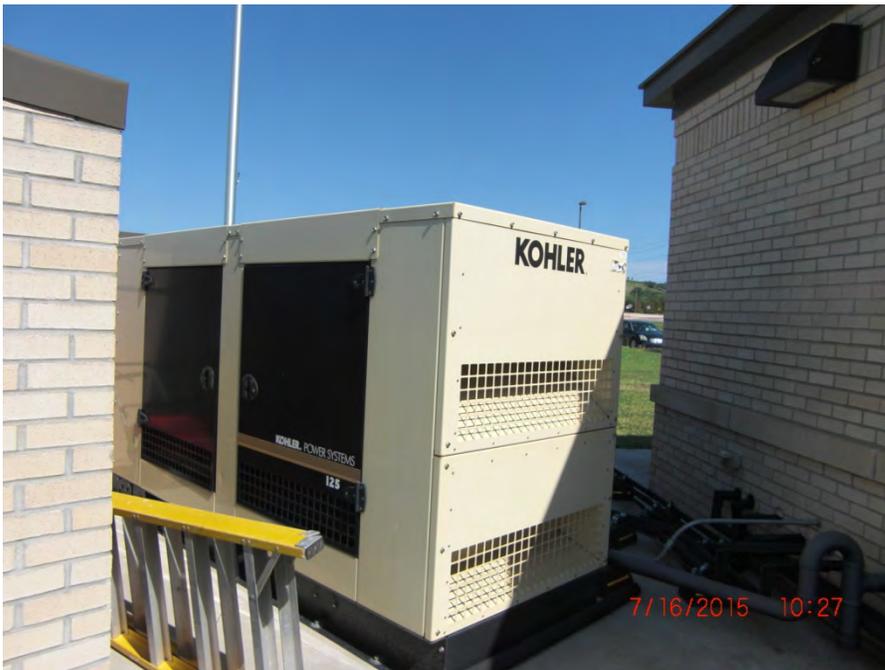
- Adequate exterior lighting system was provided for parking areas, sidewalks, building entrances and perimeter for safety, evacuation, and security measures.
- The emergency generator back-up power and Heating Ventilation Air Conditioning units are located near the patio area. This equipment is very noisy. An area away from the patio and dorm rooms would be better suited for this equipment.

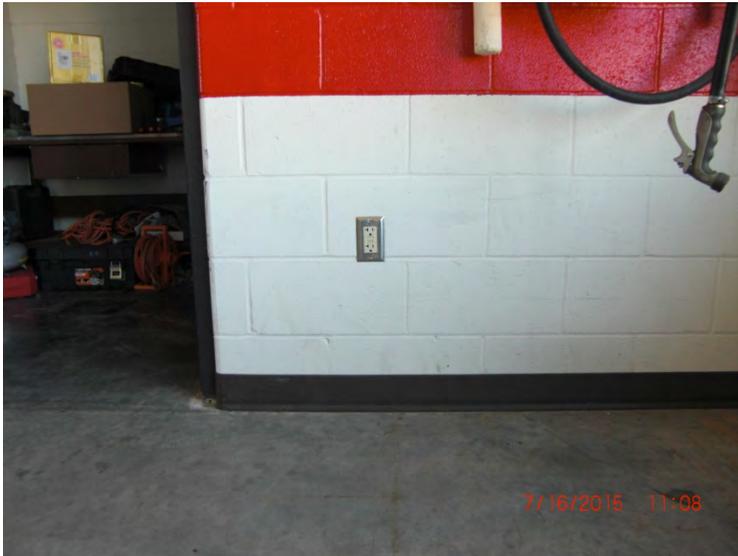
- The Apparatus Bay power outlets are not 36 inches above the finish floor. This is a problem when washing down the fire trucks. Water could get into the outlets. Power outlets should be waterproof.

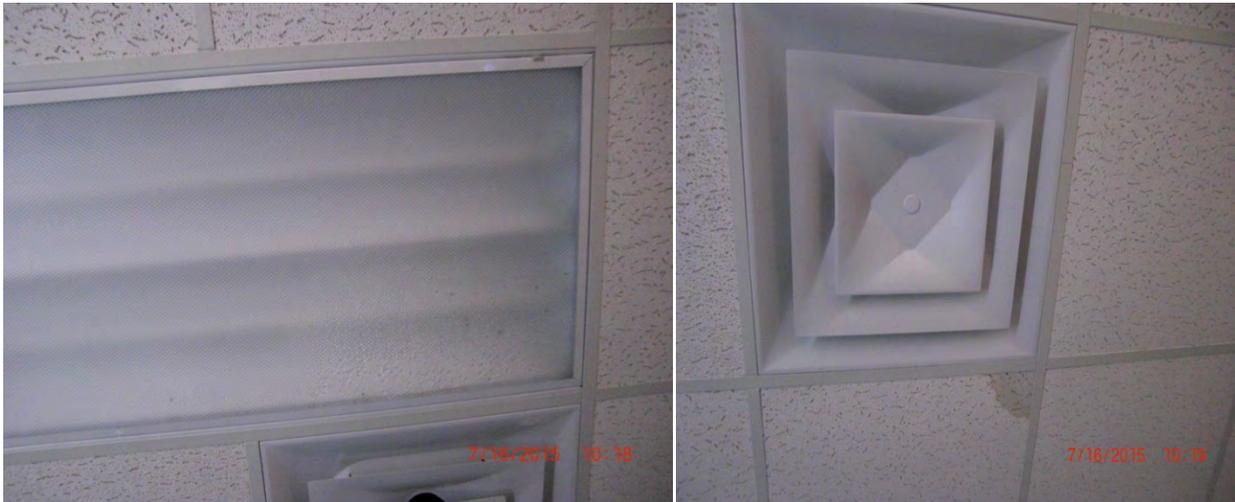
- The light fixture and ceiling tile have condensation on hot days.
