**U.S. Army Corps  
of Engineers**  
Engineering and Support  
Center, Huntsville

## **Joshua W. Soto Physical Fitness Facility**

**Building 20751  
Fort Bliss, TX**

**ESTR – Phase 1  
Project No 64614**

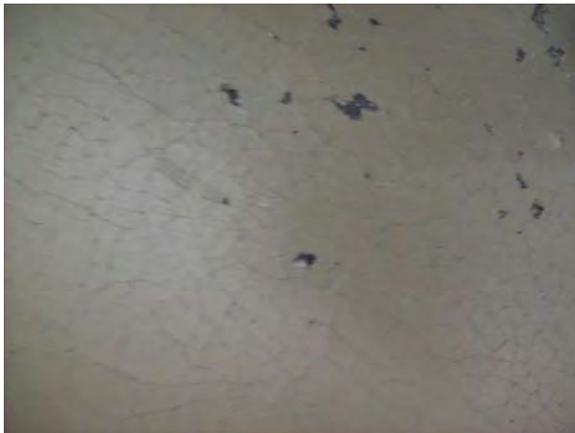
- Fire extinguisher cabinets in the gymnasium are too flimsy and are not holding up to the abuse.
- Walls in the gymnasium are also not durable enough. There are cracks and damage to the finish
- Weight room has damage on walls from the weight plates.
- Whole weight room flooring is being replaced because it is cracking from weights dropping on it. It is a poured in place flooring. Changing to 5' wide roll out surfacing more like Mondo flooring. Flooring needs to be able to withstand impact of at least 150 pound of weight being dropped from 4'-5' above the floor.

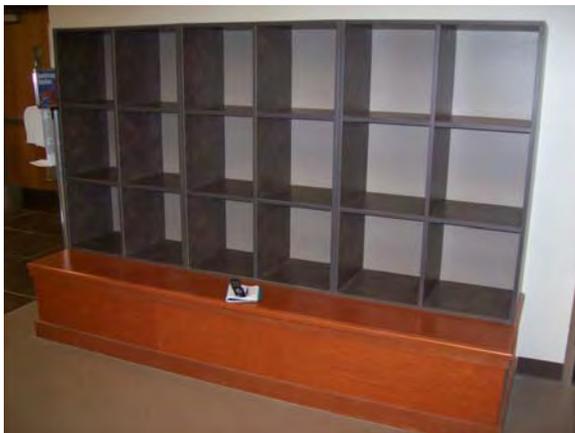
- Too many cubbies were provided throughout the facility, especially in the fitness module. They distributed them around to other places that did not have cubbies.

- There is a need for cubbies in the gymnasium as well as other areas. Add a requirement to provide cubby type storage in the gymnasium.
- Pads on the walls under the basketball goals were overkill based on how far the wall is from the edge of the court. Review the standard to see if we require the pads when the full safety zone is met.
- Need to provide general storage for the facility staff for general storage. Needs to be centrally located in the facility.
- Need to beef up verbiage about ceiling heights and exposed structure to ensure that nothing is lower than the minimum height we require, and that the space is "designed" for exposed structure, and not just look like it should have had a ceiling but didn't!

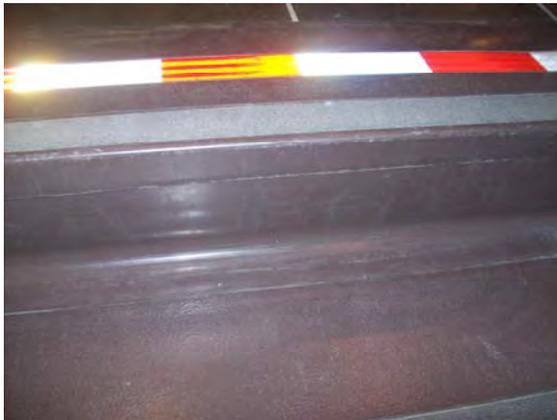
- Issues with elevator certification. Is the state required to do elevator certification in federal construction?
- Fire alarm and strobe was placed right above the heater in the sauna. On the first day of operation, those items melted down the wall.
- Top of stairs were not coordinated with the floor finish. Therefore there is a slight change in floor level at the top of the stairs which is a real safety concern.

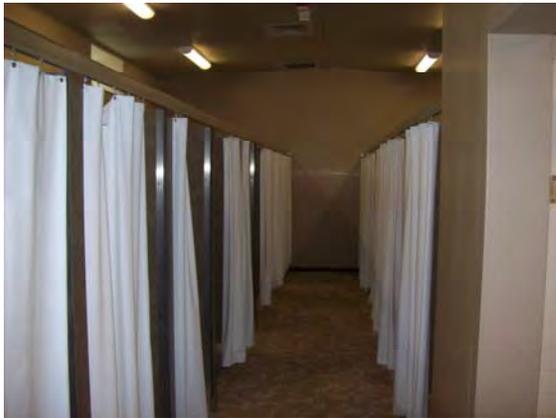
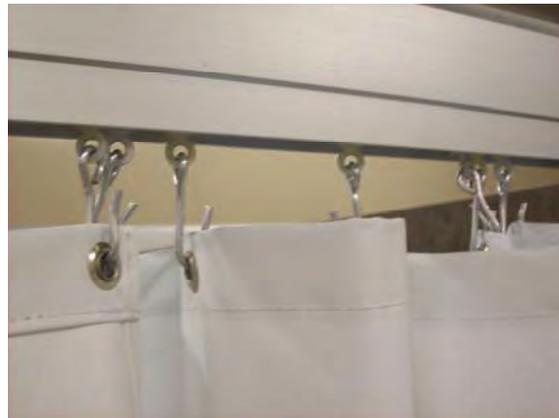
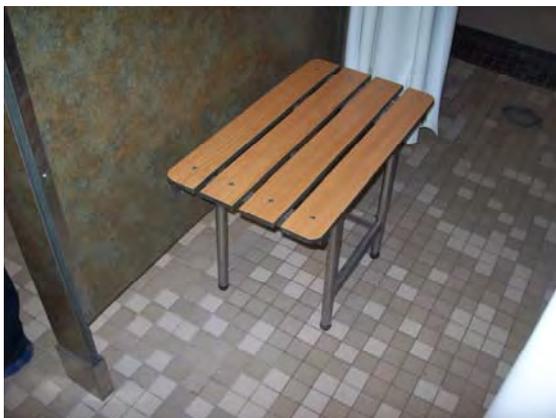
- Too many drinking fountains. People don't use drinking fountains. They bring or buy their own water.
- The private shower stalls in the men's locker room is greatly appreciated. In addition, the drying booths are appreciated, and help with facility upkeep (people are generally not as wet when they return to their lockers). Considerations for the drying booths include ensuring the bench is durable, and provided with legs if it is a fold-down bench, providing durable hooks for hanging of gear (main maintenance issue in this facility with the drying booths), providing durable commercial curtain rods and hooks, and designing to allow for users to reach in and adjust the shower before entering the actual shower stall.

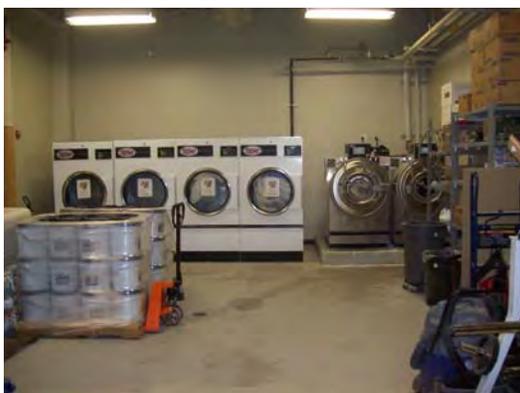
- Their laundry room (which is also oversized!) includes 2 extractors and 4 tumblers. They really only need 3 tumblers.

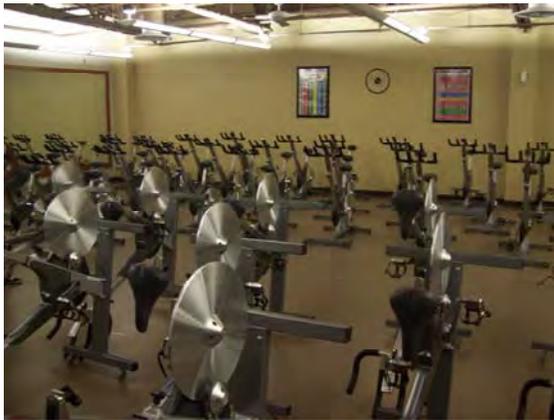
- Snack bar needs larger storage room. They took over recycling room for more of their storage. Also could use more counter top space and cabinets.
- Open concept into gymnasium and fitness module works well from the spectator standpoint. However, they needed nets in the openings around the gymnasium to keep the balls from going into other areas.
- Spinning room is a big hit. The sound proofing helps keep the sound out of the adjacent spaces. They are bringing in a consultant to “energize” the space. At first they thought that 60 bikes was going to be overkill, but they really couldn’t do with less.

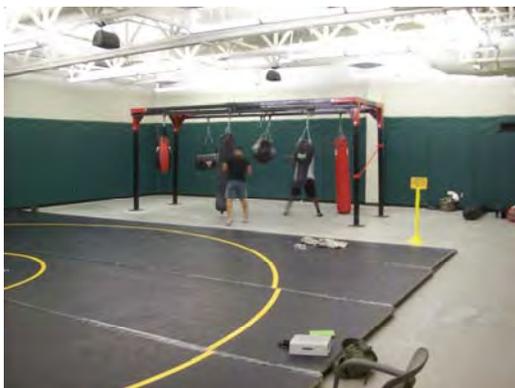
- The combatives room is crucial as well. They will still hold events, and larger combatives training in one side of the gymnasium as well. The combatives room is about half of what they need. In order to provide space for hanging bags, they do not have 2 full mats. In addition, the room was not built to the standards needed for combatives: room way out of square, columns protruding into the room, electrical outlets around the wall. Mats on the floor need to be 3” thick. Mats on the wall need to be 1 ½” thick and don’t need to be any taller than 6’. Wall mats should extend down to the top of the floor mats, not to the floor surface itself. Walls need to be reinforced in this room, especially where the bags are located.

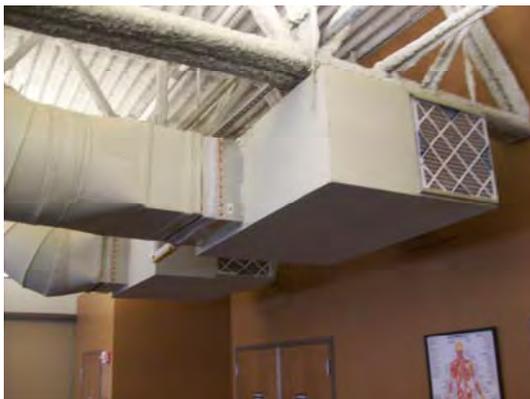
- Due to the use of Kal wall and indirect lighting shining up into fire proofed structure, the room seems dim.
- There are HVAC units above this space. When they leak, they damage the wood floor. HVAC units should not be located above wood floors.

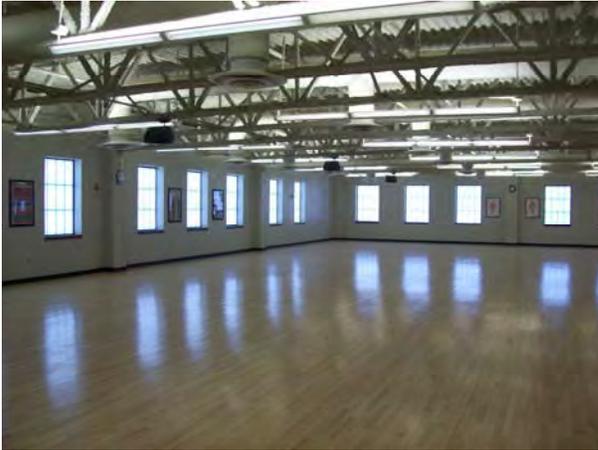
- Various spaces could use clear windows for view and brighter daylighting. All spaces seem dim, and it seems like it is overcast outside.
