**U.S. Army Corps
of Engineers**
Engineering and Support
Center, Huntsville

Child Development Center, Infant/Toddler (Medium Size)

**Building 4021
Fort Riley, Kansas**

**ESTR - Phase I (Project Review)
Project No 68850**

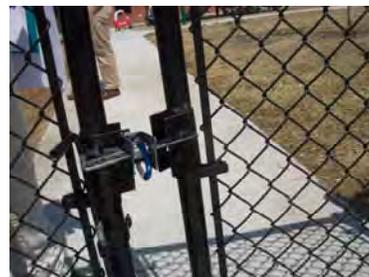
- The playgrounds are not flexible enough for the various age groups, especially when rooms are reconfigured. Sometimes groups have to walk through other spaces or around the building to get to an age appropriate playground. This has been the subject of several parent complaints.
- The location of the fencing for the playground does not follow the current standard. Installation personnel are concerned that the fence around the playground should have been taller due to its location next to a busy street and the woods.

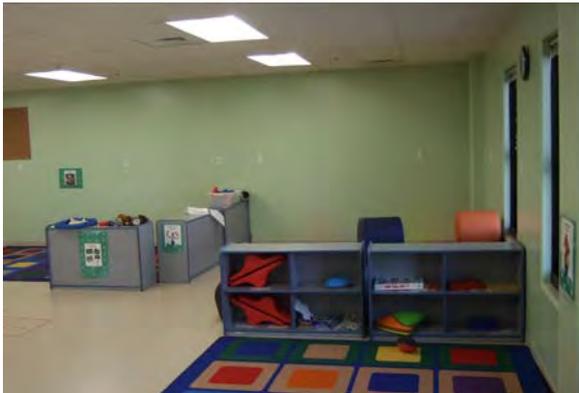
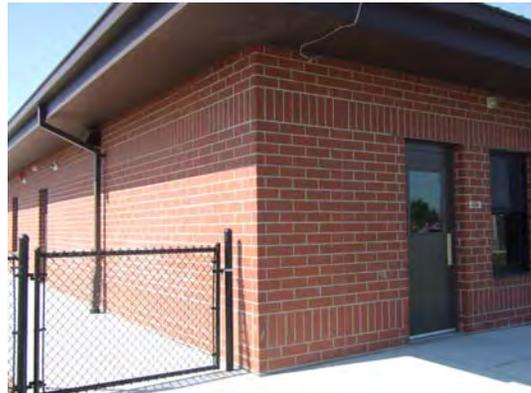
- The Active Play Room has 2 doors to the outside, and one of them is not into a fenced area. In fact, it is at the corner of the building closest to the busy road. This door is alarmed.

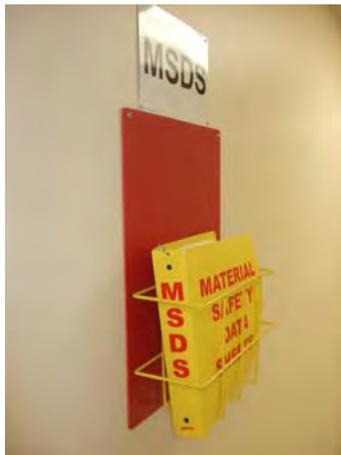
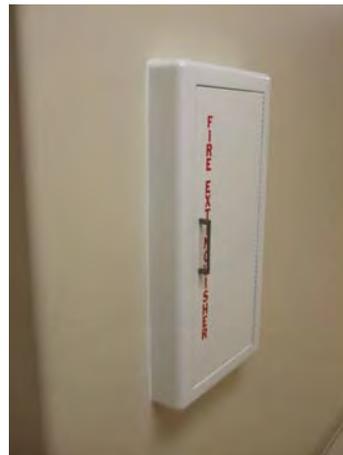
- The door from the Admin Area to the main corridor is very useful.
- Felt that the reception area for this facility is too small; too tight for 2 people. They felt the admin area in the 198 was better; however it did not include a lobby.
- Isolation area is too small and not located well. It should not be directly visible from the lobby. The child(ren) in the isolation area must have a care giver with them, so it is not required to have it open off of the reception desk. The video coverage does not completely cover the isolation area.
- Janitor closet should be by laundry, not right as you walk in the facility.
- Corridor width is barely 6', and items like the MSDS book, and fire extinguisher cabinets project into the hallway.

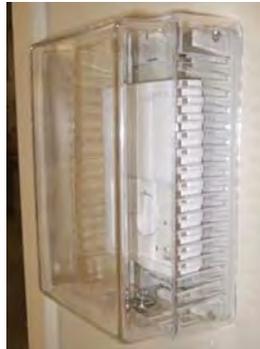
- The Plans call for the room temperature sensors to be installed at 12" AFF. The sensors were mounted at 48" AFF to keep them out of the children's' reach. The controls contractor calibrated the temperature sensors to account for the temperature stratification which would occur over the height difference. The temperature sensors have a "+/-" toggle on them. They can be adjusted anywhere between the plus and the minus allowing the staff to control the room temperature by +/- 2 degrees. Widely, there is confusion over the use of these sensors.

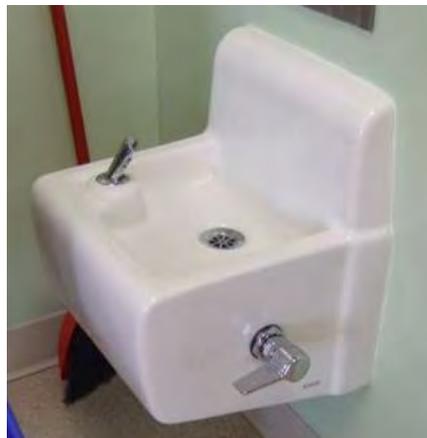
- Drinking fountains in the classrooms have large handles. Staff would prefer to have push button drinking fountains for safety reasons. Additionally the orientation of the drinking fountains should be considered. Handles should be located on the side of the drinking fountain closest to the wall. They would be less exposed and less of a danger to a child should they happen to trip.

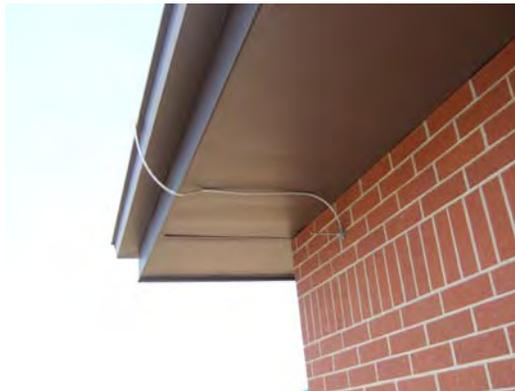
- The lightning protection installation was not in accordance with NFPA 780 section 4.9.4.1 (2008 Edition) which does not allow for a "U" or "V" (down and up) pocket. Bends were also more than 90 degrees which is also not allowed by NFPA 780 section 4.9.5. Drawings indicated a thru roof down conductor for the lightning protection system, but this was not the way the lightning protection was installed.

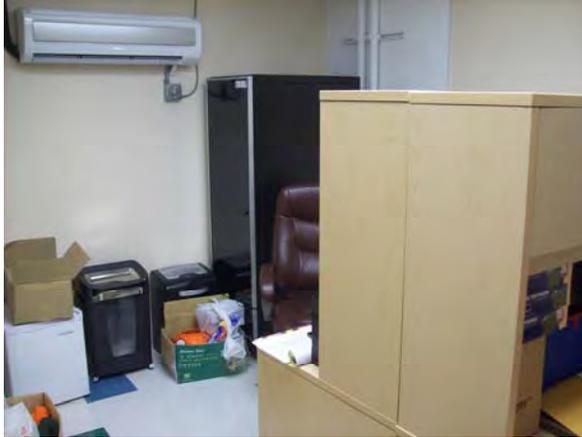
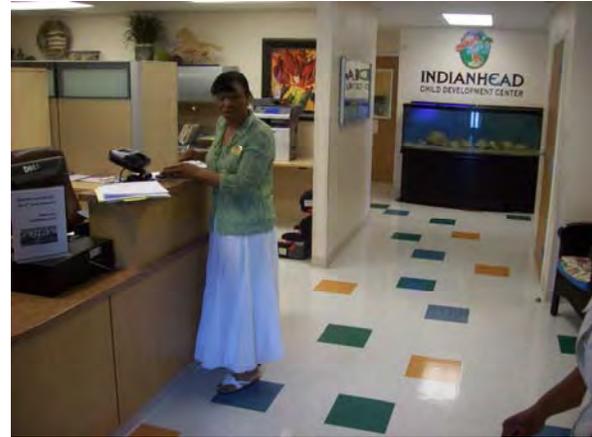
- Management staff has been increased, but not enough space. Not enough computer space either. Everyone on the staff must access information, etc. on line. The video surveillance room behind the admin area was converted to 2 offices. There is the Director’s Office, the Assistant Director and Trainer

are both located in the video surveillance room, the supervisor lead and a clerk are located in systems furniture in the admin area, plus the clerk at the front desk.

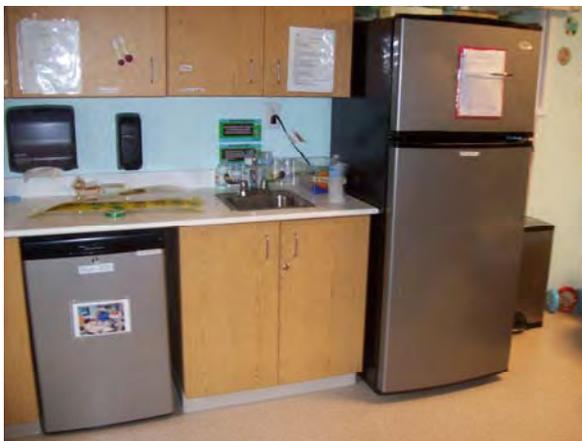
- Windows are operable, with the top sash operable.
- Space in the pre-toddler rooms is difficult to store evacuation cribs and have learning space.
- In the Infant/Pre-Toddler room, there is no place for storage of cots along with needing high chairs and regular chairs, etc. This can cause space challenges in rooms with mixed age groups.
- The under counter refrigerator in the Infant Room is insufficient in size. They have added a full size refrigerator to meet their needs. The under counter refrigerators are, however, lockable.

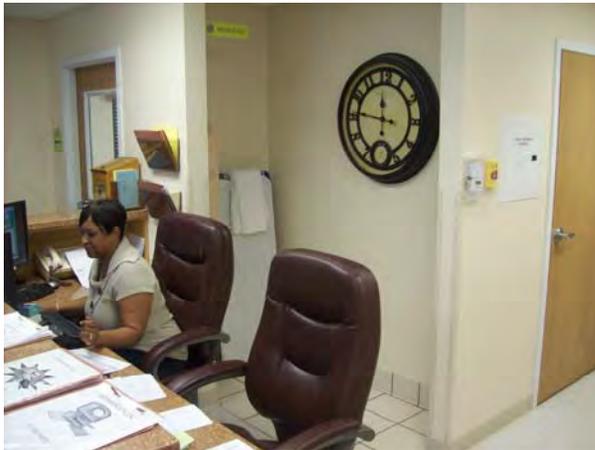
- There is no real isolation area. There is a tile area behind the receptionist that puts the child out in the open of the reception area with no privacy. The bathroom door to serve the isolation area is around the corner which is not convenient.

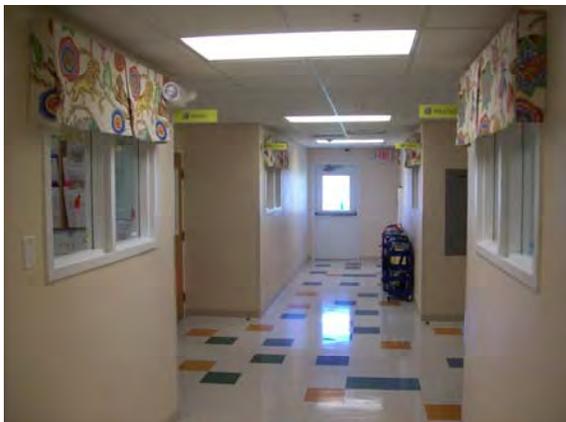
- Laundry equipment is residential style, but it has enhanced cleaning/disinfecting capabilities.
- Only vision panels (high windows) are provided between the classrooms and the corridor.

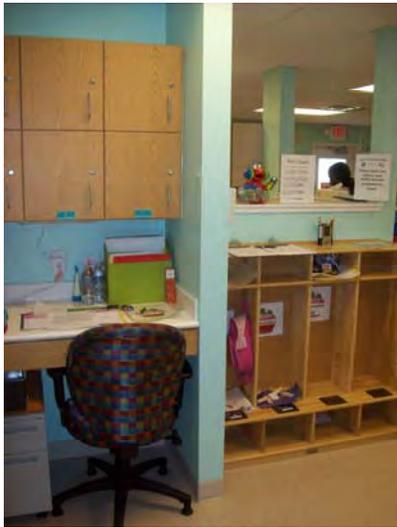
- The Director's Office is right inside the front door. Would prefer it further away (similar to where it is currently located in the standards).
- No space for car seat storage was provided, and could be used.
- This design has windows between some of the classrooms. They like the windows as it is a means to communicate between caregivers in adjacent classrooms.
- Sign-in area is used primarily by the caregivers. They use the top of the cubbies next to the door for sign-in/sign-out.
- Cubbies are Kaplan, and they appear to be 12" wide.

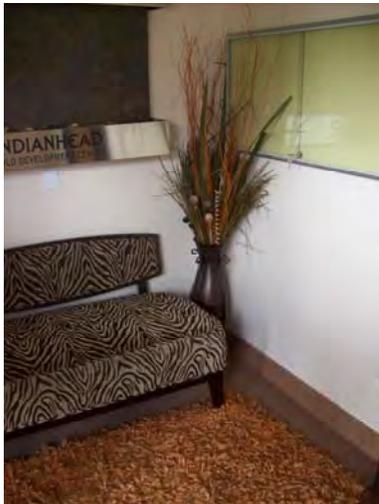
- They do not have an issue about locking the individual classrooms in case of an active shooter since the front door is locked.
- The vestibule has a quarry tile floor, no recessed mat. The vestibule is large enough to have a sofa and area rug in it.

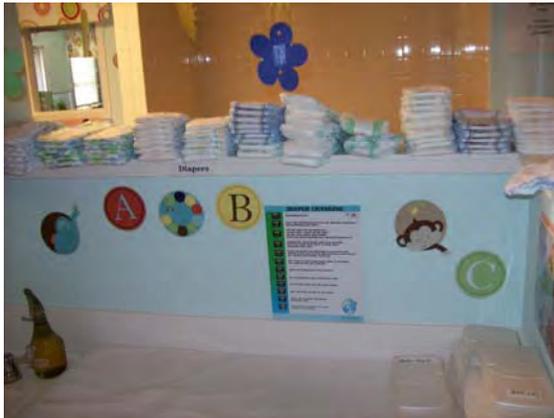
- Need to have a place for breast feeding.
- Would like to have the ceilings in the storage rooms at 9' so that there is more storage capacity.
- Diaper changing station needs to be turned around so that staff does not have back to the room. In addition, the walls behind the station are too tall to enable staff to look into the toileting area.
- Inadequate storage for diapers around the diaper changing table (especially in Infant Room) based on the number of diapers brought by parents and used on a daily basis. Also need space to store bleach and other cleaning supplies at the diaper changing table. Need to have a large built-in trash receptacle as part of the diaper changing table.

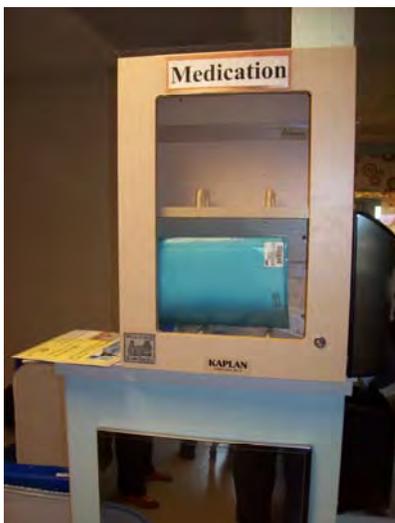
- Could use recessed first aid cabinets in each classroom. They had to add surface mounted cabinets as a result of an inspection.

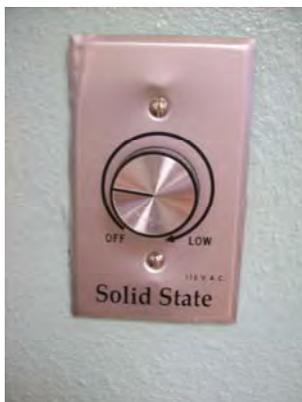
- There is an unknown control in the activity rooms!

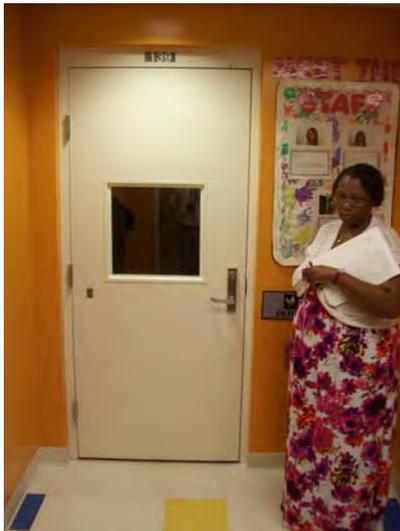
- Entry door, especially the inside door of the vestibule, is dragging and has had a lot of issues. When windy, the door really gets yanked by the wind. Have one leaf that remains locked due to the wind. The problems seem to be the leaf that has the handicap button to push to open the door. The push button for the handicap access will only last a certain period of time.
- Can hear conversations in the open office that are taking place in the private offices.
- They have a safe room for tornados, but it was a big fight to get it. They used one of the classrooms, and it required a special door. The door had to be retrofit to accommodate a window as required. There was not enough room for a sidelite.

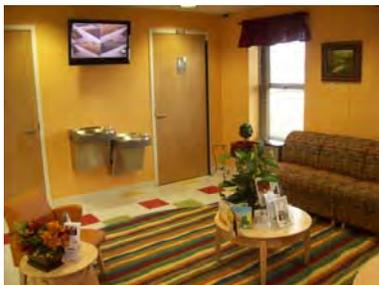
- Thresholds are allowing water to come in during driving rains. Putting a French drain across the sidewalk in front of the door as well as installing a shield on the door will greatly help.
- Two of the hose bibs had problems with leaking.
- Adhesive on sheet flooring shows through when using a trowel. Needs to be rolled on instead. Flooring manufacturers accept rolling the adhesive, however it's not in their specs. It shows up on light colored floors that are buffed.
- Office furniture was delayed for 6 months. And there are still some pieces of furniture missing.
- They like the colors in the center and the furniture provided. They did a change order to change from SW scheme to primary scheme.

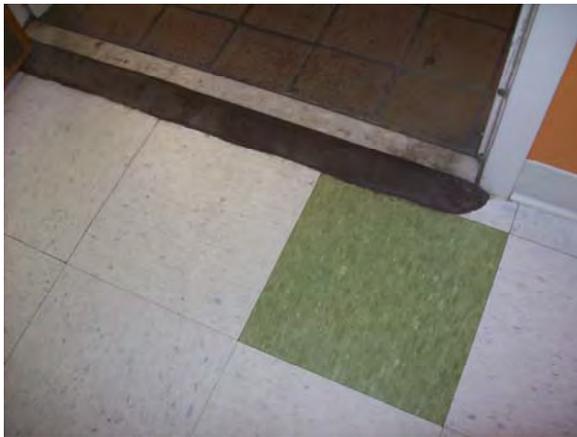
- Lighting controls.
- Toilet partitions will not stand up to use. Needs to be more durable.
- Some plumbing walls at the diaper changing stations were too tight; had to go to 2x6 construction.
- Had a gas leak in the kitchen.
- Kitchen has had issues with blowing breakers. Also same problem in Break Room. There are larger loads in these areas.
- Threshold at kitchen door to corridor creates problems for carts.

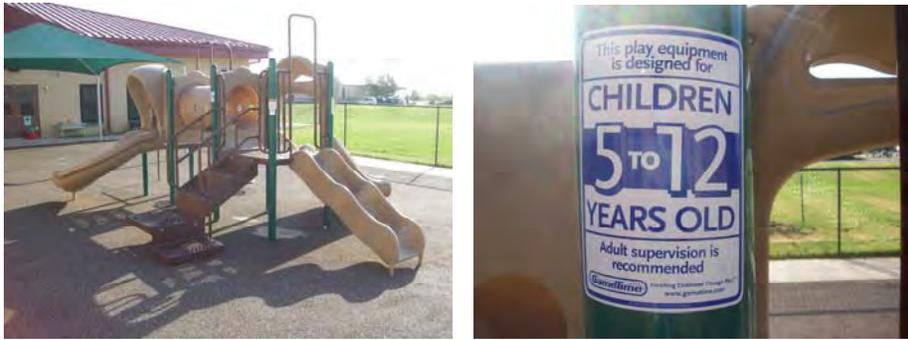
- Grout in kitchen floor was a problem. Kitchen floor is very difficult to clean.
- Paper towel holders that come with the building are great. However, the contractor needs to coordinate with the installation to ensure they are providing the correct holder for the towels provided on the installation.
- They have grass area between the building and the perimeter sidewalk.
- They love no sand and no trees in the playground. And they love the playground surfacing.
- Some areas of the infant playground are in the sun. In addition, some of the slides are in the sun. Needs more shade.
- Play structure in the Pre-K/Kinder playground is a little small for the Kindergarten children. However, the label shows for ages 5 – 12.

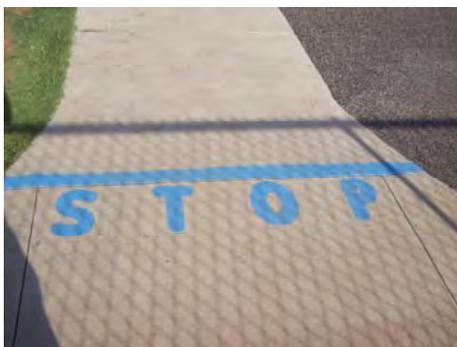
- Toddler playground gate is not 50' from the face of the building.
- Each playground has 1 hose bib and 1 telephone. But no electrical.
- Sidewalks beyond the gates out of the playground are needed. They finally got them constructed.
- Some gates are not located well; they create some blind spots. Some classrooms go into a small fenced area before into the playground. After further investigation it was noticed by the evaluators that the standard was not followed in this regards.
- Concerned about the durability of the Little Tykes equipment installed. Typically not considered commercial quality.
- Instead of providing a stop sign, just painted stop on the sidewalk.

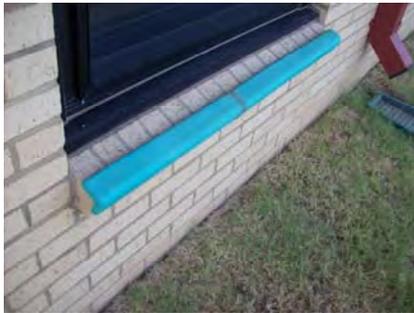
- Installed bumper guards on the window sills outside for safety.

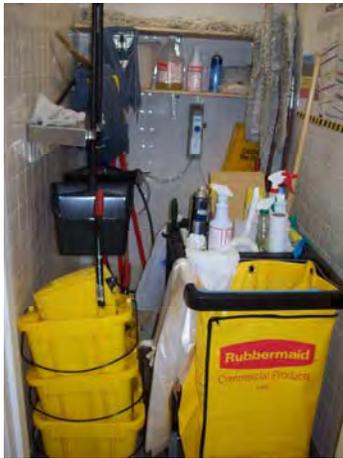
- Janitor closet is so small there is no place for things like paper towels, toilet paper, etc. They gave up a storage room off the corridor for janitorial supplies.

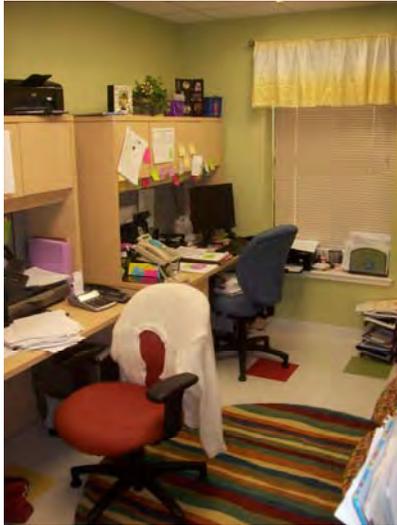
- They had intercom at the sign in desk in the activity rooms, but moved it to the main part of the room so it does not require caregiver to go to blind spot to use it.
- Kinder rooms could be larger; 24 children that age take a lot of space.

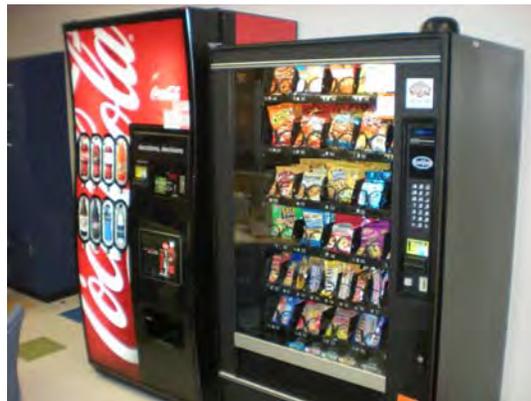
- The staff lounge room 110 has issues with throwing breaker due to overload on the circuit. The area within the staff lounge had seven receptacles on a single circuit 31 of panel RP-1 throughout the room. Two of those receptacles were being used by vending machines which were not identified as such in the drawings on page E-105. These should typically be dedicated circuits. The room-by-room description indicates vending machines but does not specify them being on a dedicated circuit. I did not verify the circuit was installed in this fashion, but it would explain the overloading of the circuitry identified by the user.

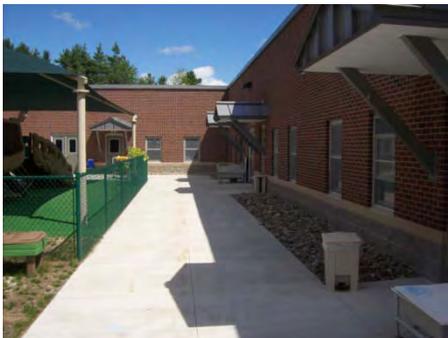
- Gates need to be as wide as the sidewalks around the building for snow blowers.
- Sidewalk cannot be against the building in this location due to snow removal.
