**U.S. Army Corps
of Engineers**
Engineering and Support
Center, Huntsville

Gate 10 CDC (Gardner Hill) (0-5);

Building 7404 Fort Campbell, KY

**POTR – Phase 1
Project No 58583**

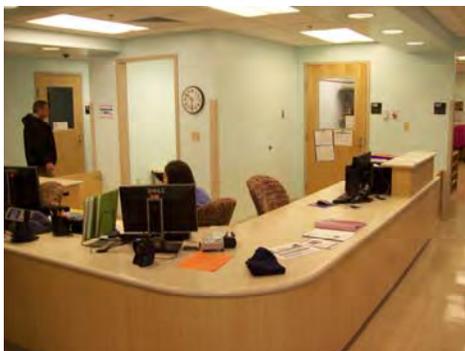
- Problems with some of the drinking fountains in the classrooms leaking.
- Outside set of doors on the vestibule cannot be locked at any time. This has led to an instance when someone came into the building and vomited in the vestibule.
- The reception counter functions well, and there were adequate data and electrical outlets provided.

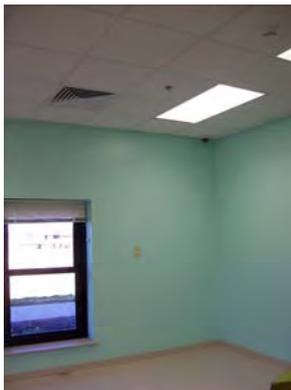
- All activity rooms exit into the playgrounds. Only doors that exit into non-fenced areas are alarmed.
- Exterior window sills are so low in the activity rooms that the children climb on them. They are approximately 14" off the floor. In addition, from an aesthetic standpoint, the tops of the windows are below the tops of the doors. Both problems would have been resolved had they raised the windows approximately 6".

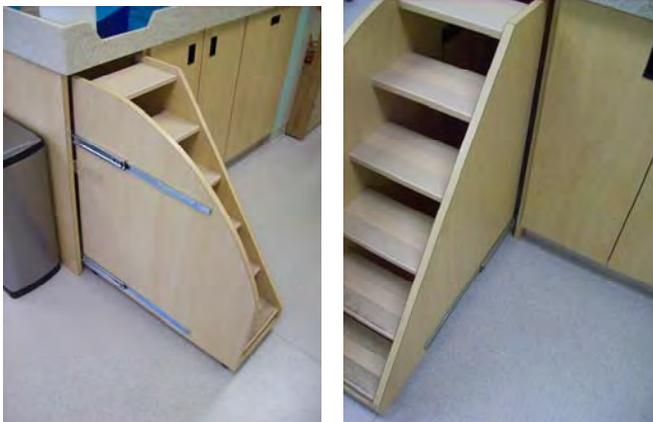
- Issues with the diaper changing station. More details need to be provided in the room by room document to help the contractor understand what is required. Stairs have been a problem. Rollers did not provide the correct type of locking. Drawer slides help, but are not durable enough.

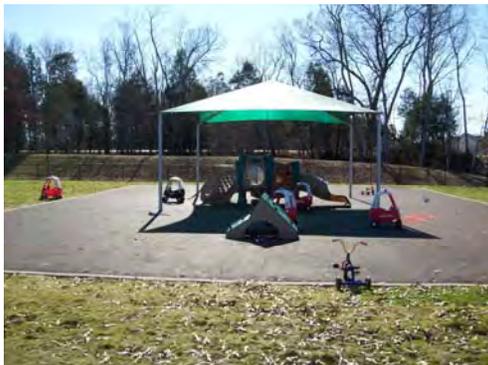
- No trike path in the Toddler/Pre-school playground. Instead, there is a trike path in the Infant/Pre-Toddler and the Pre-K/Kindergarten playgrounds.
- In the Toddler/Pre-school playground no paved path was provided to second shade structure area. Contractor came back and provided one to first structure, but would not go the extra 12' to the second one.

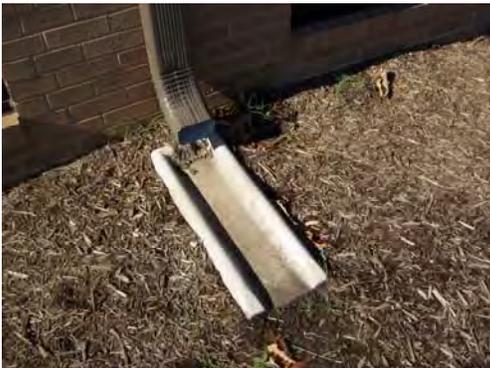
- Downspouts have sharp edge exposed in playground.

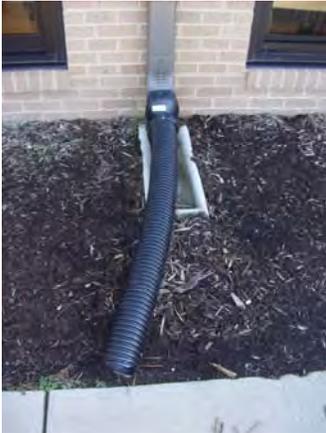
- Parking lot is the “boat dock” configuration, which leads to cars driving on the sidewalks and other traffic concerns. The sidewalks are at the same level as the parking. The parking lot is pervious paving.
- Perimeter sidewalk is not against side of building. Gutters empty on to splash blocks. Have problems with run-off water washing away mulch and dirt.

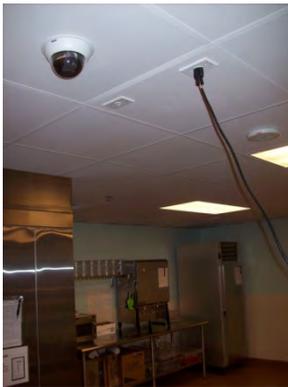
- Kitchen needs a steam table or warming oven to keep food warm while serving.
- Kitchen needs a mop sink. Looking at installing one adjacent to interior door alcove.
- The kitchen needs more outlets in the ceiling, but need to be centered above equipment. Cord is barely long enough.

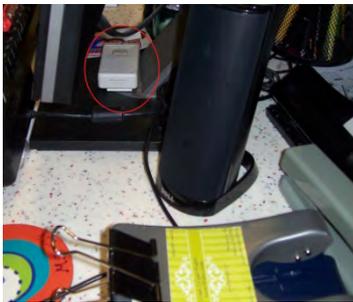
- A duress alarm is provided; however it looks like a garage door opener, and presently just sitting at base of one of the computer monitors.

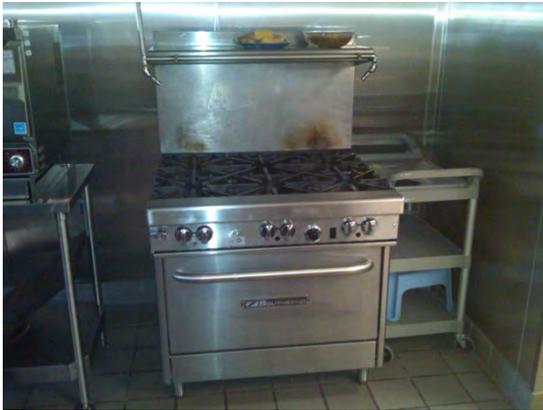
- One of the major issues with the facility and standards is that the standards require grass; however, grass is not allowed at Ft. Irwin (way too difficult to grow). CYS would have liked to use artificial turf instead, however G-9 would not approve. Instead, the only other option was wood chips, which is a maintenance and safety concern.
- The range is smaller than they would have liked and than what they need. This kitchen actually serves all CYS facilities. They could really use a griddle as part of the range.

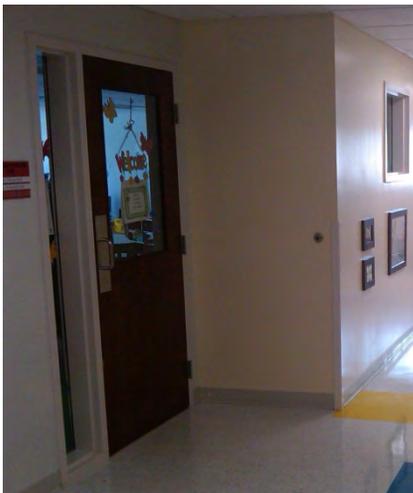
- Doors from the activity room to the corridor do not latch. Instead they are basic push/pull doors. This is a real concern as children can easily open the door and get out; which has happened. It's a staff issue because the caregiver can lose their job if a child gets into the corridor, but the caregiver may not be able to get across the room and get the child before they get out of the room. Originally the doors had latches, but evidently a group from Omaha COE came to the facility and told them they couldn't have latches. This was not a G-9 or contractor issue. Ft. Irwin reps are going to see if they can find documentation on this, however, it is felt that this came up in a discussion as they were doing a "pre-" walkthrough, and said if the doors had latches they would be written up when they did the final walkthrough. At this point no one is clear who this group was and who they were representing.

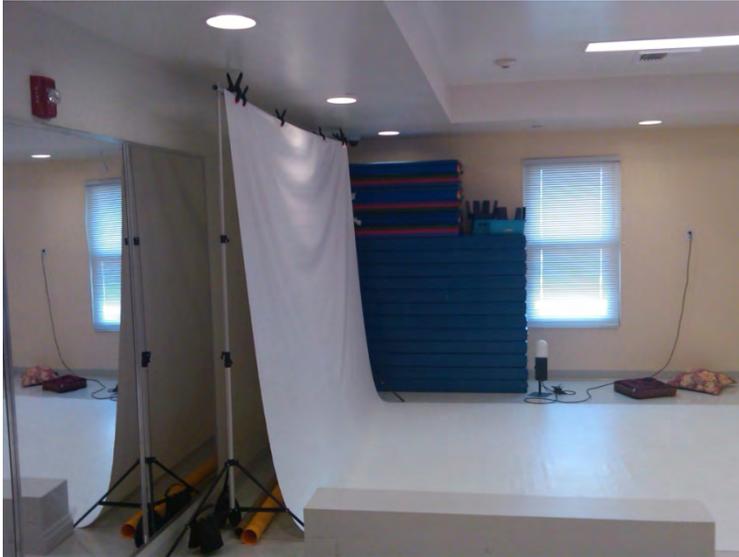
- The sprinkler heads in the active play room are the recessed type to avoid damage.

- Recommend considering using recessed sprinkler heads in the Active Play Room to avoid damage to the sprinkler heads and to avoid the need for cages around the heads.

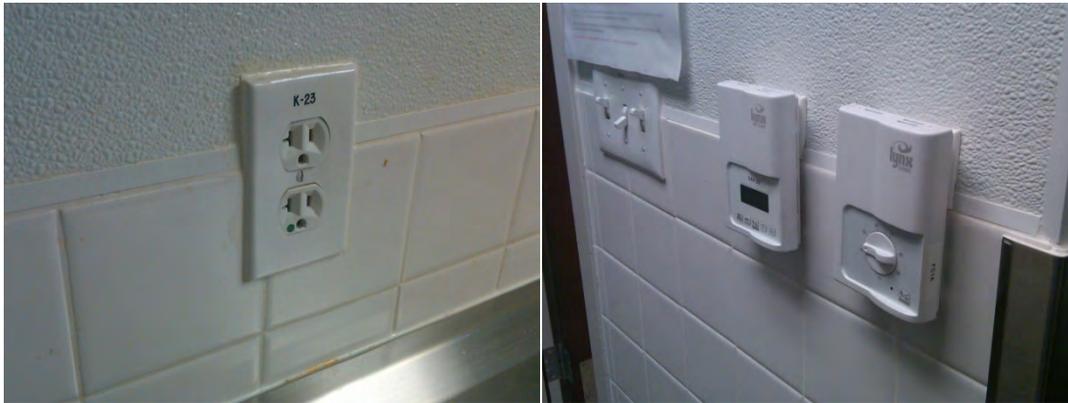
- Cubbies and diaper changing stations were custom built. Cubbies are at least 48" tall, which is too tall. Forces the windows to be even higher. Most staff and parents are not able to use those windows.
- Had to add a handle and lock to the stairs in the diaper changing station. Unique design actually has the stairs behind a door when not in use.
- Some issues with the location of outlets/switches/etc. not being coordinated with the height of wainscot.

4. General cleaning and fit and finish items such as Floor, paint smears, windows must be completed.
5. Repair stairs to diaper changing station that do not lock and rub when opened

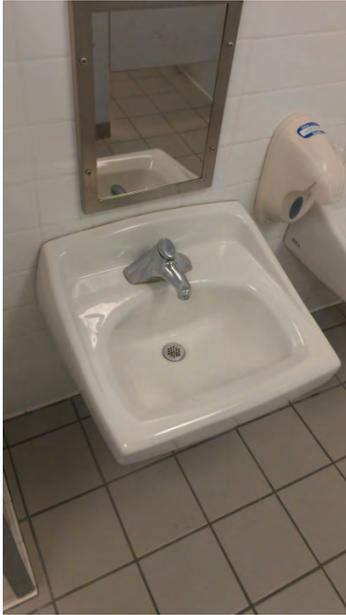
- Hot water needs to be circulating so that the push-button sinks can get tempered water quickly.
- Push button sinks do not allow enough water flow to get hot water without pressing the button many

times.

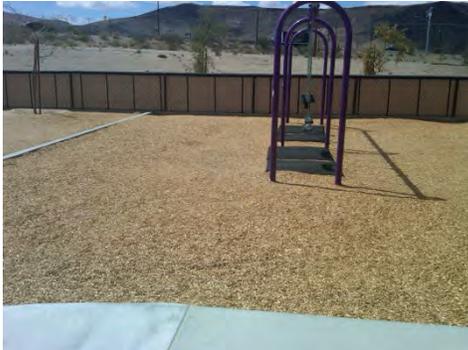
- Parking area was not wide enough for 2-way traffic, so they remarked it for one-way circulation
- Need shade structure over swings.

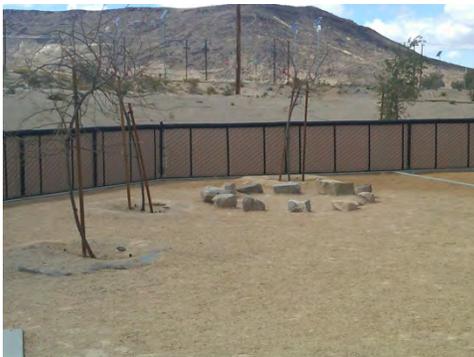
- Lots of issues with snakes, scorpions, etc. Have snake fencing and then a screen material to keep unwanted creatures out.

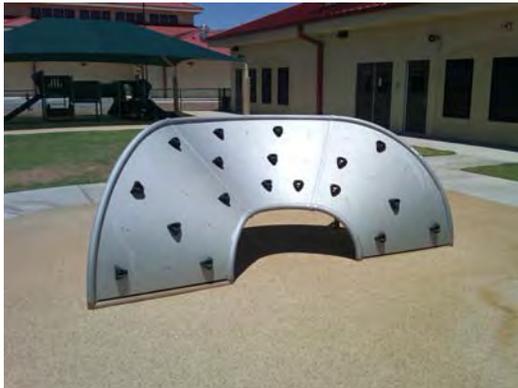
- Water softener and irrigation control should be controlled/accessed by the users. DPW will not touch the water softener
- Playground equipment in some playgrounds is age inappropriate, such as the climbing wall. In addition, the climbing wall is in full sun, and is unprotected metal. Gets extremely hot.

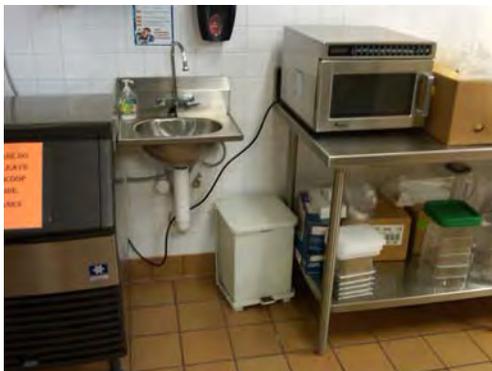
- RFP needs to say a dedicated HVAC system for the Video Equipment Room
- Integrity of the sewer lines needs to be evaluated before tying into them. The sewer smell would not be a problem if the main sewer line were replaced.
- Would prefer athletic flooring in Active Play Room. A little more cushion and more durable; would allow roller skating inside.
- Need storage areas for maintenance equipment such as mowers, weed eaters, etc.
- Kitchen needs more electrical outlets on the wall. The cord for the microwave had to be run under the sink.

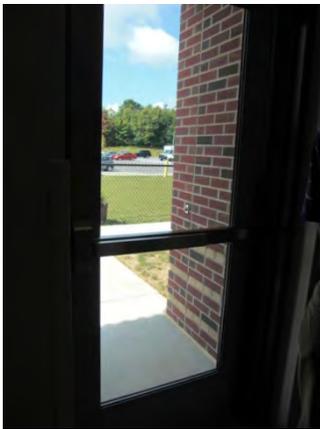
- The users had a question about the function of the Outreach/Transitional Care Room. I stated that it was basically an hourly care. They stated that they interpreted the regulations that you couldn't have hourly care in a facility with full-time children. They were basically using it as another full-day room.
- There was a request for a design change after construction to put side lites at the doors at the ends of the corridors. This could not be accommodated, however they replaced the solid doors with solid glass doors. If side lites are required at the end of the corridor, this needs to be clearly noted in the criteria.

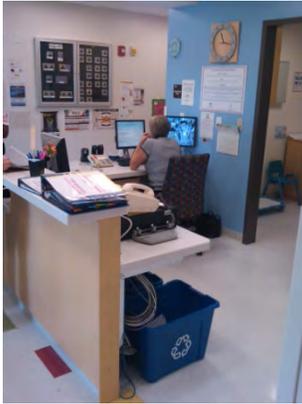
- Front door buzzer system is not holding up for more than a week.
- All doors should have a vestibule for energy concerns (very important here)
- Diaper changing stations are not working – stairs are too wiggly. The user indicates that even 3 year olds don't use them if they have to have their diaper changed. They are not using the stairs at all.
- The Control Desk is very small for the small facility. Isolation area is used for admin storage. Need place to put copier. Cannot comfortably fit 2 admin personnel behind the desk at one time.

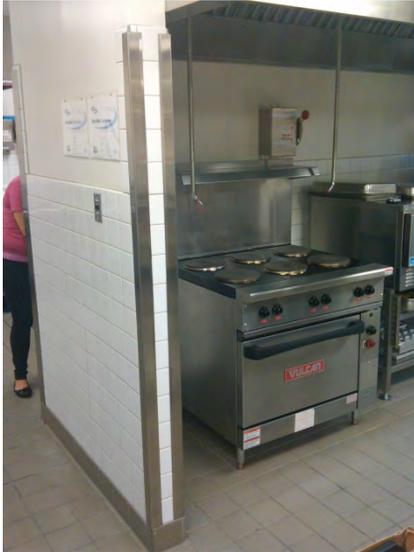
- The kitchen, laundry room and janitor's closet have quarry tile floors, ceramic tile wainscot, and vinyl faced acoustical tile. The kitchen had interesting tile work to accommodate the corner guard. Need to

ensure this is not driven unnecessarily by our criteria.

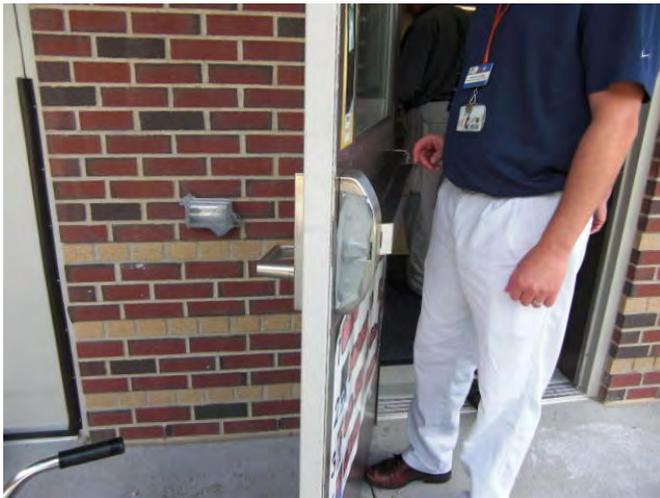
- It was noted that the ceiling tile throughout the facility was lay-in and not tegular.
- Document if all activity rooms exit directly into the playgrounds. Yes activity rooms exit to outside. The doors must be locked at all times. Teacher need a key to re-enter activity room from the playground area. Tape is placed on doors to allow the teachers to re-enter from the playground area.

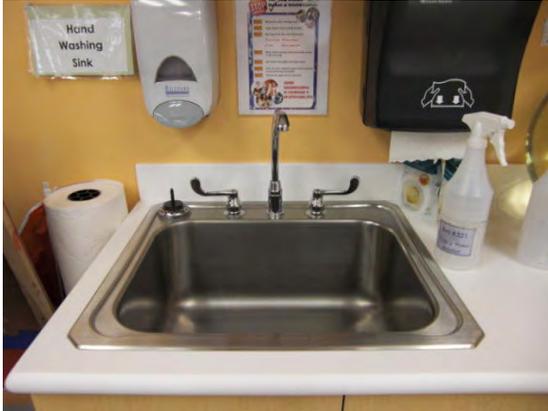
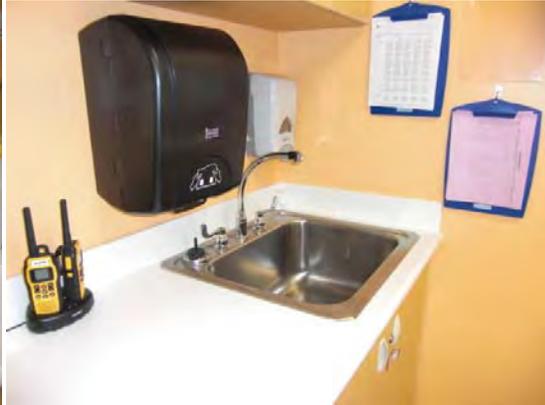
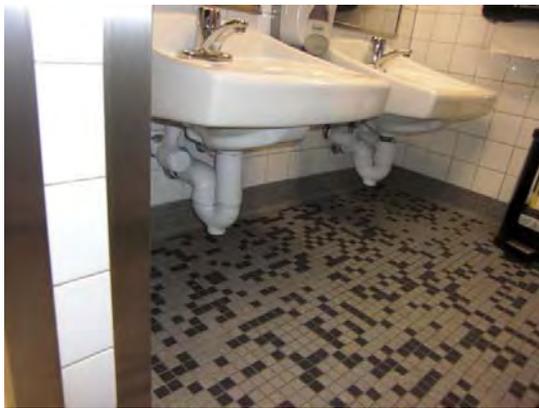
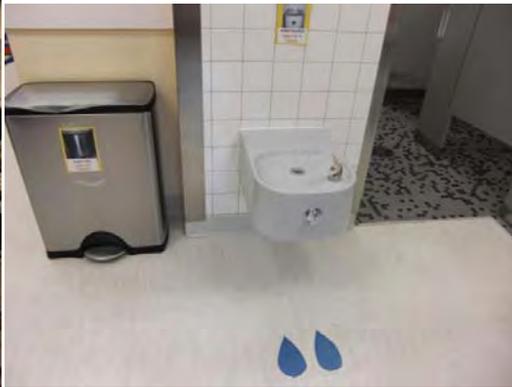
- Plumbing in exterior walls for washers is a concern in this climate.
- Document satisfaction with plumbing fixtures installed (high efficiency type used)

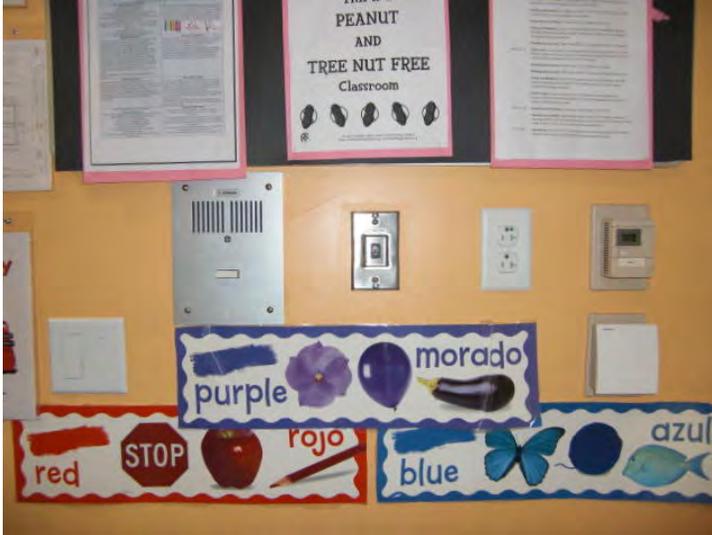
- The Communications Room in this facility does not comply with I3A.
- A standard they implement at Ft. Drum is to provide an electrical outlet at every data drop.

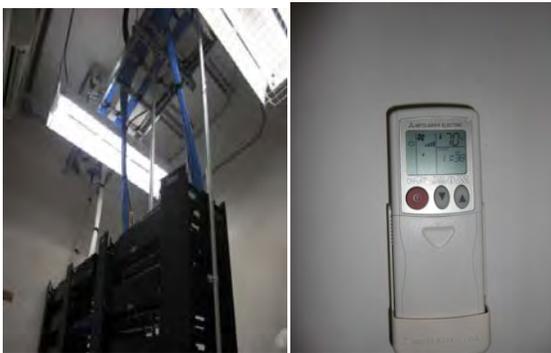
- The Communication Rooms are adequately heated/cooled. The owner do not like the “L” shaped room. It is too small.

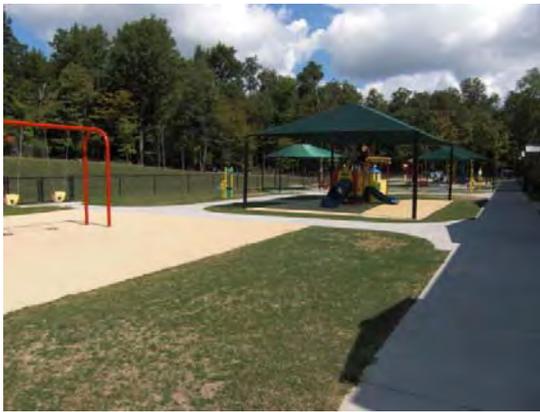
- They would like to recommend, or at least be able to use, “sand-filled synthetic carpet”. It provides the same fall attenuation, and doesn’t get nearly as hot as the poured in place rubber surfacing.
- They are getting temperatures on the playground surfacing of 160 – 170 degrees. Safety will not allow use of playground if the temperature exceeds 110 degrees, based on the water temperature allowed for the children. Need to document what is an acceptable temperature, and if lower than possible with the surfacing in the sun, then provide larger shade structures. The surfacing used was light in color – a solid tan.

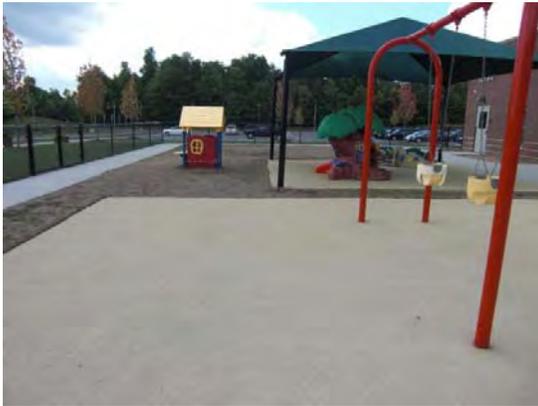
- Critters are digging under the fence and using the bathroom on the safety surfacing. Foxes live under the shed next to the building.
- Document if playgrounds include concrete trike path, shade structures, and correct play elements. Ensure the playground equipment is age appropriate for the playground where it is installed, and that it is commercial quality.
- There is no play equipment for infants through 18 months old children in playground area.

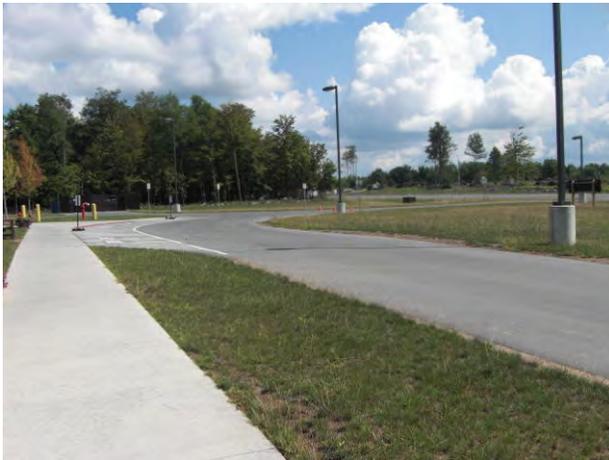
- Challenge with the size of rocks in the top soil. This led to a large discussion with the Contractor. The contract calls for loam, but it should say the maximum particle size allowed.
- The drop off drive has been closed because patrons were using it and parking along the edge to check their children in. It became a safety concern.

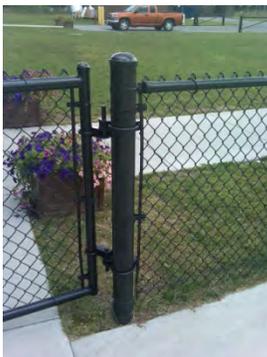
- Hinges are offset to accommodate a required gate swing. However, they provide large holes for animals to get into the playground through. Need to see if there is a better solution.

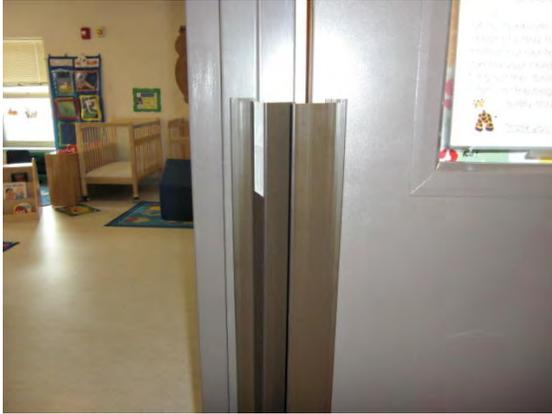
- The designer of record should specify the size of the playground canopies.
- The finger guard had to be replaced with these.

2. Provide Fingersafe MK1A and MK1B finger guards or approved equal in the correct length at locations as required by the contract documents.
3. Move the walk-in cooler condenser unit and associated power and refrigerant lines from the present pad-mounted location in the front of the CDC to a location at the back of the CDC. Mount the condenser such that it is at the same elevation as the split unit A/C condensers. Follow manufacturer's installation recommendations for mounting requirements and maximum distance from walk-in cooler for optimum performance. Remove the existing concrete pad and buried associated power and refrigerant lines, except for lines under asphalt or concrete paving. Restore all disturbed areas in accordance with contract documents.

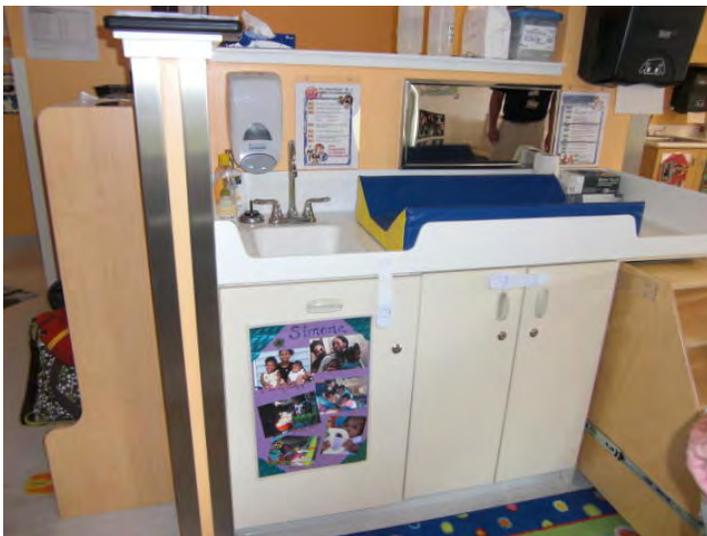
- There is a line of sight problem for the bathroom and diaper changing station.

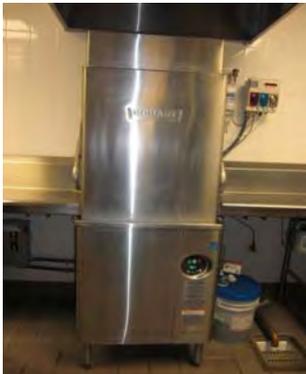
- Light ballasts are causing a beeping.
- Floor tiles are shrinking and joints between tiles are getting larger. 2'x2' floor tiles were used.
- There was a concern about formaldehyde in the ceiling tiles.
- Playground equipment labeled for 2-5 year olds, but not acceptable for toddlers. Army classifies ages of children differently than the manufacturers classify their play structures.
- The water temperature in the dishwasher is not hot enough during washing, and the dishes aren't drying.

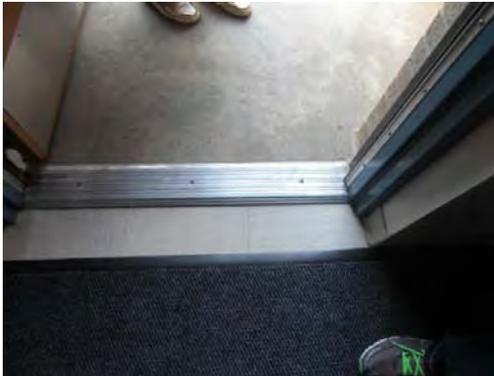
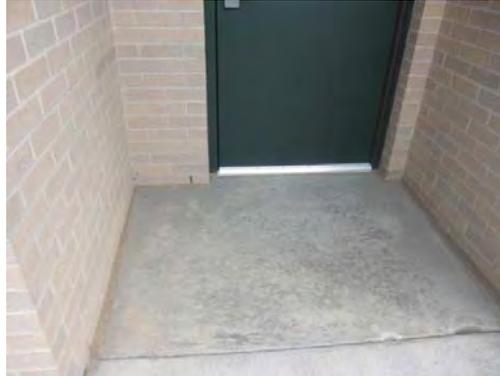
- The fencing at the bottom of the “T” is incorrect. Instead of gates at both corners of the building, there is one gate near the building exit. This creates 2 hiding areas for children.
- There is a sewage smell in summer.
- Doors on the west face of the building allow water to penetrate under the doors; especially the door at the end of the corridor.

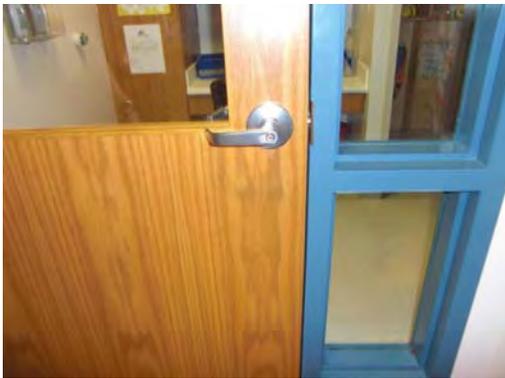
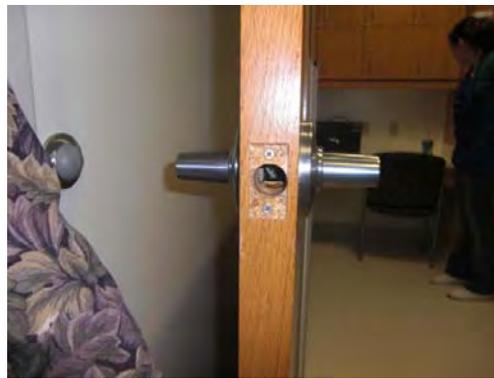
- The door handles stick. Some of the locks were removed.

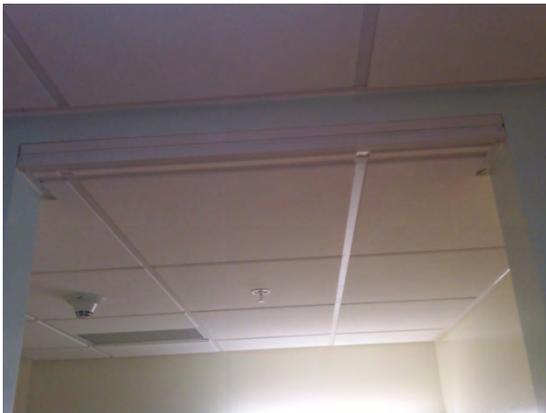
- They feel there should be more cameras in the administration area.
- The ceiling in the Active Play Room was originally installed too low, and had to be raised. There is an awkward transition in ceiling height between the Active Play Room and the Active Play Room Toilet.

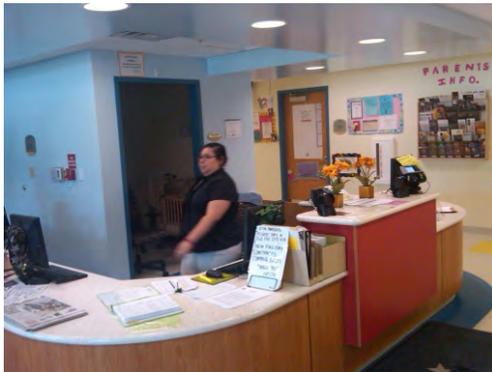
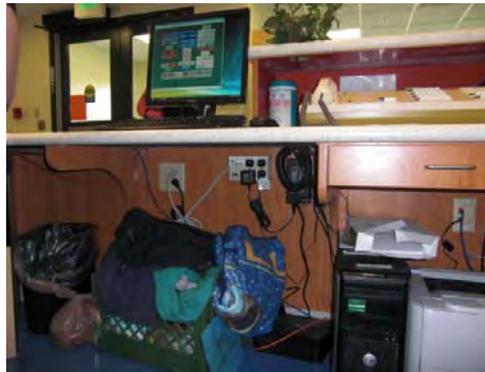
- The reception counter works well, just need more data outlets due to the hourly care function. There should be more power/data outlets in the reception area for the phones, cameras, and receptacles.

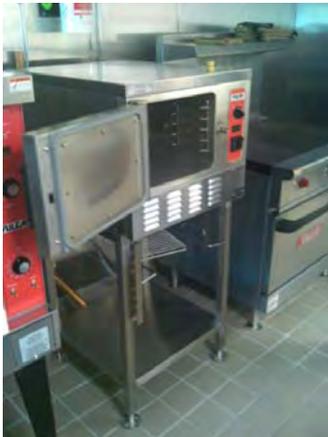
- The Active Play Room needs harder wall surfaces.
- The Active Play Room was provided with an athletic flooring.
- The steamer provided in this facility is too small.

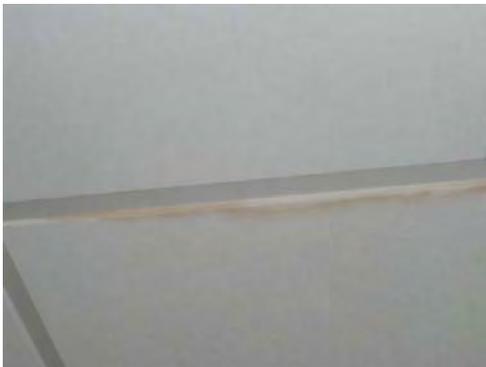
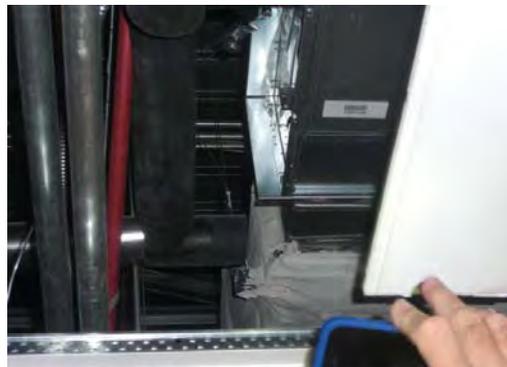
- The Fan Cord Unit 2 leaks on the ceiling tile in room numbered 111.

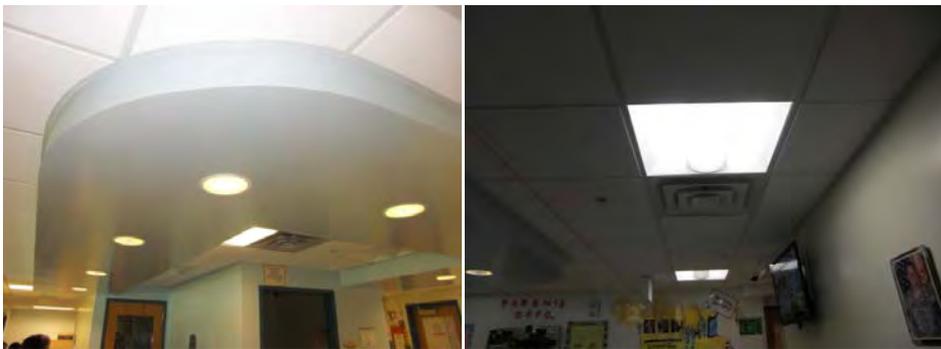
- Document if there is multilevel switching or dimming in admin and/or other areas. No dimming in admin/or other areas.

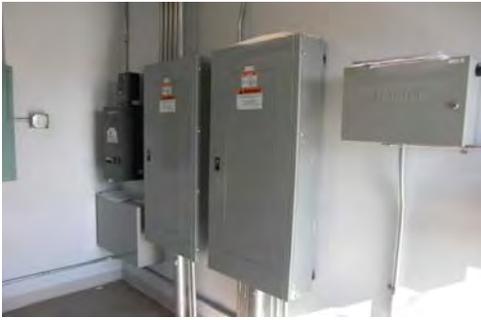
- Document if concealed/flush boxes are used for devices in finished areas and on exterior walls. No

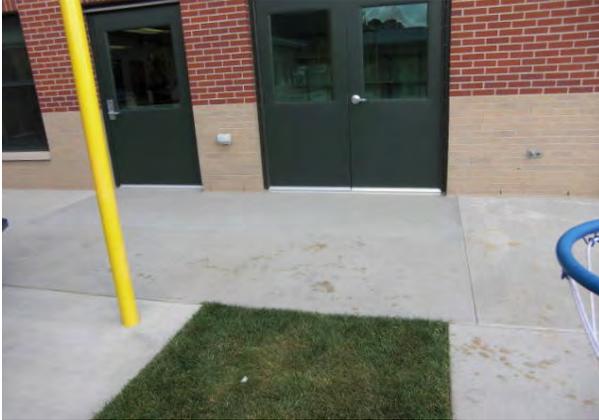
- Document satisfaction with security systems. Playground area should not have key card access.

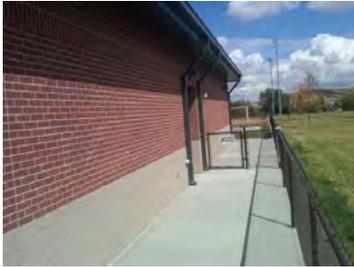
- The fencing at the bottom of the “T” is not correct. Instead of fence and gates at both corners, there is only one fence and gate near the exit door from the building. This creates hiding places in 2 playgrounds.

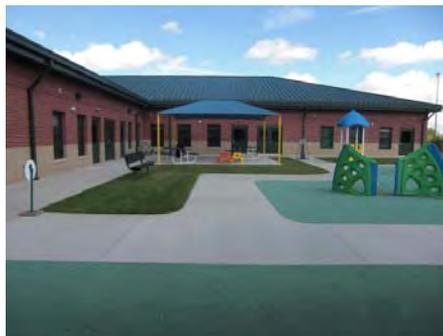
- The playground equipment is not appropriate for Toddlers (manufacturers indicate equipment for 2 – 5 year olds; Army classifies Toddlers as younger than 2). It is a better fit for older children. A child fell through the ladder shown below.

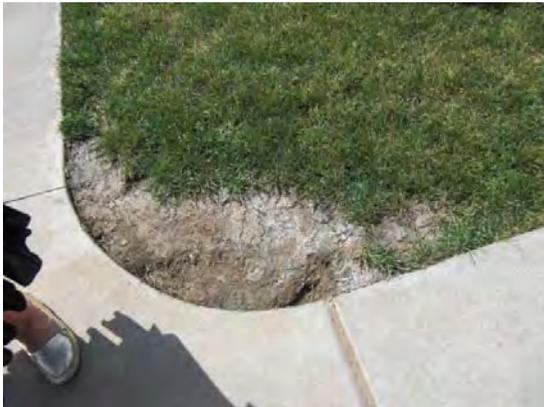
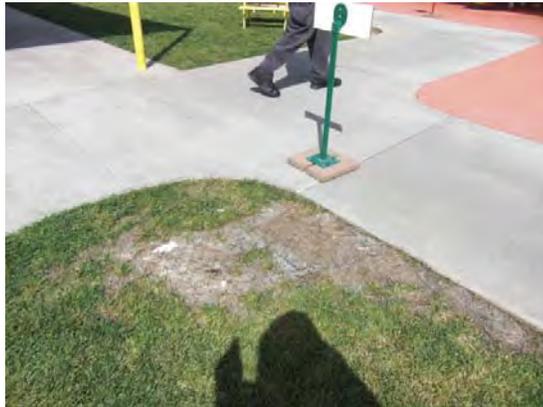
- The water in the playground area does not drain in all areas. It sometimes puddles.

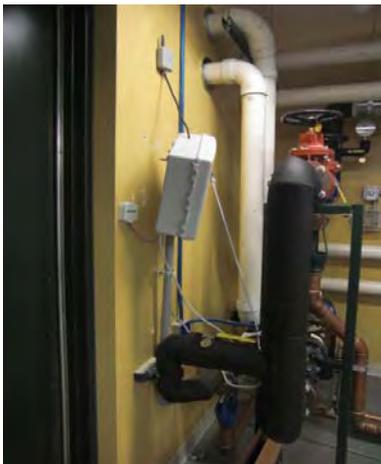
- Document any unique seismic design features. This box is not anchored to the wall.

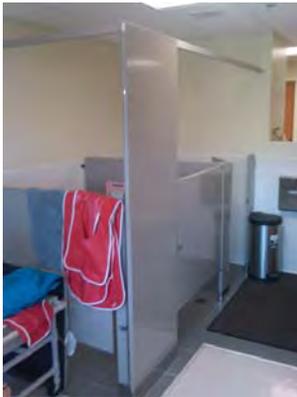
- They would like taller ceilings in the storage rooms to allow for another shelf for storage. They would recommend putting lighter items on the top shelf.
- The corners of the handicapped stalls in the Pre-School rooms are braced overhead. This was a change as originally they were not braced and were very flimsy.

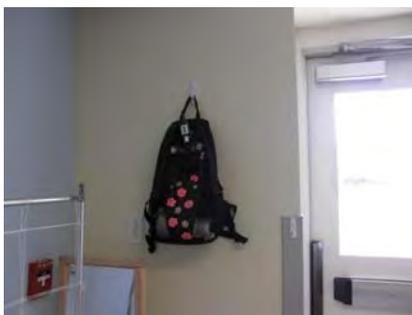
- Need to require fiberglass screens on the windows, and not allow metal screens to avoid slicing hazard.
- Requirements for not allowing caregiver medications in the activity rooms means some smaller personal size lockers need to be provided in the break room for the caregivers.
- Need to provide emergency bag hooks at exterior doors at 6'-0" AFF, and these hooks need to be screwed into the structure. (In this facility they are adhesive stuck to the wall)

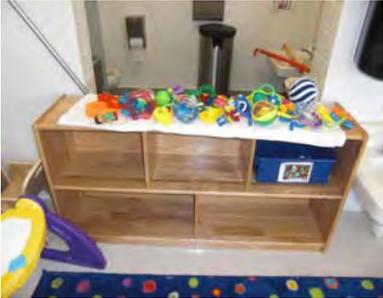
- The infant rooms need sliding doors or gates to close off the toilet area.

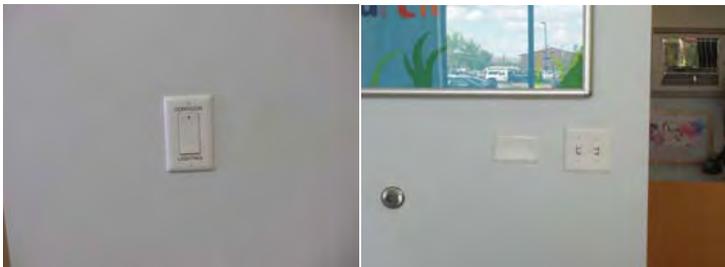
- Document if the lighting fixture is damage or hanging open? None
- Document if the lighting is controlled IAW ASHRAE 90.1 (time clock, motion sensors, etc) No, motion detector were removed.

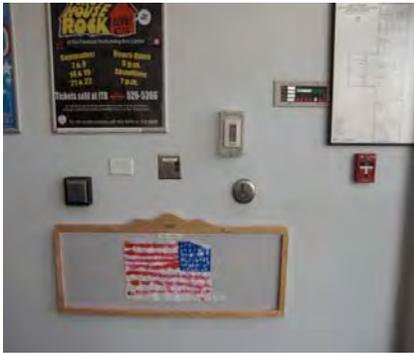
- Document if there is a timed over-ride at main entrance for janitorial staff. No

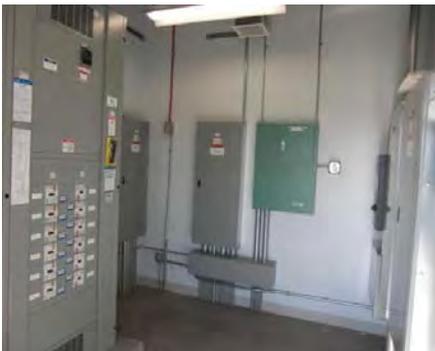
- Document if there a Service Entrance Panel metering (EMS/UMCS connection?) There is an issue with the electric meter. The electric meter does not read in KWHR at the Utility Control Station. This meter was difficult to interface. The warranty is expired. The electrical contractor (West Electric) is no longer in business, so this will be taken care of with another contractor.

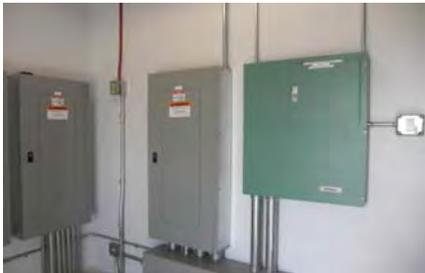
- Document adequate working clearance for electrical and communication panels

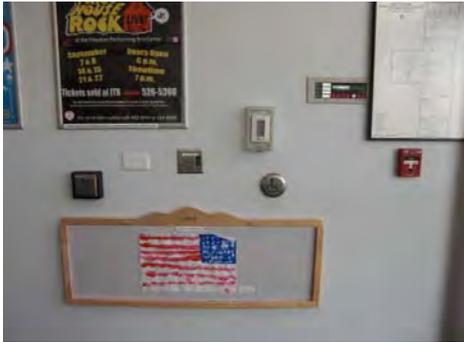
- Document satisfaction with intercom system (announcements understandable) No, The intercom is position too low on the wall.

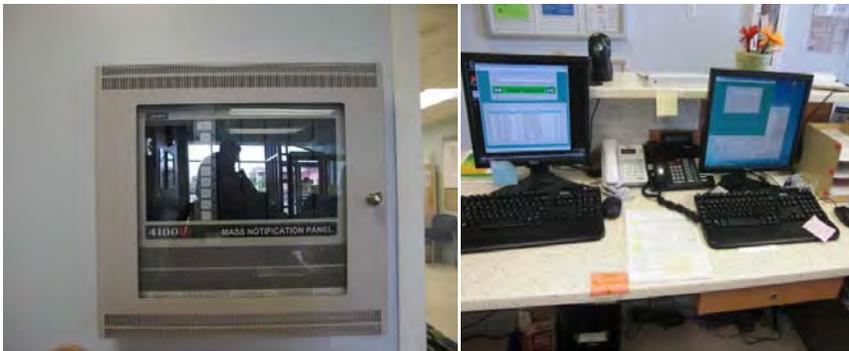
- Document type of intercom system installed (wall mounted, free standing, etc.)

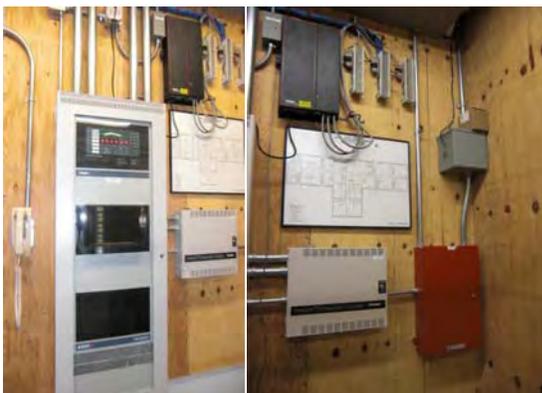
- Document if Telephone/Data/Power outlets meet needs at reception and admin areas. Yes
- Document if Communication Rooms are adequately heated/cooled. The temperature is 66 F. Water is dripping from the ceiling. A copper line has water on it. This is in room 186.

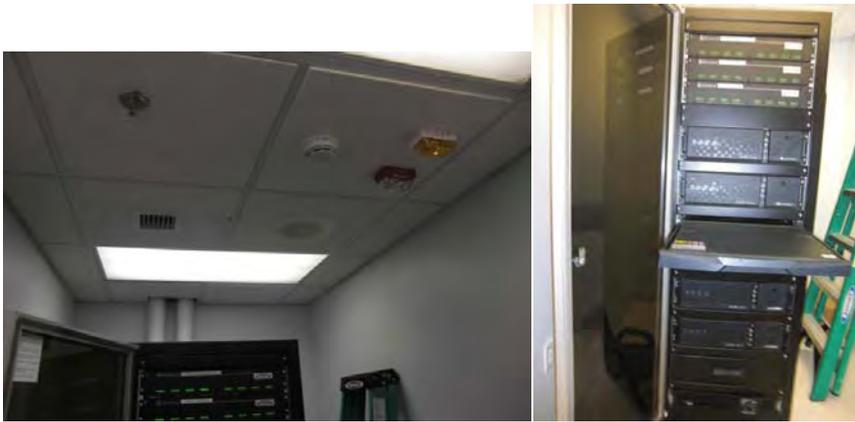
- The HVAC system installed is geothermal wells tied into fan coil units
- Video surveillance room: Racks are over heating in the video surveillance room because there is no air conditioning in this space to maintain a required temperature.
- The POC for HVAC related issues the user encounters is DPW-Kira.

- The video room is too warm. There is no AC unit in this room. This is room 174. SPAWARS stated they are about to lose \$30,000 worth of equipment because of the temperature issue. They have already lost video footage due to the heat.

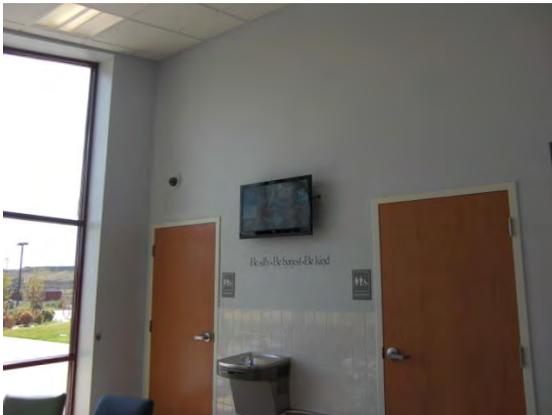
- Document satisfaction with security systems. No. The door would not unlock.
- Document any playgrounds or exits not within view of security system. Yes. The TV monitor is not located in a good place. The windows produce a glare onto the TV monitor.

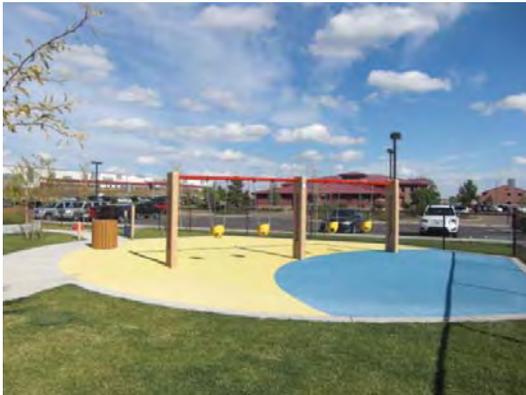
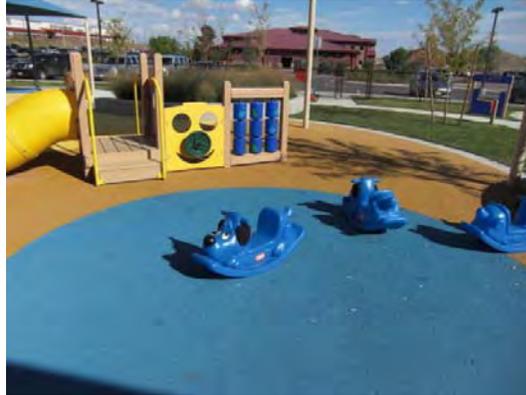
- Playground equipment labeled for 2-5 year olds, but not acceptable for toddlers. Army classifies ages of children differently than the manufacturers classify their play structures.

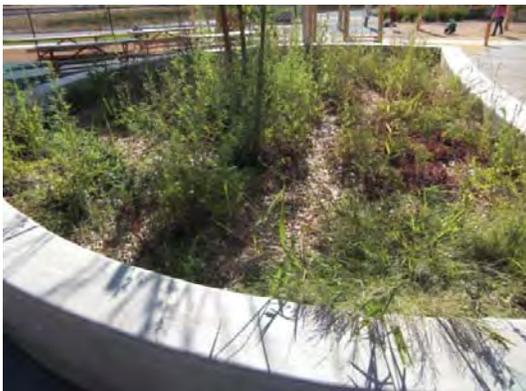
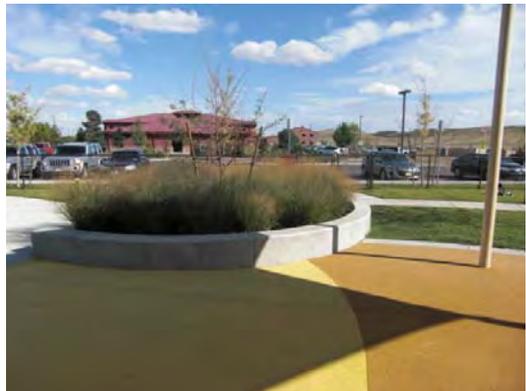
- There are some raised planting areas in the playgrounds that have some tall ornamental grasses. These are providing good hiding spaces for children. Also, some concern about the corners of the raised concrete planters. Users would like to have these removed.
