**U.S. Army Corps
of Engineers**
Engineering and Support
Center, Huntsville

Pershing Child Development Center

**Building 1140
Fort Eustis, VA**

**POTR – Phase 1
Project No 69811**

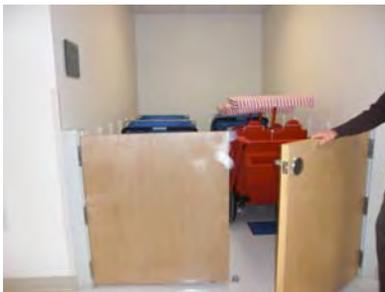
- The Air Force required all "alcoves" in the hall to be provided with doors.

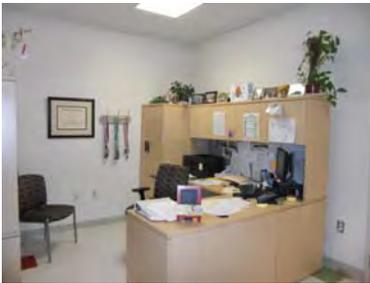
In the administration area, the office space is open. There is no privacy.

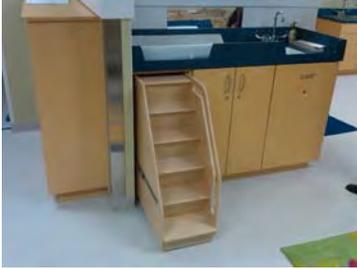
- They have some issues with the stairs on some of the diaper changing stations. The plastic locks will break, or sometimes not catch, which causes safety concerns with the stairs.

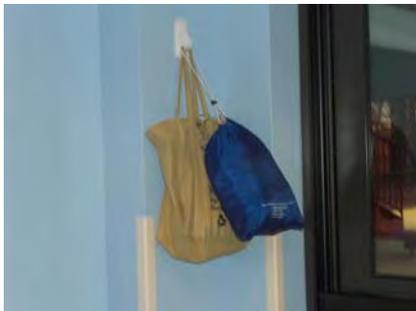
- Need a permanent hook, for the emergency bags, located at exterior door from the activity rooms.

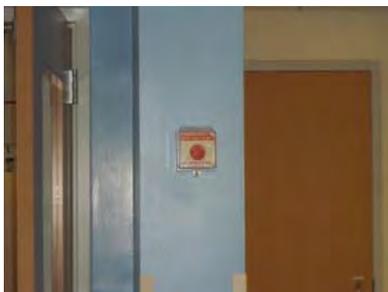
- HOA switch in the reception area.

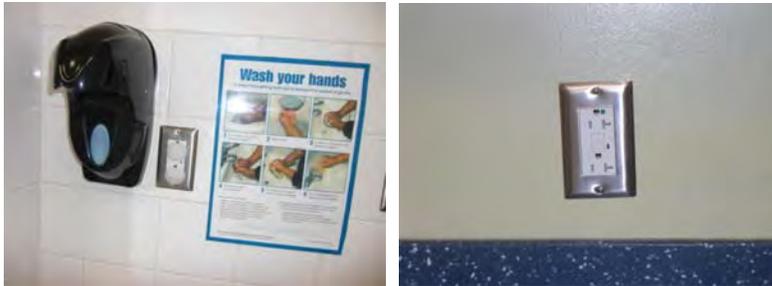
- Child proof receptacles are used in the required areas. Covers were added to the receptacles in the bathrooms.

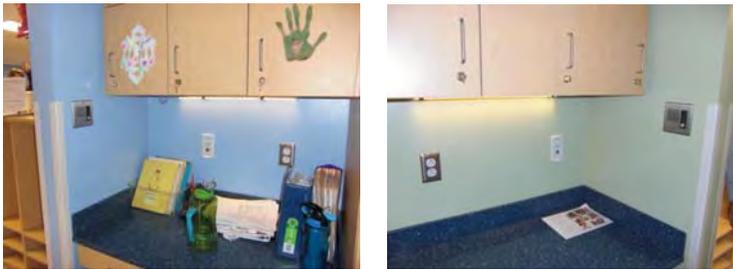
- Intercom System announcements are not always understandable due to background noise.
- Intercom is located at the entrance of classroom. When the staff uses the income the children are out of the view due to the location of the intercom system.
- An intercom system with a handheld receiver and microphone is desired. They would like the intercoms in the activity rooms to be a handset located near the storage room door.

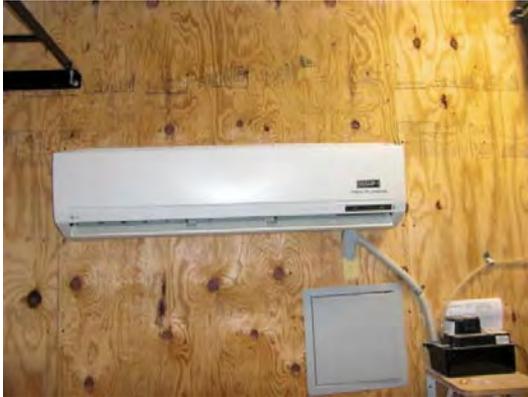
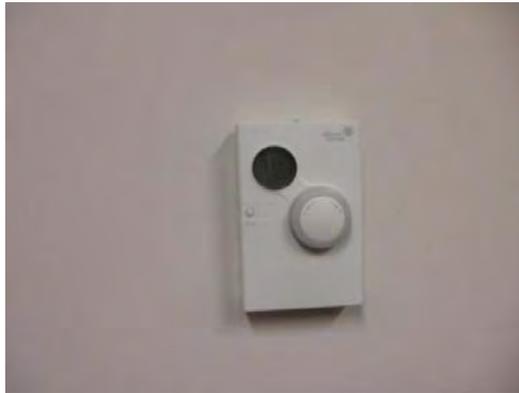
- There is a pipe that passes through the communication room over the data termination racks. It may be the condensate line for the air conditioning unit.

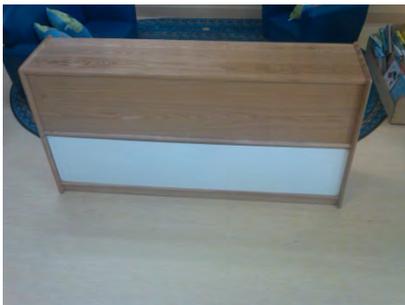
- The metal plates on the back of some of the cabinet pieces are a safety concern with their sharp edges and ease of coming off.

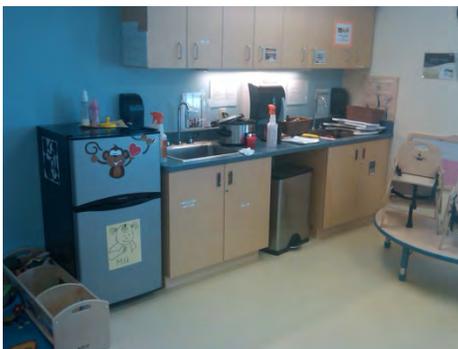
- Have concerns with the location of the diaper changing station, with the caregiver's back to the activity room.
- Under counter refrigerator is not working. They cannot find a refrigerator that will work. The little refrigerators won't hold enough, and the refrigerators that will just fit into the opening are overheating due to no air circulation. Could look at putting openings in the sides of the cabinets to enhance airflow around the refrigerators.

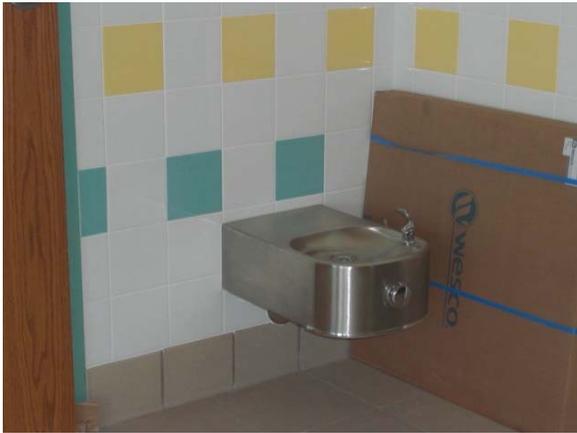
- Water fountains are mounted too low for pre-school.

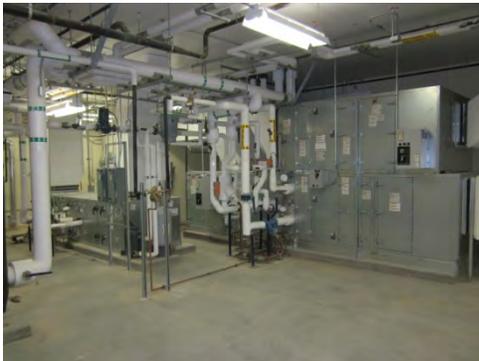
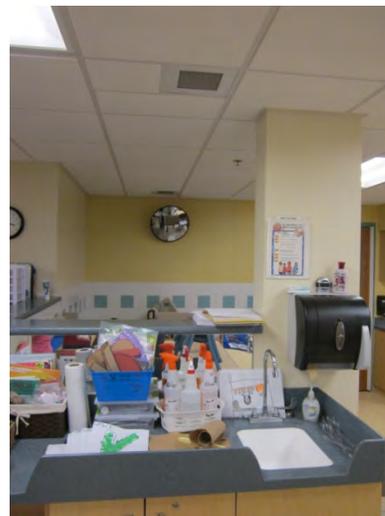
- HVAC system consists of fan coil units above the ceiling and a built-up, dedicated, outside air handling unit. An air-cooled chiller and gas-fired boiler provide heating and cooling.
- System was not providing enough cooling after building became occupied. The chilled and hot water connections to the fan coils were reversed and had to be re-piped. This corrected the problem.
- Sound transmission from classrooms was noticeable while drums were being played loudly. Ceilings and ductwork have no acoustic insulation to provide sound isolation.
- System was able to maintain comfortable indoor temperature and humidity conditions.
- Mechanical Room is oversized.
- Close manual damper in exhaust registers located above diaper changing stations to save energy where classrooms are used for older children and diaper changing stations are not used.

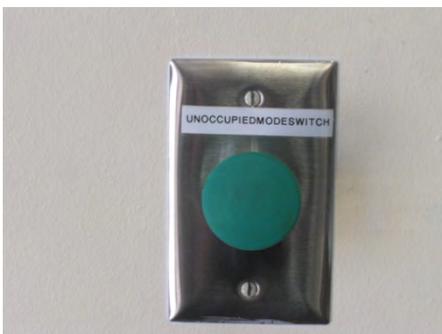
- There is a timed over-ride at main entrance for janitorial staff. The occupant want the timed over-ride to be a keyed switched.

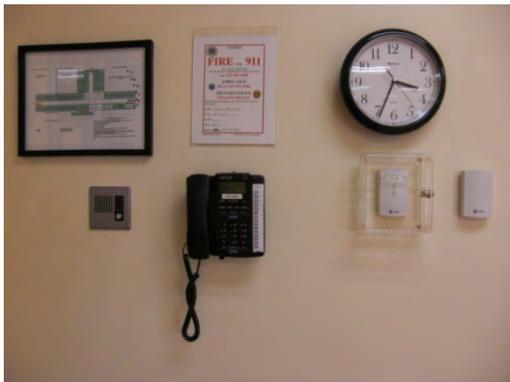
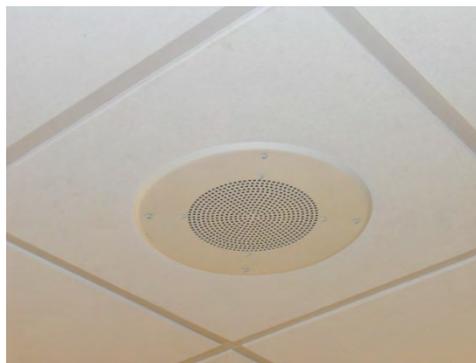
- Need to provide phones in the activity rooms. The caregivers need to be able to call out in case of an emergency.
- The occupant is not satisfied with the intercom system. Need the intercom to have an “open mike” when an activity room is called. This would allow the caregiver to speak at a speaker in the ceiling while attending to the children as opposed to having to go over to the intercom, press a button, and speak.

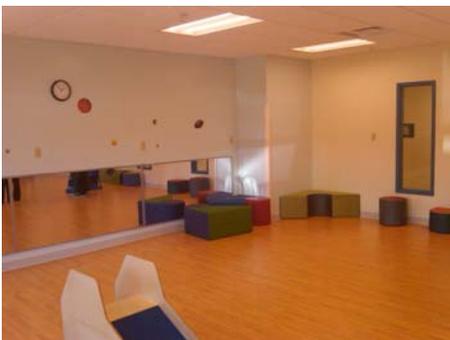
- Door into the toilet area and into the Storage Room in the Active Play Room are less than 36" wide.

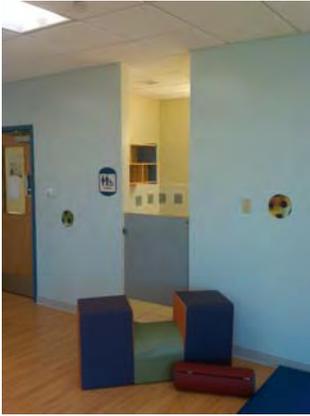
- The corner of the handicap toilet stalls in the Pre-School/Pre-K/Kindergarten rooms are overhead braced.

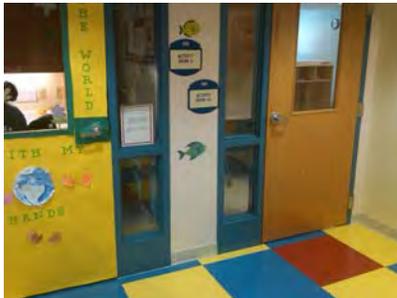
- The flooring is 2' x 2' vinyl tile in the corridors/lobby.

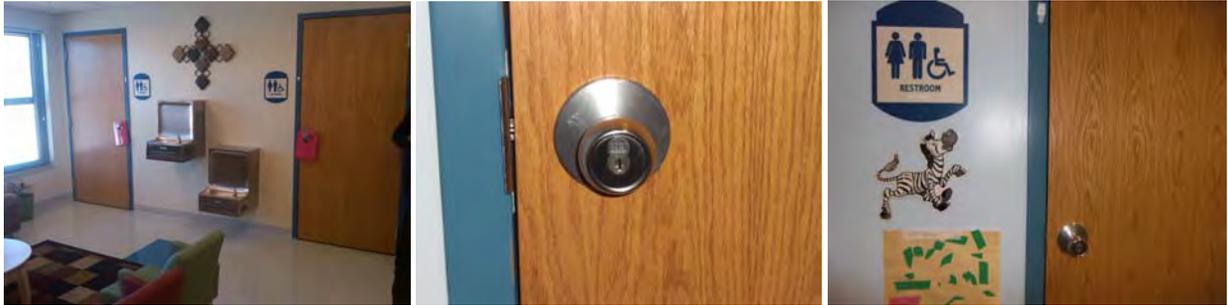
- Door hardware into toilets do not comply with ABA/ADA. Lever hardware was not provided – these are

actual door knobs.

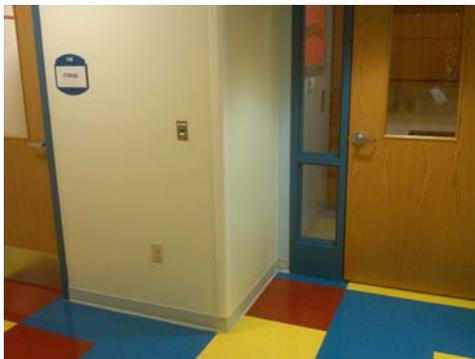
- The storage room in the base of the "T" was not recessed like shown in the standard. While this provided a slightly larger storage room, it impacted the alcove and requires the door to swing into the storage room.

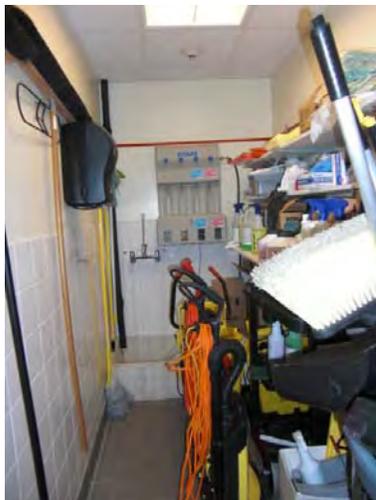
- The janitor closet is too small.

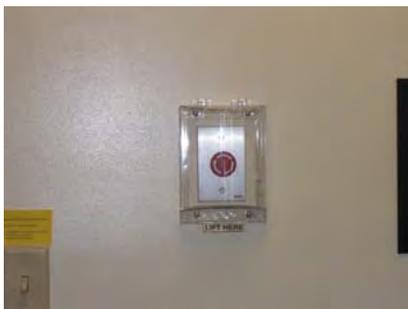
- There is a time over-ride at main entrance for janitorial staff. The over-ride does not work because it is not programmed.

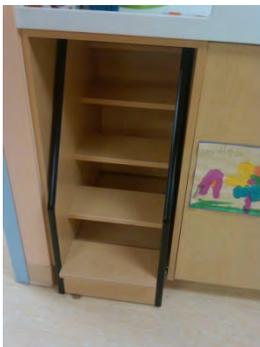
- There is no handle on stairs on the diaper changing tables. Diaper changing surface is almost too tall for some care givers. Also has some sharp edges. Had to install vinyl edging on the stair handrails. The bottom step is a concern since it projects past the stair handrails.

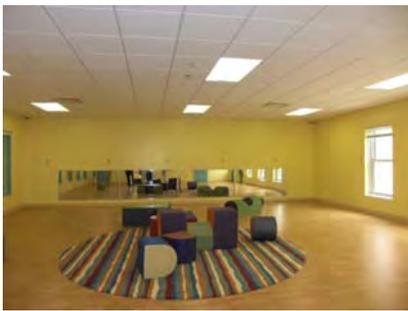
- The lighting in the activity rooms should be impact resistant. The ceiling tiles in the activity rooms should be fastened down.

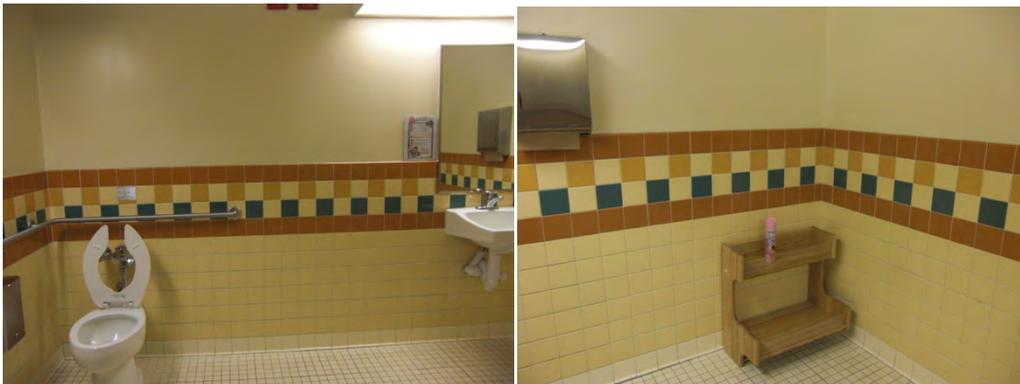
- The interior Electrical Room is very large.
- If the kitchen door does not have a window or peep-hole then add a monitor that shows a view of the delivery area.
- This restroom is very large. This space could have been used elsewhere in the building.

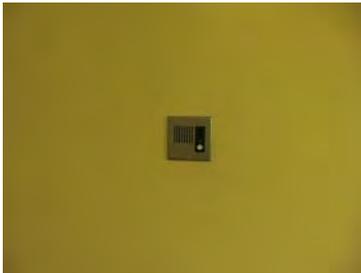
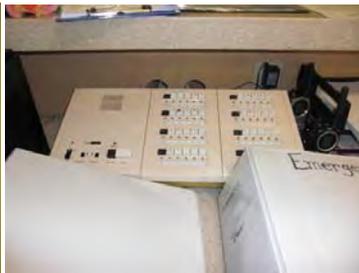
- The occupant is satisfied with the intercom system. It is wall mounted.

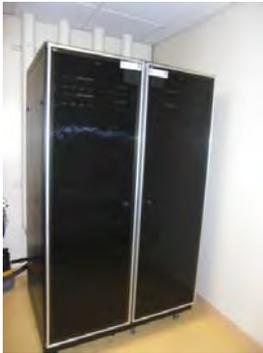
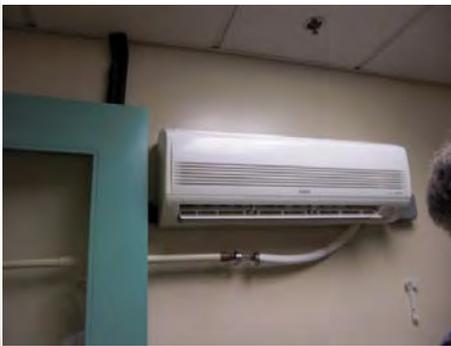
- There are enough telephone/data/power outlets at the reception and admin areas.
- The Video Room is not adequately cooled.

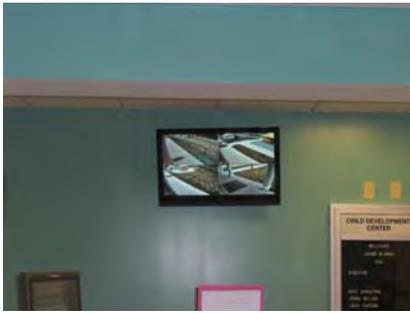
- There is no prohibited equipment/systems passing through Communication Rooms.
- The security system does not have a view of all the exits to the playgrounds.
- The security system does have the capability to record.

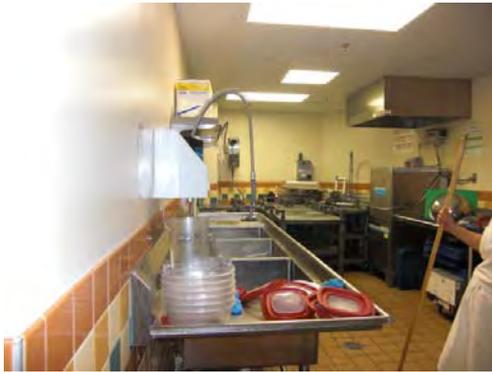
- More power outlets are needed in the staff lounge.
- A 2x2 light fixture was added near the dishwasher area to increase the illumination level.

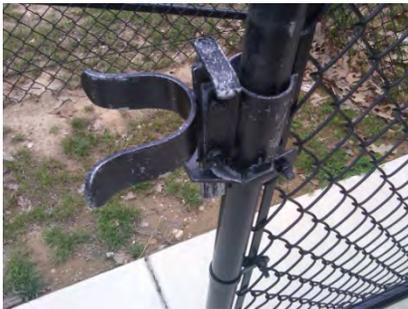
- Gate hardware is not working well.

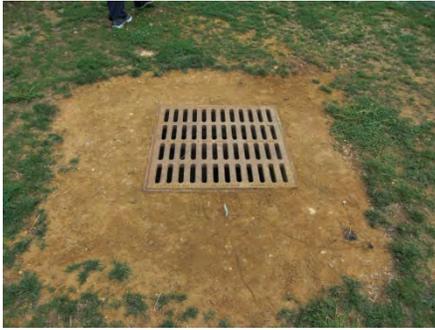
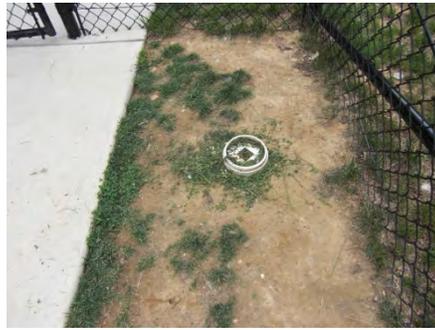
- There are pot holes and sewer manholes in the playground areas.

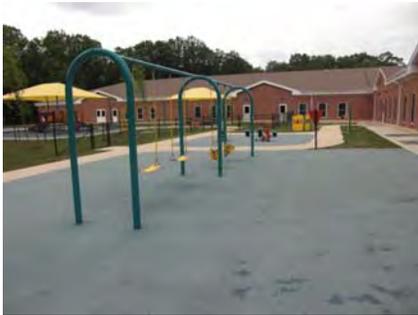
- Some of the swings had to be replaced with bucket swings to be age appropriate.

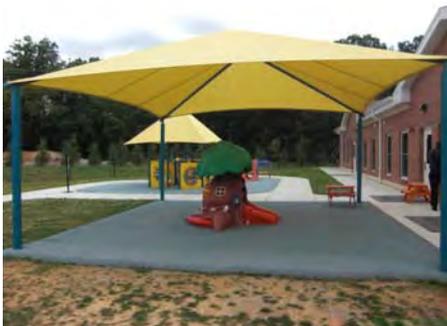
- The canopies over the playground equipment need not be waterproof.

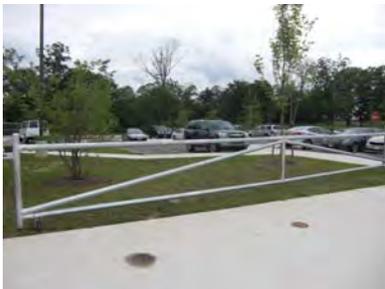
- ATRP gates are not used as they should be.

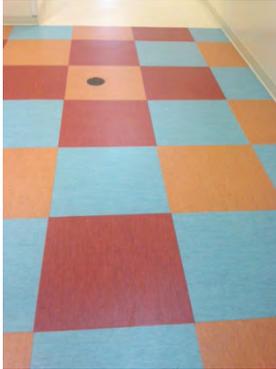
- Flooring in corridor is 2'x2' squares of sheet vinyl with welded seams.

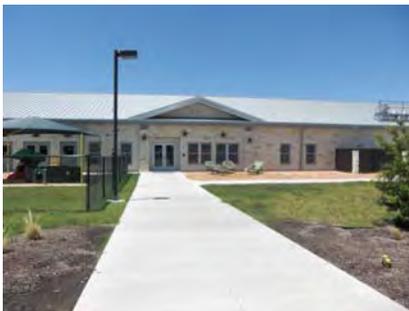
- Need a larger canopy at front door. There is no shelter or protection from the weather.

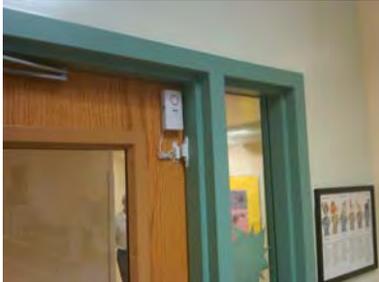
- Desk drawers and coat closet at sign-in desk do not have locks; have to utilize child safety locks.
- Lever door handles are easy for children to open. Have installed alarms on each door so that care givers know when the door is opened.

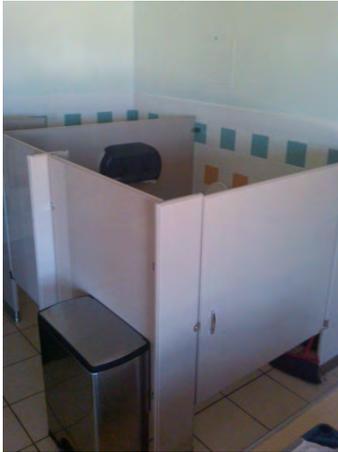
- The corners of the ABA toilet stalls in the Pre-school/Pre-K/Kinder rooms are not braced overhead, but they have been firmly attached to the floor, and at this time do not have much deflection.

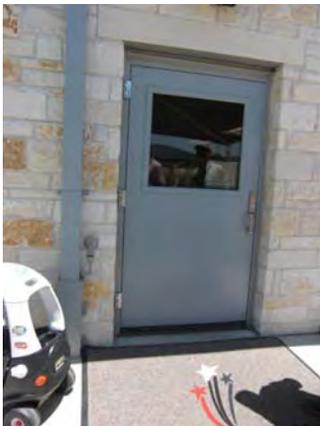
- The doors at the ends of the corridor are alarmed even though they exit into fenced area. In addition, the users have added alarms on each interior door into the activity rooms to notify the caregivers if the door has been opened.
- Currently the Active Play Room is utilized as an activity room since other centers are closed for renovations.
- The laundry room finishes are quarry tile floor, ceramic tile wainscot, epoxy paint on gyp bd, solid gyp bd ceiling. The laundry room was provided with an extra wide door.
- Exterior doors from activity rooms are extra wide.

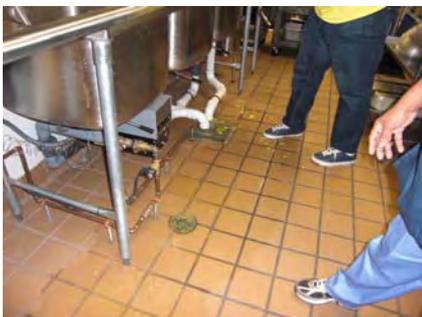
- Initially when the kitchen sprayer was used, the water throughout the facility was delivered at the extremely high water temperature. This has been resolved.
- Trap in garbage disposal overflows when you put the trap in. Major sanitation issues when using the garbage disposal. Food does not readily enter into the garbage disposal either.
- The garbage disposal is connected to the grease trap. The grease trap gets clogged and water overflow onto the floor.

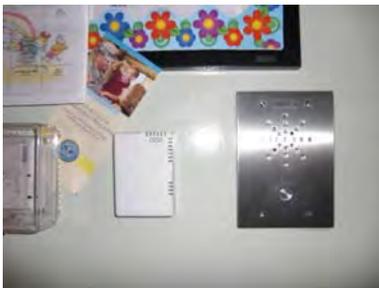
- No prohibited equipment/systems passed through the Communication Rooms.
- Intercom cannot be heard when a room is full of children, or when there are children on the playground (there are intercom speakers on the outside of the building, which is a benefit). When they have called in work orders and folks have come to look at the situation, the rooms are empty and the speakers are able to be heard just fine.

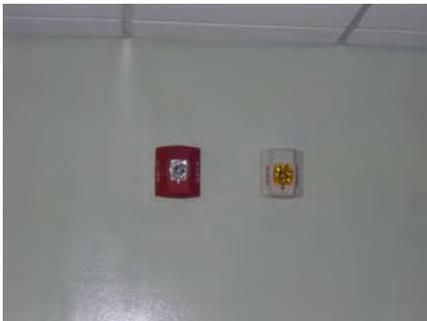
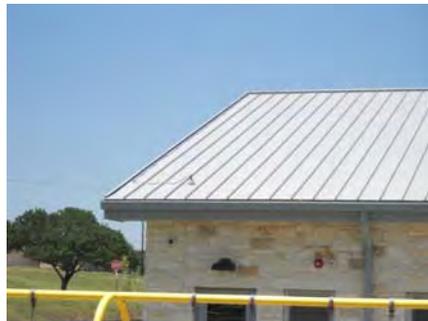
- The fire alarms are hard to see and hear. The fire alarm on the outside of the building cannot be heard when the playgrounds are in use. In addition, some rooms cannot hear the fire alarm when children are in the rooms.

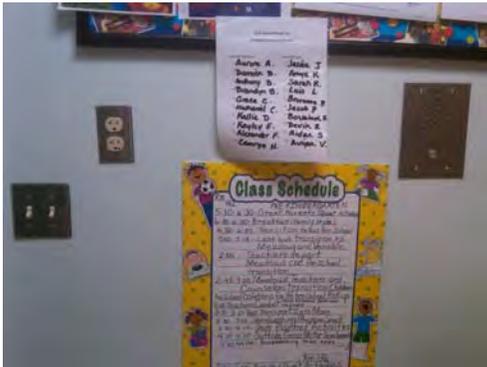
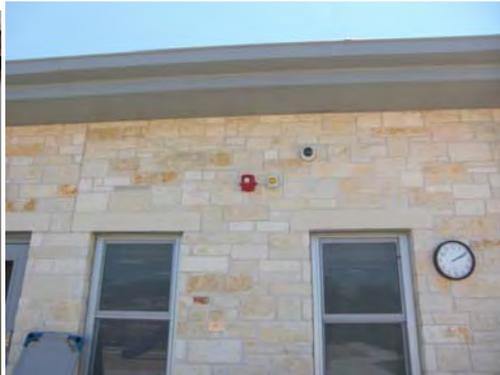
- The intercom speakers are not loud enough. It is hard to hear over the children noise.

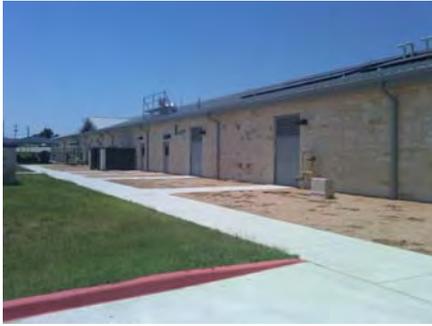
- Only provided one small area for parking, with the "boat slip" configuration. It is part of a larger parking lot which also serves the chapel and post office. Depending on other activities, parking for the CDC can be very difficult.
- Small stones used in the landscape are not a good idea. The small stones are a safety hazard.

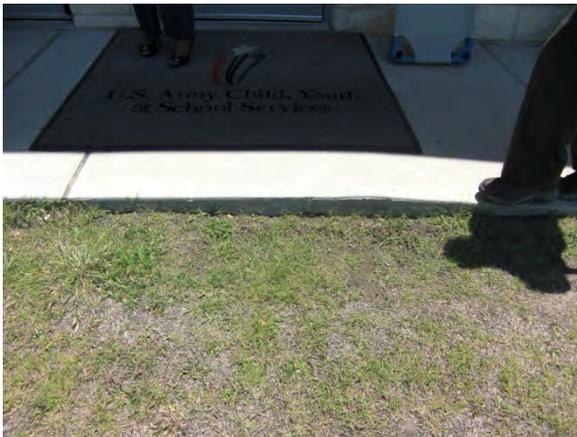
- Playground equipment says age appropriate for 2-5 year olds, which eliminates play by the 18 months old who use the playground.
- The sidewalk around the perimeter of the building changes elevations at each door. This was brought up as a concern during construction. Contractor reduced the number of changes by replacing sections of sidewalk between doors that are close together. This also leads to a number of places where the ground is significantly below the level of the sidewalk.

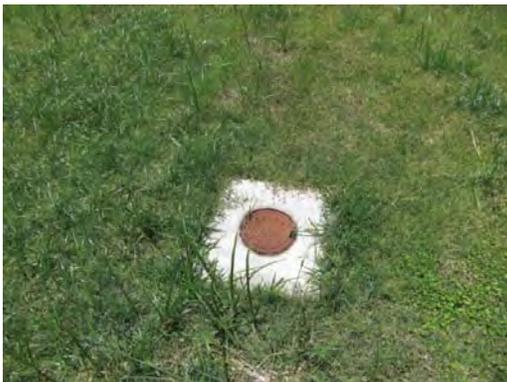
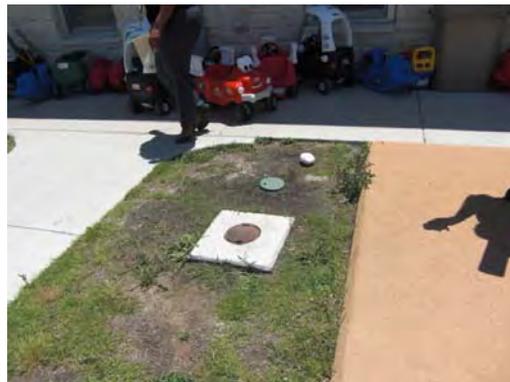
- There are drain cleanouts and other safety concerns located in the playground areas

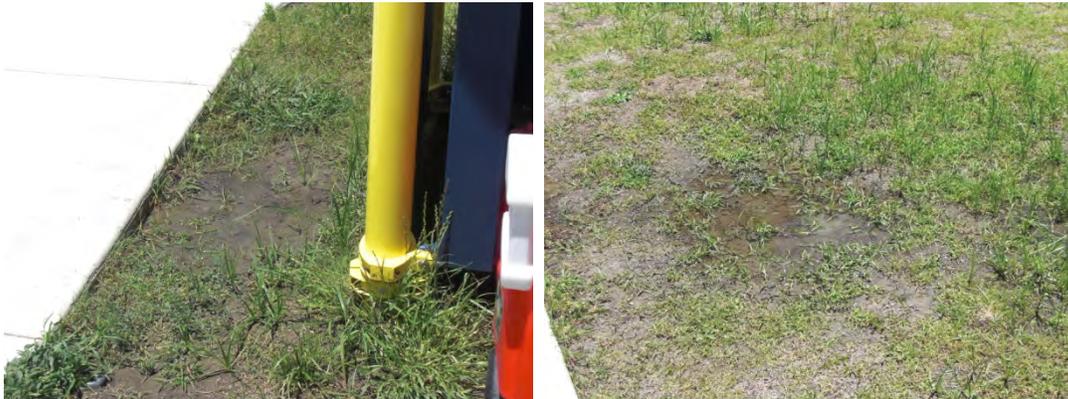
- There is standing water in the playground area.

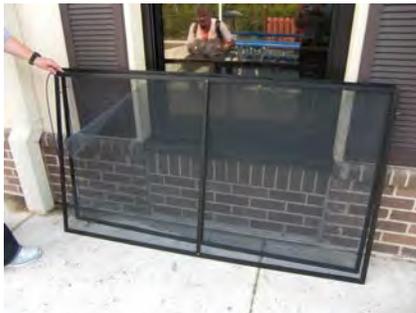
- The oven cleaning system was an issue when it locked down the oven; the users could not get it restarted. This has since been resolved.
- They are fighting nut grass in the landscaping.
- The window screens are not holding up to children putting their hands on them. The rubber spline comes out of the groove that holds the screen in. We recommended trying a larger spline to see if that helps.

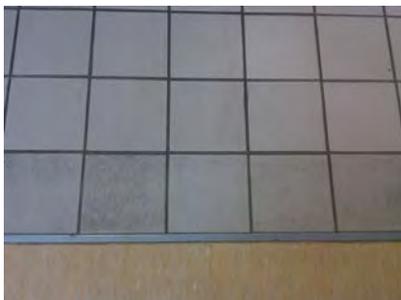
- They had some odor issues in the corridor. This was resolved when they found an open pipe above the ceiling and sealed it.
- There are some seams that have come apart in the sheet vinyl. The last of these seams will be fixed this weekend.
- The tile floor in the toilet areas turns black and is very difficult to clean. The inspection team believes this is due to the textured surface of the tile which helps avoid a slippery surface when wet.

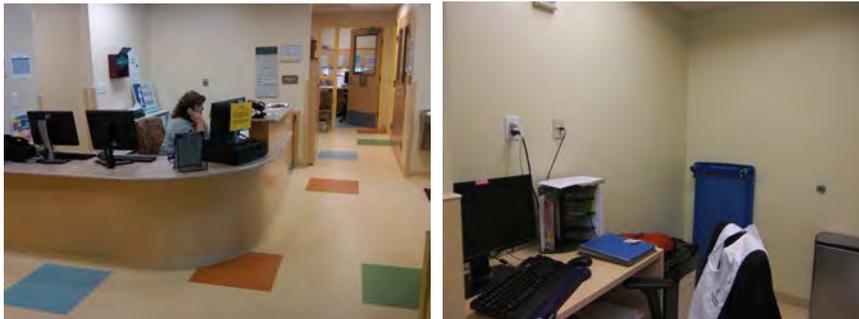
- The reception counter functions well for this facility. However, more space is needed for all of the computers. Each computer can only do its specific function. There is a computer for POS, a computer for the video monitor, and a computer for parents swiping their card. A fourth computer is needed for office type functions such as preparing documents and spreadsheets. In addition to the space for the computers, additional electrical and data is required as well. They added a workstation in the Isolation Area for this fourth computer.
- The lobby/reception area is small in this facility compared to the same area in a similar sized modular facility. The occupant had to setup the computer in the isolation room.

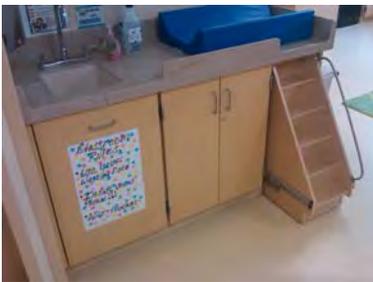
- The flooring in the Active Play Room is the standard sheet vinyl used throughout the other activity rooms.
- Handrails had to be added to the steps on the diaper changing stations.

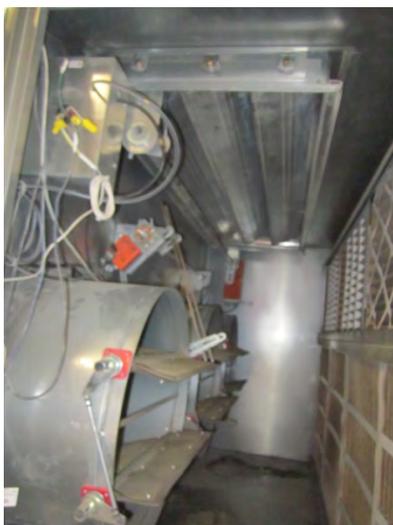
- There is no air-to-air energy recovery in the mechanical system to recover energy from air being exhausted from the building.
- Although there are variable speed heating hot water pumps, no two-way valves were indicated on the drawings to reduce pumping energy.
- The two indoor air-conditioning units serving the communication rooms are located above lay-in ceilings and are difficult to access for filter changes and routine maintenance.
- The outside air dampers in the air handling unit are fully open and the return air dampers were only about 20% open on a warm day. It appears that the damper positions need to be adjusted to allow more return air and less outside air to reduce energy consumption.

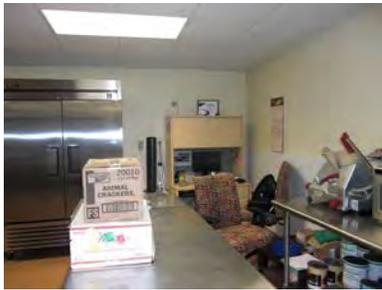
- More telephone/data outlets are needed in the administration area.
- More data/power outlets are needed in the kitchen.

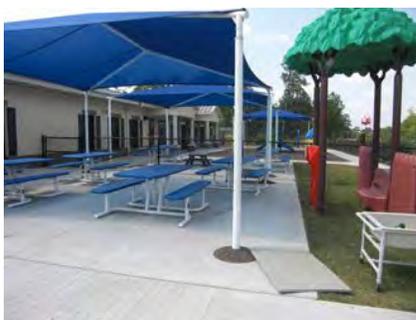
- The playground areas do not have an intercom call.

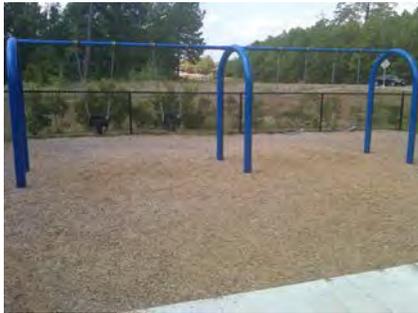
- Wood chip surfacing was provided under the swings in the 2 playgrounds in the back. This is not desirable. Wood chips should not be allowed.

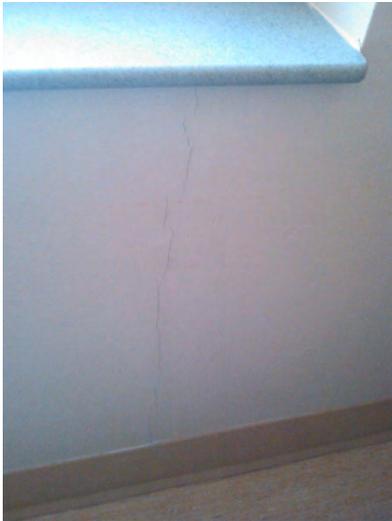
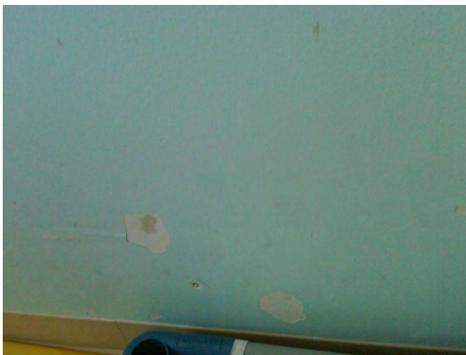
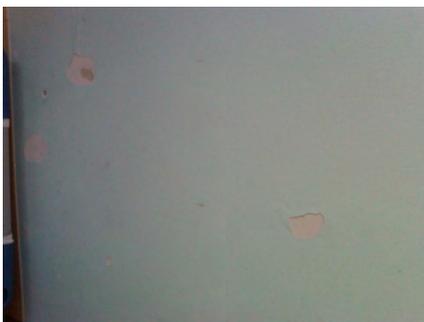
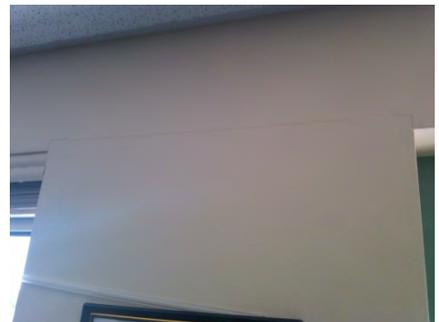
- Restroom doors need to have key lock on them. This requirement needs to be added to the criteria.
- They are having a lot of issues with the sheet rock walls, especially in the activity rooms. The paint is showing damage from furniture being moved. In addition, the paint is bubbling and peeling, and the screws are popping. This is all in the bottom portion of the walls, mainly under and on the side of the windows; however, the same thing is happening in other locations. We found a bubble in the paint above a mirror in one of the adult restrooms. In addition, the users find they are unable to remove a lot of the marks on the paint. The installation feels that a wainscot should have been provided; however, the COS has never seen this kind of damage in any of the facilities inspected, and believe the wrong type of paint was used and the substrate was not adequately prepared. At this time, the COS does not

have a good reason for the screws popping. In addition, there are also cracks appearing in the sheet rock, especially at corners of doors and windows.

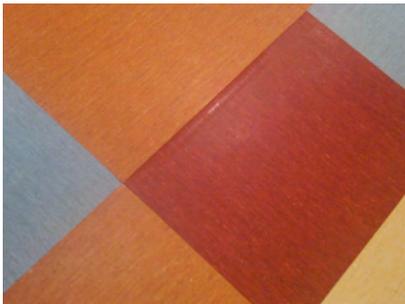
- The irrigation system had some issue with sprinkler heads being damaged. This has been repaired.
- The timer for the parking lot lights did not work. The timer was replaced the week before our inspection.
- Freezer gauges not working properly, now continually freezing up, forming ice, and keeping door from closing tight.
- Floor tiles are bubbling in the hallway. The latest tiles are outside of room 143.

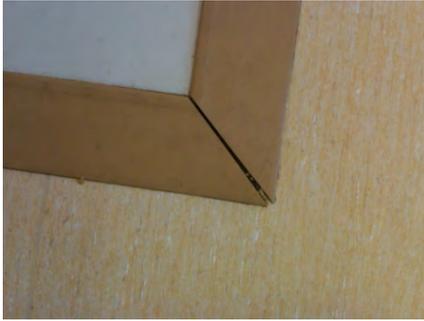
- The transition strips between the ceramic tile floor of the toilet areas and the seamless vinyl flooring of

the Activity Room is separating.

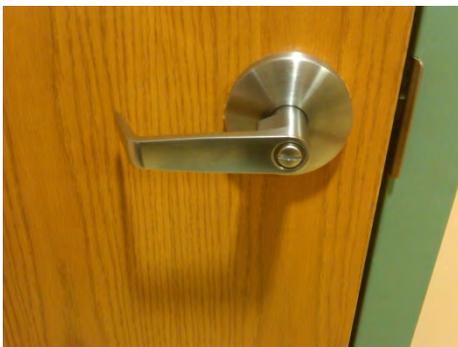
- Mechanical yard needs to be better designed so that it is not the first thing you see when you come up to the building.
- Need to ensure wall finishes are durable enough for the movement of furniture.
- Provide a higher ceiling in the closets to allow for more vertical storage.
- There is a new requirement for the children to have visual access to their playground. This is a challenge when the age groups change in the rooms.
- Need to provide key-lock hardware on doors to adult (Staff) toilets, unlike privacy lock as provided in the facility and shown below.

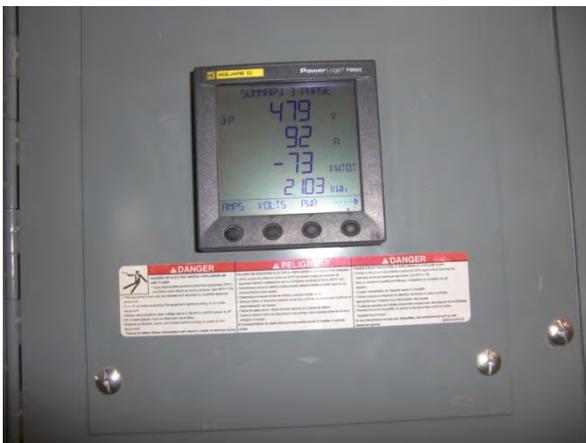
- The Service Entrance Panel is metered. There is not EMS/UMCS connection. The energy consumption is not being tracked or logged.

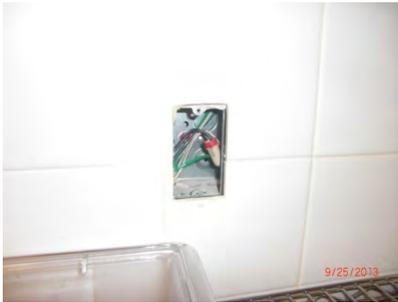
- All wiring is not concealed from view in finished rooms/areas.

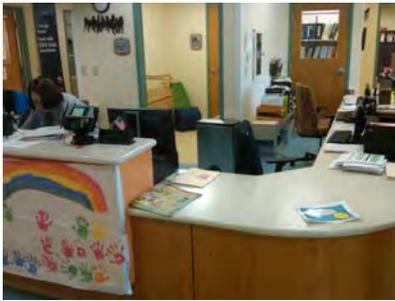
- There are not enough data/power outlets in the administration area.

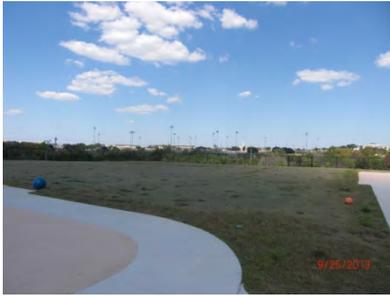
- Playgrounds are very large with large open grass area. Would have been beneficial if the 2nd playground were split into 2 separate playgrounds due to the wide range of ages in that playground.

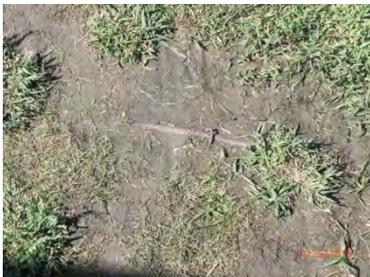
- In some areas of the playground, the ground is significantly below the level of the sidewalk, and in some areas the sprinkler pipes have been exposed. These areas need to be filled and sodded.

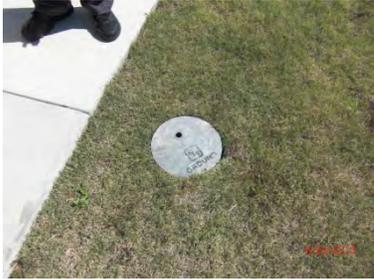
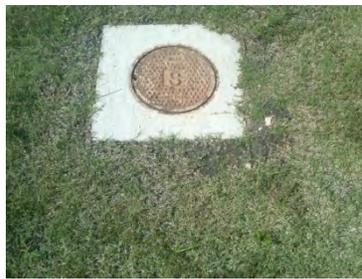
- The fence around the playground is 5' tall.
- The landscape has dips and holes.
- There is a ground well located in the playground areas. There are a number of other manholes in the playground as well.

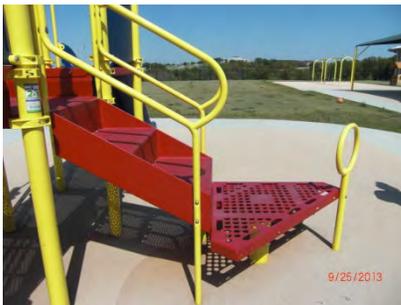
- Some of the playground equipment in playground 2 is not age appropriate for children 18 months to three years old.
