**U.S. Army Corps
of Engineers**
Engineering and Support
Center, Huntsville

Large Consolidated Fire, Safety, and Security Headquarters Facility

**Building 20709
Fort Bliss, TX**

**POTR – Phase 1
Project No 64608**

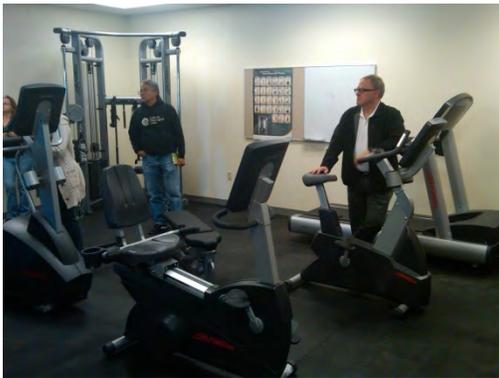
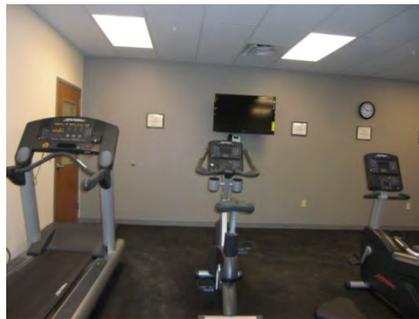
- Add mirrors with medicine cabinet in the Fire Chiefs shower and toilet area. Provide a medicine cabinet for each person using the dorm room. (If 2 people use the same bathroom, then provide 2 medicine cabinets)
- Admin. areas need more storage space.
- Add a door to the laundry room.
- Add gas capability to the patio area.
- Provide high ceilings and ceiling fans in the fitness area. Also add telephone(s).

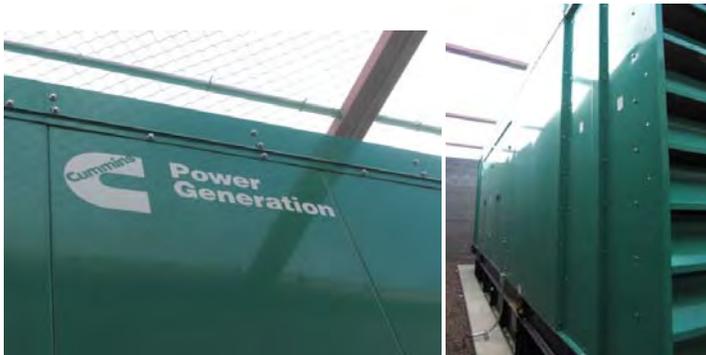
- There are adequate exterior lighting systems provided for parking areas, sidewalks, building entrances and perimeter for safety, evacuation, and security measures.
- Lighting is controlled by motion sensors. When the motion sensors malfunction, manual switches were added.
- Emergency lighting switches OFF when area not occupied or during unoccupied hours.
- 100% emergency generator back-up power has been provided.

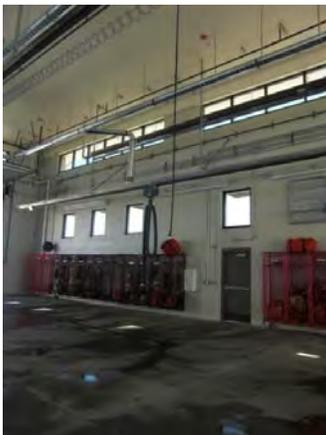
- Emergency generator has been provided with 72 hour on-site fuel storage.
- The Firefighter Alert System does provide simultaneous visible and audible alerts inside and outside.
- The Apparatus Bay does have self-retracting electric drop cords between vehicles that reach to either end of each bay.

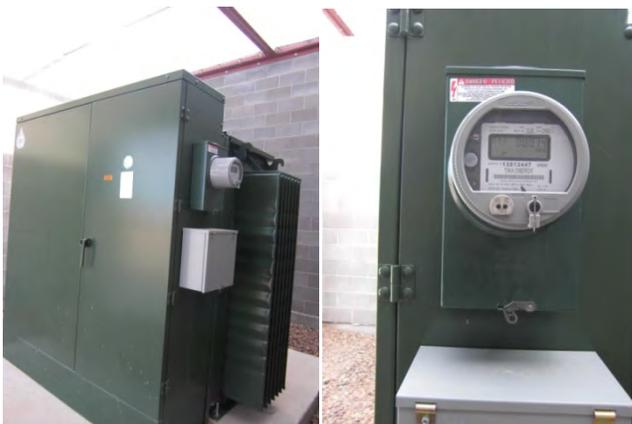
- The transformer is metered.

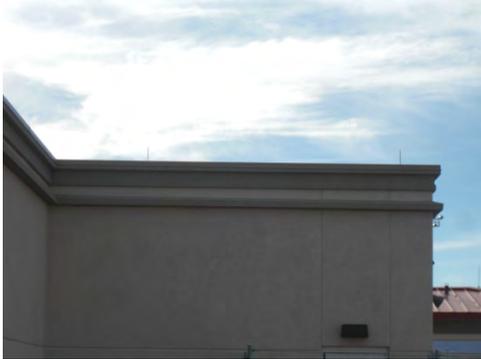
- At a minimum, has the transformer meter, gas meter, and water meter been integrated with the post-wide UMCS/EMCS and are the required data logging being recorded/stored for the facility? This information will be provided later.
- Adequate Lightning Protection System was installed.

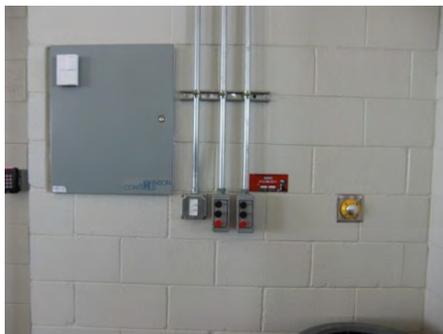
- The Dispatcher's Suite UPS does serve all Dispatch computers, telephones, and firefighter alert system to provide a fully functional dispatch when transitioning from normal to emergency power.
- The Day/Training Room (including kitchen) does have dimming controls for the lighting. This room is not used that much.
- The Recreation Room does have dimming controls for the lighting. This room is not used that much.
- General use duplex wall outlets were provided not less than 10' on center and located to eliminate the need for extension cords. More power outlets are needed in the fitness rooms.
- The Station Officer's Office/Watch Desk has been provided with operational control to open the Apparatus Bay Doors.

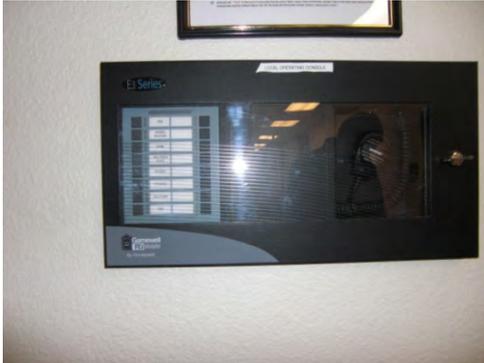
- The Station Officer's Office/Watch Desk has been provided with operational control of the Firefighter

Alert System.

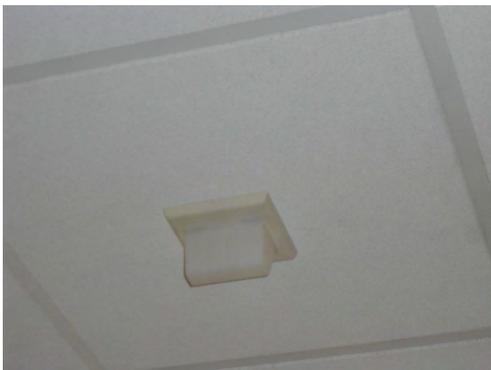
- The Firefighter Alert System does correctly control audible alert and dedicated alert lighting in Dorm Rooms, corridor lights from Dorm Rooms to Apparatus Bay, and Apparatus Bay.

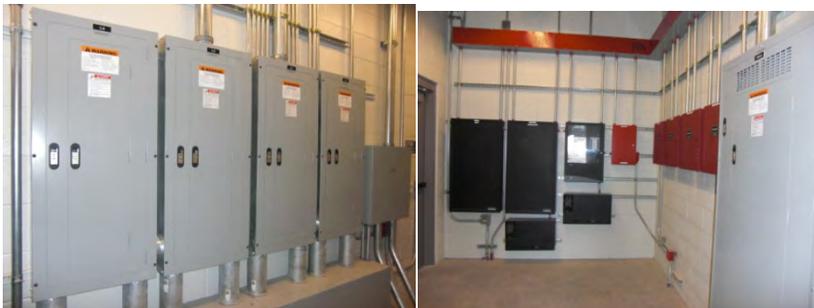
- The wiring is concealed from view in finished/areas.
- There is adequate working clearance for electrical and communication panels.

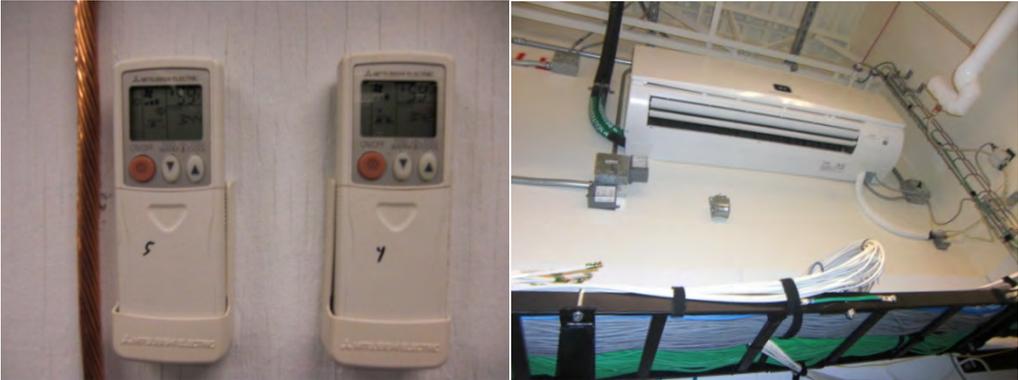
- The occupant is satisfied with intercom system (announcements understandable).
- The Telephone/Data/Power outlets are not all connected at the reception and admin areas.

- The Communication Rooms are adequately heated/cooled.

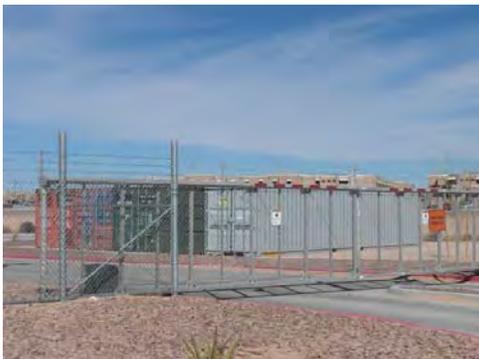
- The design for the outdoor storage area for fire extinguishing agents sufficiently limits access to the area.
