**U.S. Army Corps  
of Engineers**  
Engineering and Support  
Center, Huntsville

## **Fire Station #2**

**Building 68328  
Fort Huachuca, AZ**

**POTR – Phase 1  
Project No 60550**

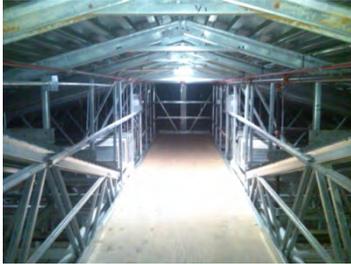
- The main entrance door is rarely used. The primary door used by the users is the door off of the dayroom.
- Regulations say they are to open the bay doors before starting the trucks. This does not always happen.
- The apparatus bays are drive through.
- The vehicle apron is concrete.
- The attic has a catwalk system to access the HVAC units.

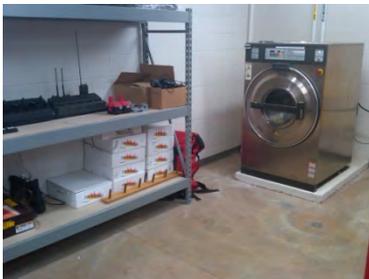
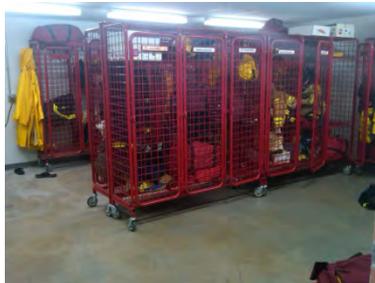
- By relocating the PPE storage, they gave up the protective clothing laundry and fire extinguisher inspection/maintenance and Storage areas. They have no issues with losing those areas. There is an industrial extractor in the PPE storage room.

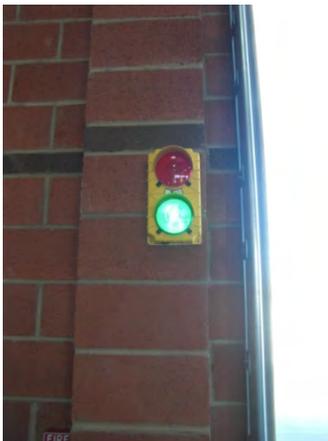
- There is adequate an exterior lighting systems provided for parking areas, sidewalks, building entrances and perimeter for safety, evacuation and security measures.
- The lighting is controlled by motion sensors.
- The facility has 100% emergency generator back-up power. The emergency generator has been provided with 72 hour on-site fuel storage.
- The Apparatus Bay does have self-retracting electric drop cords between vehicles that reach to either end of each bay.
- The Apparatus Bay has Red/Green signaling system for each door to indicate whether the bay door is fully raised.

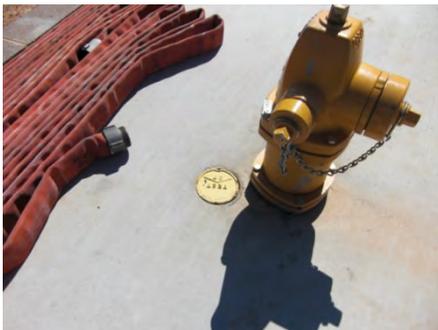
- Cathodic Protection System was installed.

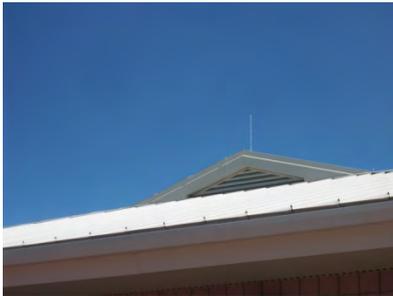
- Lightning Protection System was installed.

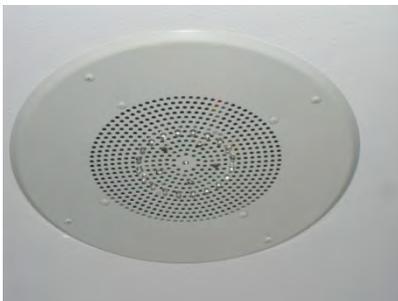
- The Firefighter Alert System correctly control audible alert and dedicated alert lighting in Dorm Rooms, corridor lights from Dorm Rooms to Apparatus Bay, and Apparatus Bay.

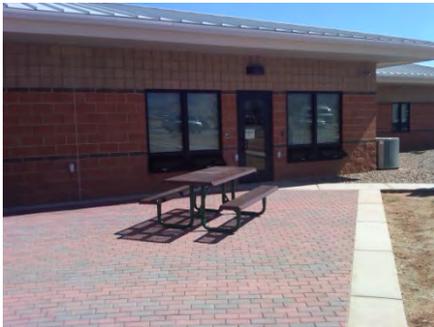
- There are approximately 30 POV parking spaces and 3 handicapped spaces. Parking is located so that you don't have to cross the apparatus drive to access the building.
- There is a patio off of the dayroom.

- A large number of the plants have been uprooted and eaten by wild Javelina.
- The grass did not grow too well.
