## **4<sup>th</sup> IBCT Physical Fitness Facility**

**Building 8437  
Fort Stewart, GA**

**POTR – Phase 1  
Project No 71152**

**DATE: October 17, 2012**

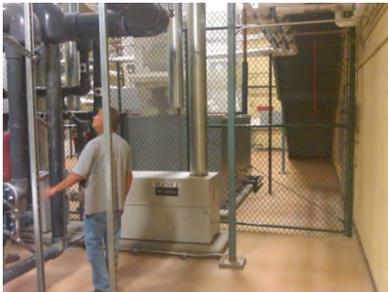
- Approximately 1000 soldiers use the PFF for PT in the morning. The facility is packed!
- The pool mechanical was combined with the building mechanical. They had to separate the 2 areas with a chain link fence since the users need to access the pool mechanical.

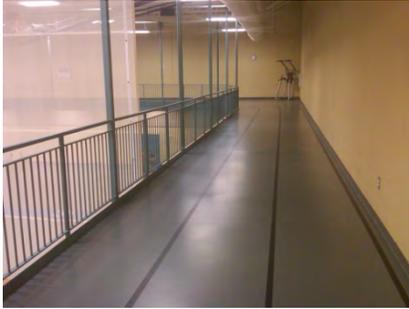
- The jogging track is 3 lanes. There are not banked corners, and they have received comments wishing the corners were banked. The entrance to the track is on the straightaway.

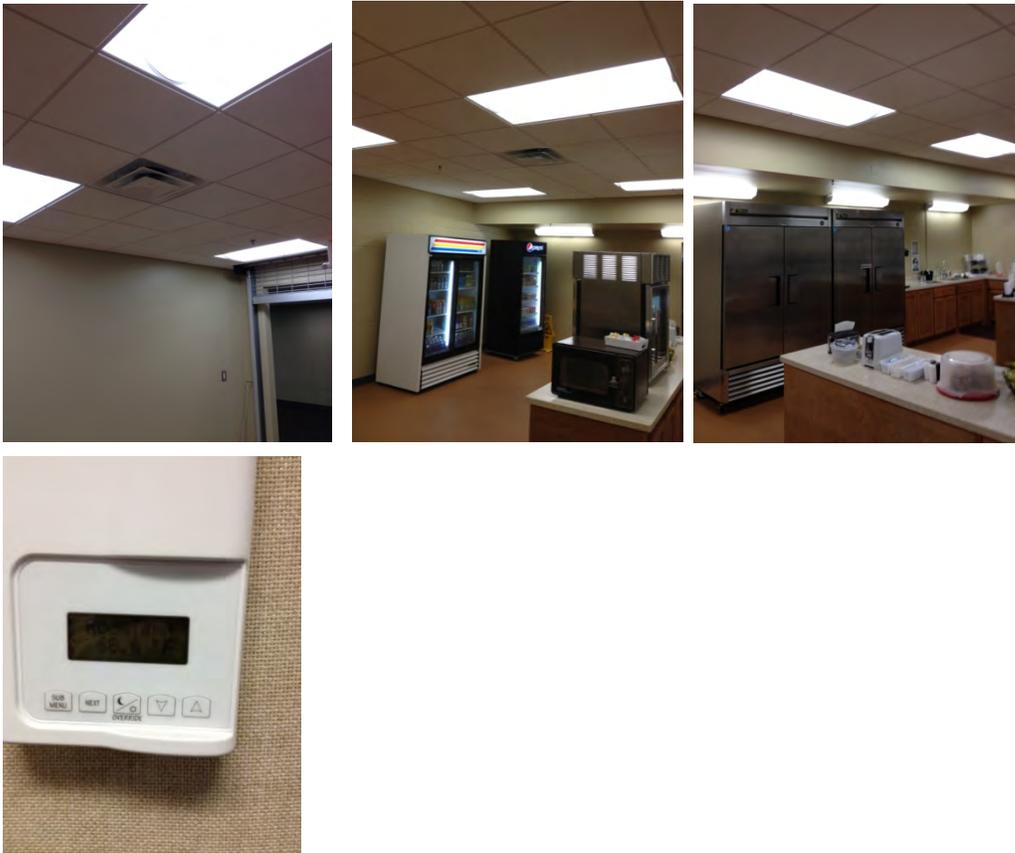
- The maintenance personnel indicated that the racquet ball courts and the smoothie shop were warm and they had issues cooling the areas. The smoothie shop was warm due to the amount of food equipment that was in the area that generated heat. They tweaked the dampers in the areas and adjusted the controls and now both areas are comfortable.

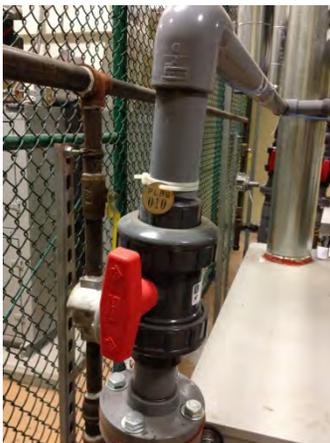
- The maintenance personnel indicated that the maintenance schedules of the HVAC system were being followed.
- The facility engineers indicated that they had to add a chain link fence to separate the mechanical room area from the pool control room.

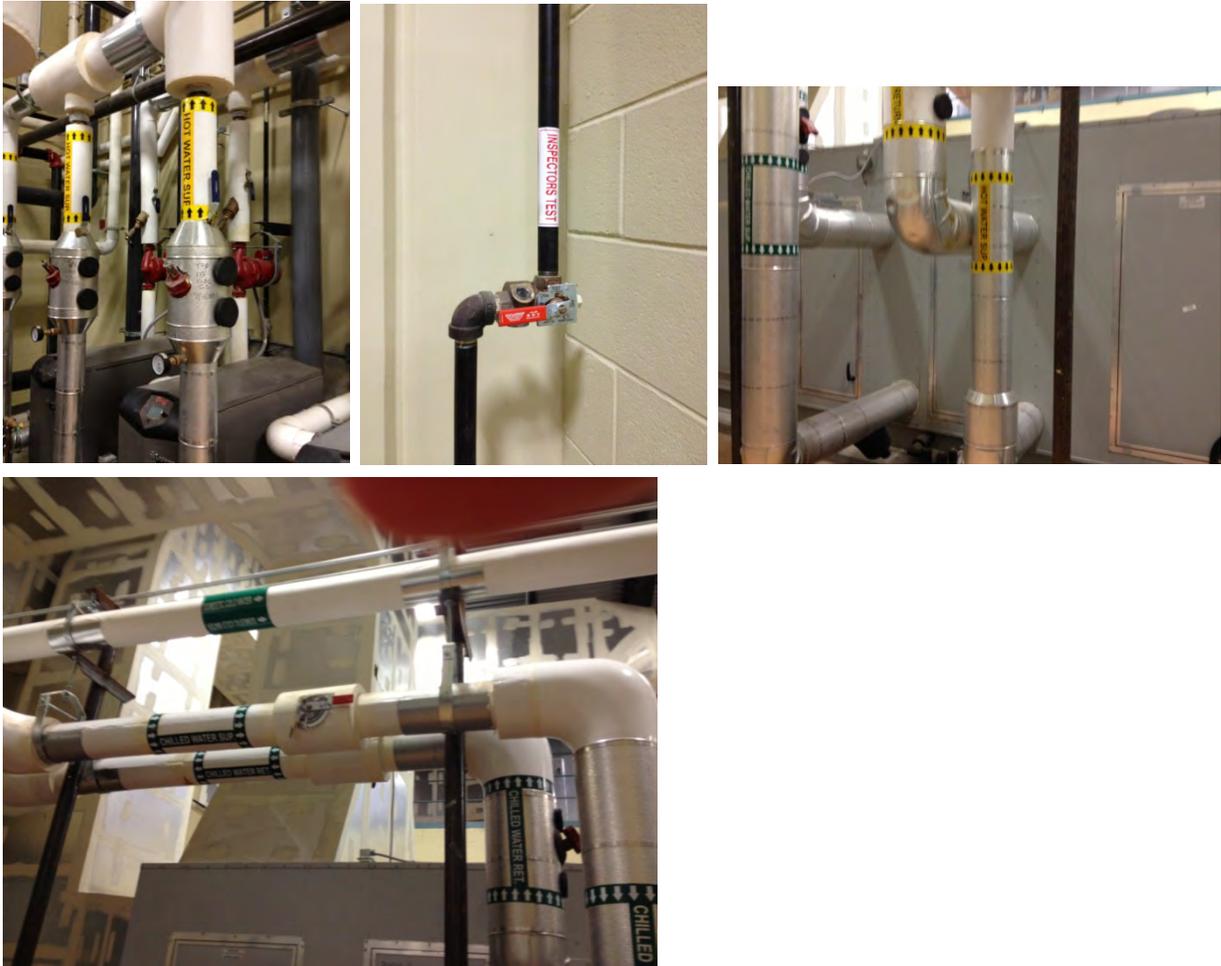
- Ducted returns were utilized throughout the facility.
- Piping in the mechanical room was labeled and legible.

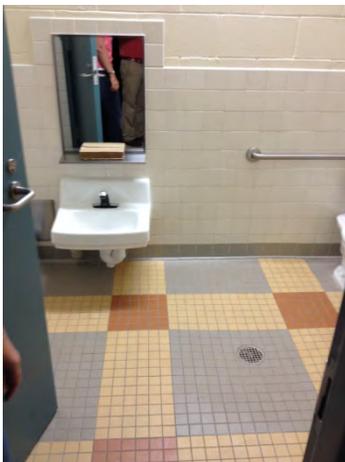
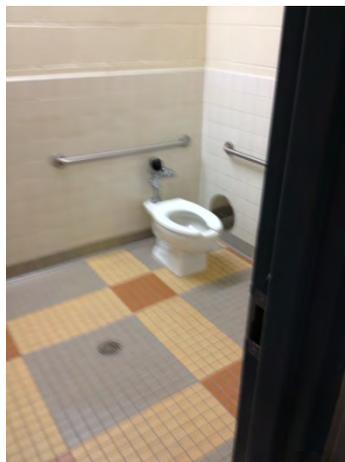
- The sink that was installed in the play room for children is too close to the floor and the toilet is at standard height.

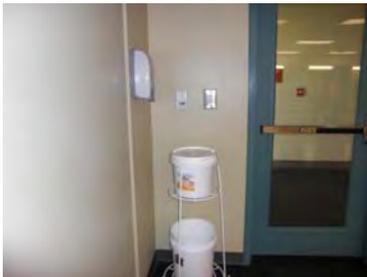
- Document if the lighting is switched to allow for different light levels and natural light via windows. This lighting is switched but it dose not allow different light levels. The lights are on or off.

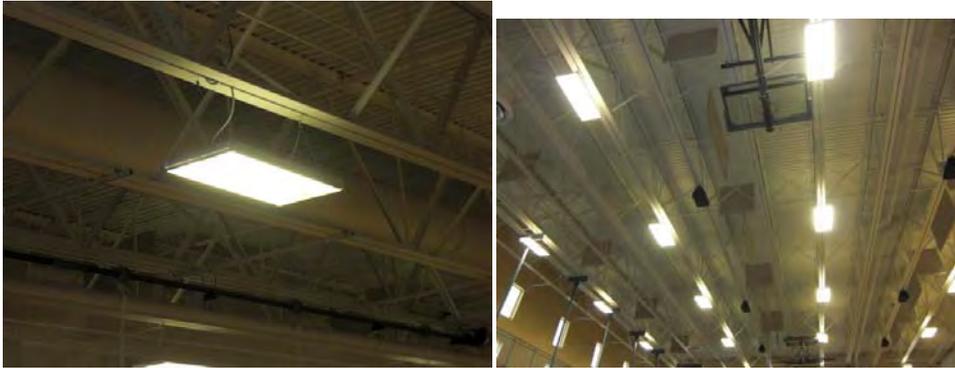
- Document the type of direct/indirect lighting that illuminates the gymnasium

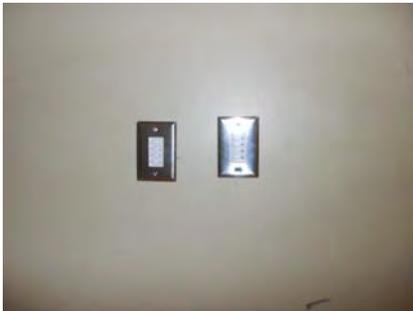
- Document if there is multilevel switching or dimming in the gymnasium. None
- Document independently control lighting on each court or for special activities are provided in the gymnasium

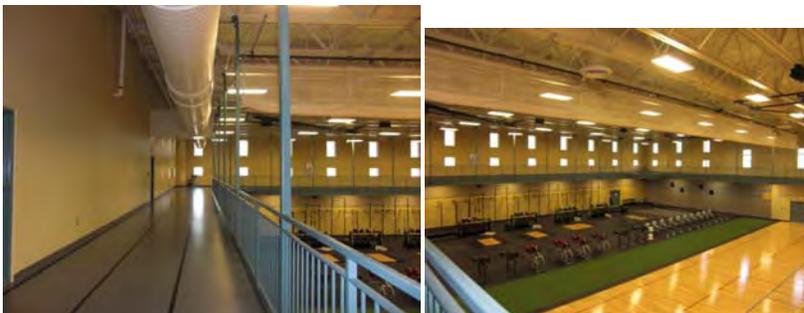
- There are natural lights shining into the gymnasium spaces through the use of windows/overhead skylights.

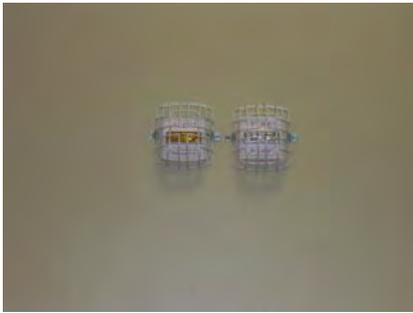
- Document type of physical protection (wire cages/etc) for the gymnasium lighting, exit signage, fire alarm/annunciation devices.

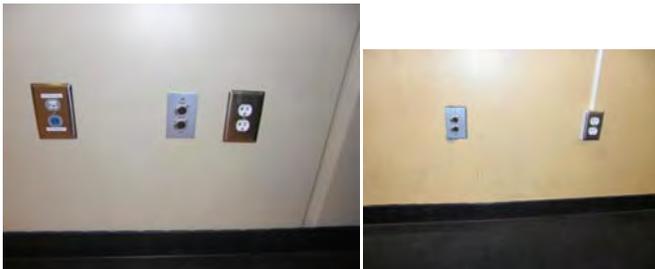
- Document where lighting control is located. (controlled/protected location) The lighting controls are located in the storage room.
- Only wall mounted outlets provided.

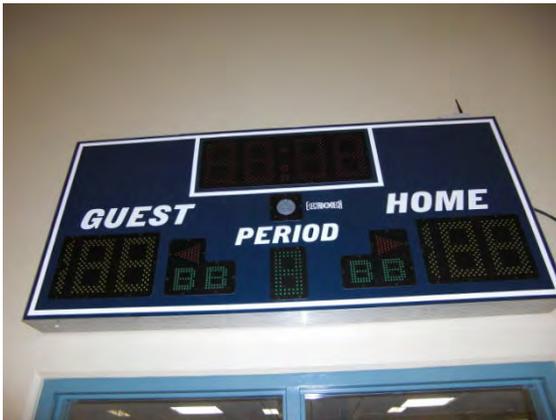
- Document the type of electronic scoreboard.

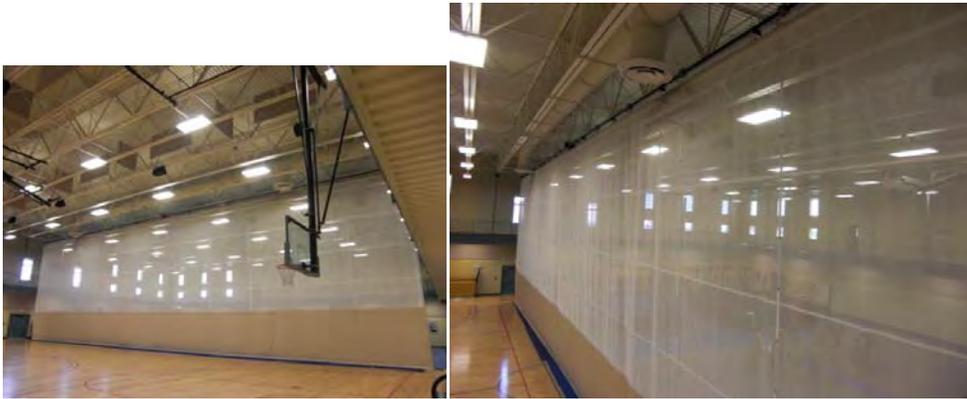
- Document if there is a divider curtains that blocks views , lower light levels in gymnasium

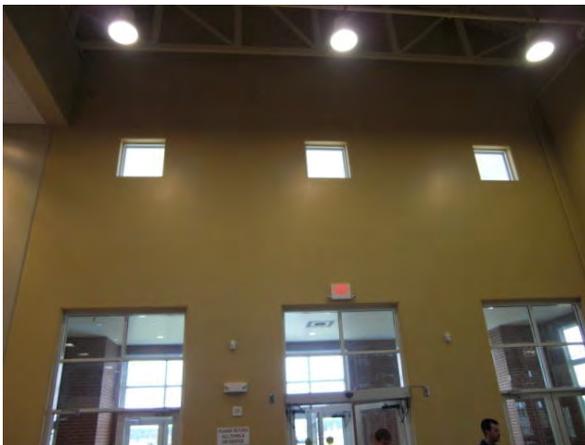
- Document if Lobby lighting allow for natural light through large windows and clerestories

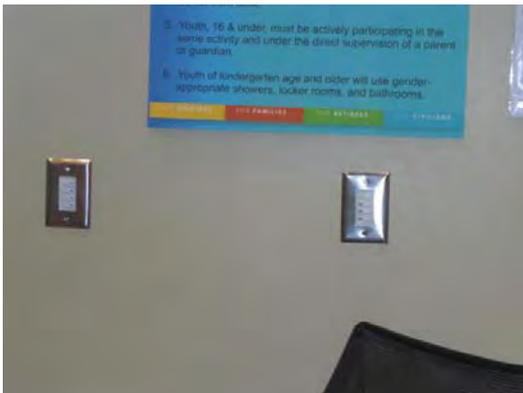
- Document the type of lobby lighting control center at the control desk.

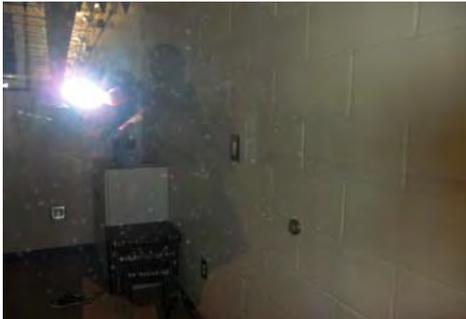
- Document if there is multilevel switching or dimming in admin and/or other areas. No
- Rooms (such as storage rooms, laundry rooms, etc) with more than one entrance should have 3-Way (or 4-Way) switching so the lighting can be turned "on" when entering each door. The lighting is controlled by motion detection.
- Document if Lighting is controlled with an automated time clock with a manual on/off time override in the natatorium. Yes

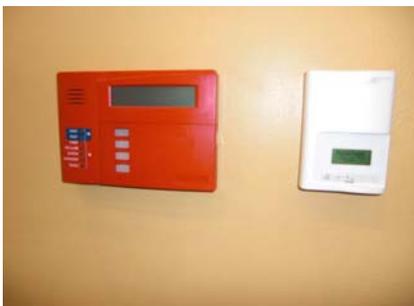
- Document if there is a timed over-ride at main entrance for janitorial staff. No

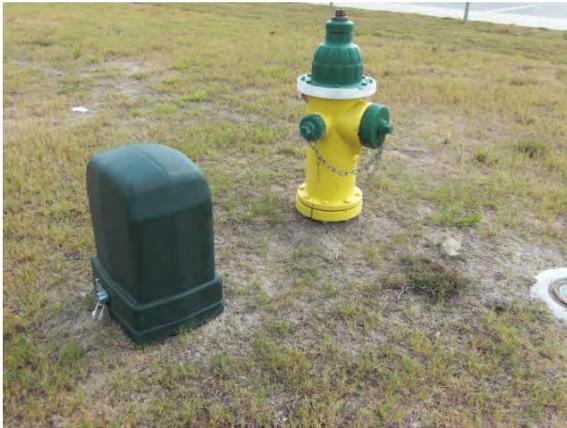
- Document if Cathodic Protection System was installed. Yes

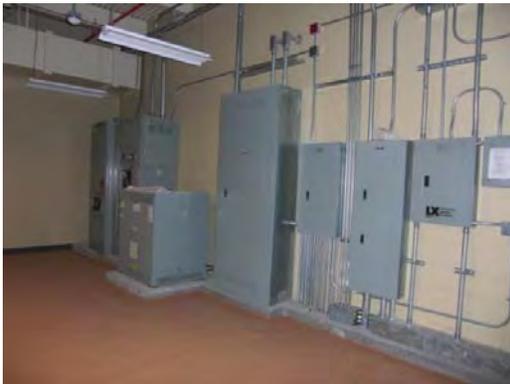
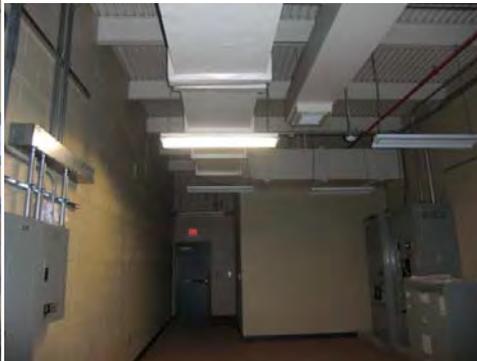
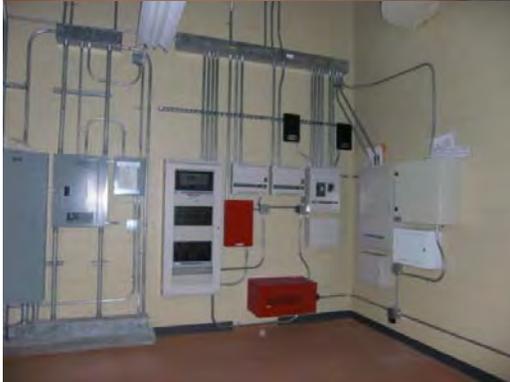
- Document if wiring is concealed from view in finished rooms/areas. Yes
- Document if there a Service Entrance Panel metering (EMS/UMCS connection?) No
- Document adequate working clearance for electrical and communication panels

- The lights are not dimmable. The lights are either on or off. The break area lights do not work.

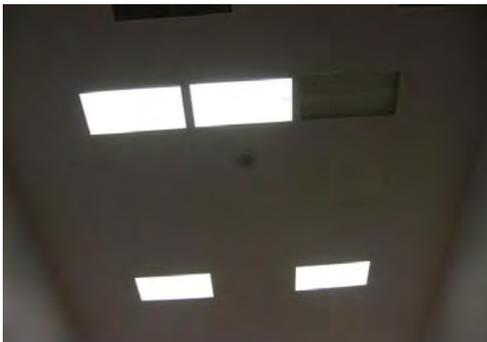
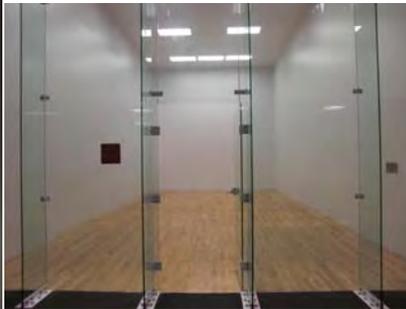
- Document type of sound system in the racquetball court. (Flush recessed speakers linked to paging system. Provide one speaker in spectator/waiting area with court speaker at back upper wall)

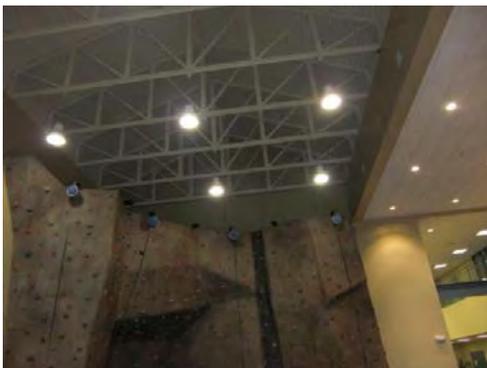
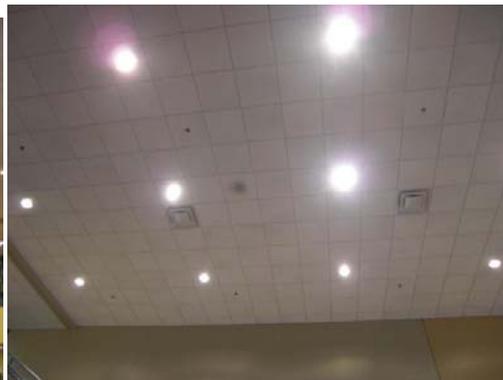
- Document type of sound system in the Climbing Wall area. (Speakers, paging system)

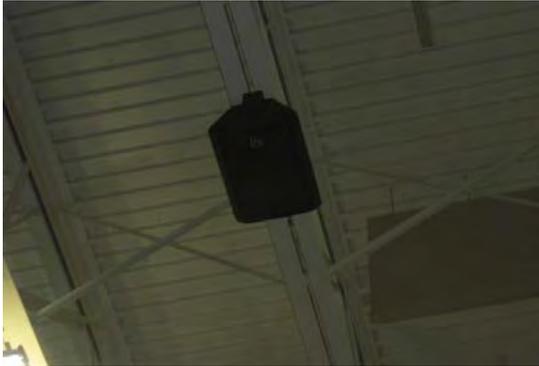
- Document type of sound system in the Combative area. (Speakers, Public Address)

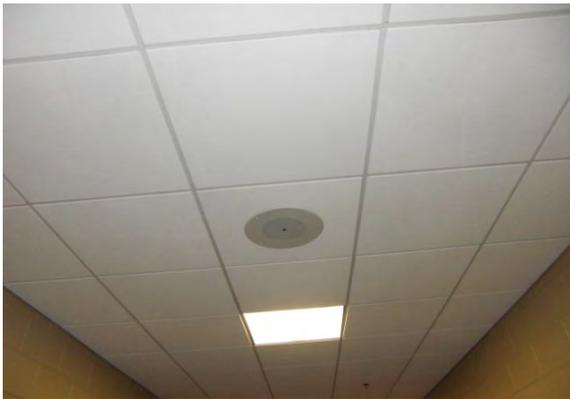
- Document type of ceiling mounted speakers for public announcements in corridor.

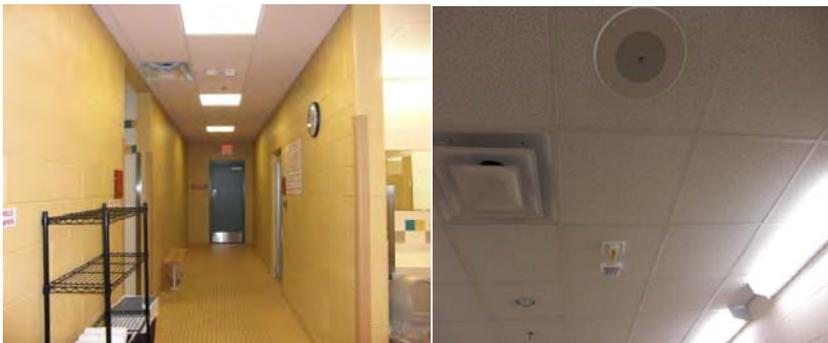
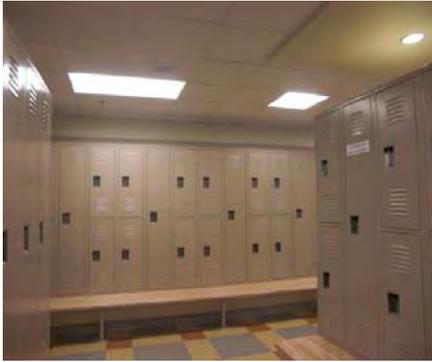
- Document type of sound system in the lockers, showers, toilet, sauna areas. (Speakers, Public Address)

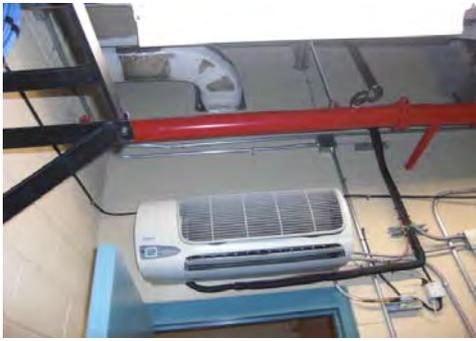
- Document if Communication Rooms are adequately heated/cooled. Yes

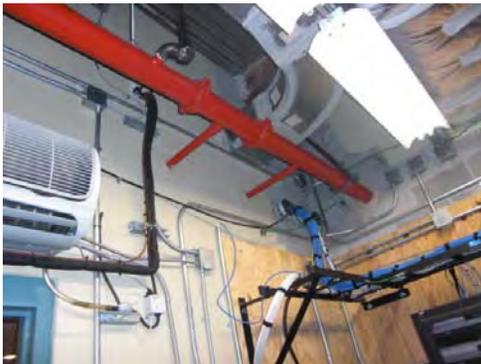
- Document if prohibited equipment/systems passed through Communication Rooms. Yes

- The intercom does not work in rooms 207-1 and 207-2. The User had an XM Radio installed after the building was turned over. This could have caused speakers in the in the gymnasium to not work. The contractor has not been notified about this issue. There may be a warranty issue with this sound system.
