**U.S. Army Corps
of Engineers**
Engineering and Support
Center, Huntsville

School Age Center

**Building 7160
Fort Stewart, GA**

**POTR – Phase 1
Project No 71177**

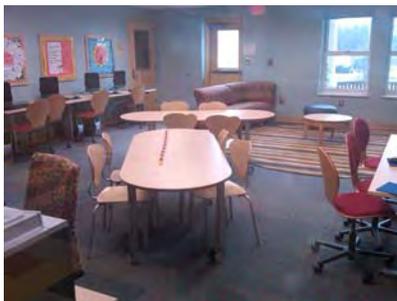
- The user felt that the facility doesn't completely meet her needs. She needs a larger homework lab. The homework lab and computer lab are combined, and there isn't enough space for the number of children needing to use this area. These 2 functions need to be separate rooms.

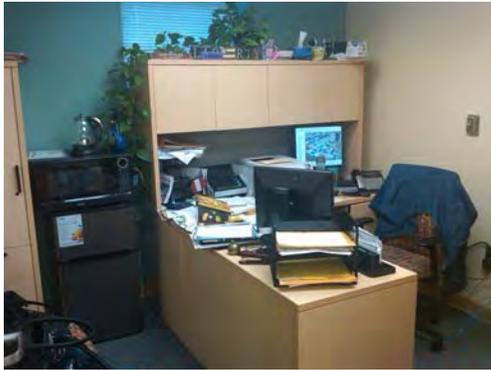
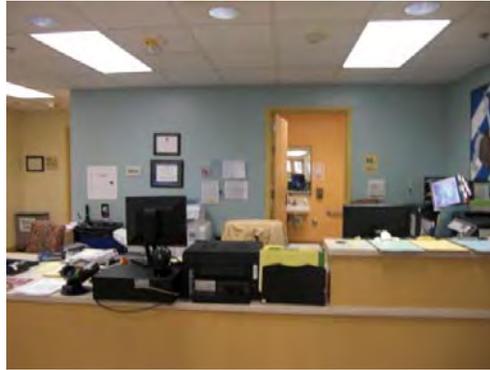
- Another issue is that the break room and training room is combined. This does not work for the staff who has their office in the training area. This also needs to be 2 separate rooms.
- The users would have liked a lot less storage so that more space could be provided for child activities and functional areas (such as admin).
- There are conflicts between where all the various switches/pulls/etc. were placed on the walls in the reception area and the director's office, and where furniture was supposed to go. As a result, the director had to rotate her desk and block her window so she could access the emergency switches on the wall. This needs to be coordinated between the COS and G-9 Interior Designers, and then addressed in the criteria. For example, the Fire Alarm Enunciator Panel and the HVAC Shutoff could have been located on another wall.

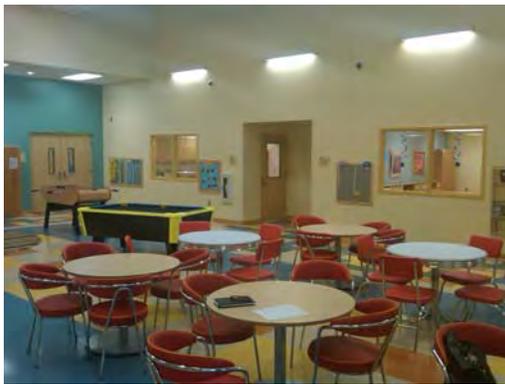
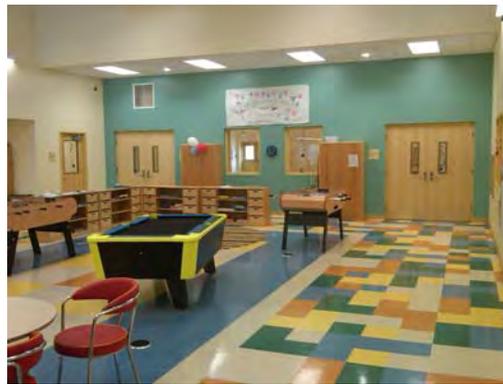
- The small facility can barely accommodate 100. When the children come in for snacks, the entire atrium is taken over. There is seating in the atrium for about $\frac{1}{4}$ of the children.

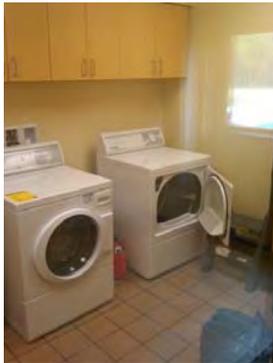
- The reception counter functions well and there were enough outlets provided. There is a duress button; however, it is not hooked up.
- Due to the combined training/break room, they feel there is inadequate admin space.
- They felt that in some areas taller ceilings in storage rooms would be a benefit; however, they are concerned if there is more storage space, people will store more junk.
- There are some acoustical issues at the reception counter when the atrium is full of children.
- Doors to the exterior from the atrium and activity rooms are alarmed. The doors from the Multi-Purpose Room are not alarmed.
- Laundry room has quarry tile floor, painted walls, and acoustical tile ceiling.

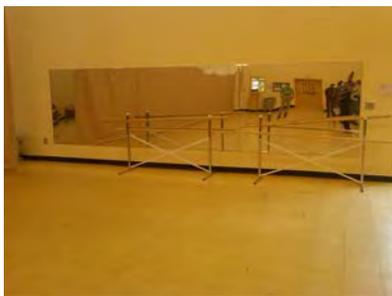
- Ceiling tiles through the facility were not tegular.
- Mirrors in Multi-Purpose Room have the “fun-house” effect.

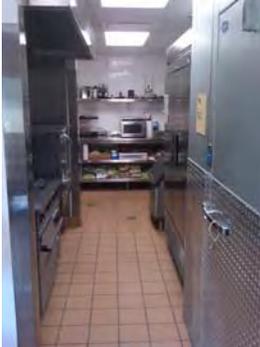
- Kitchen is very tight, especially around cooking area. The kitchen is provided with quarry tile floors, full height ceramic tile walls, and vinyl faced lay-in ceiling.

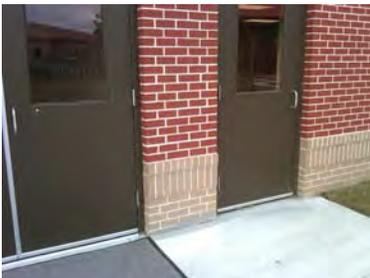
- Door hardware on the doors from activity areas are pull only, with no ability to unlatch the doors.

12. **Provide external door hardware on all exterior doors to allow children and staff the ability to re-enter the building. Lack of hardware poses a safety and program issue for staff and children needing to re-enter the facility to use the restroom, reach emergency services, escape severe weather, or unseen threats. Hardware shall meet the quality criteria found in Section 5, General Technical Requirements, page 2131 and Section 6.5 Architecture, page 2154.**

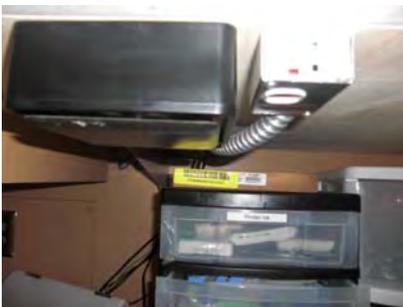
- A duress alarm was provided, but it was not connected to the MP station.

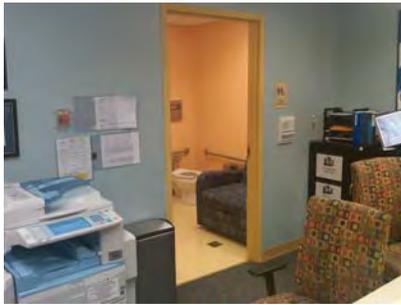
- Need to tighten requirements of flooring in Multi-Purpose Room. Needs to be a seamless floor. The tile athletic floor is not an acceptable solution.
- Need to provide more activity rooms.
- Need to provide a separate homework room and computer lab.
- Need to provide a separate training room and break room.
- There is no isolation room, only the bathroom. Need a place for the sick child to be instead of stuck in the bathroom.

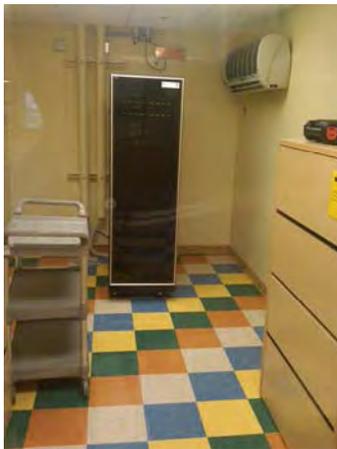
- Video Monitoring Room is too large.

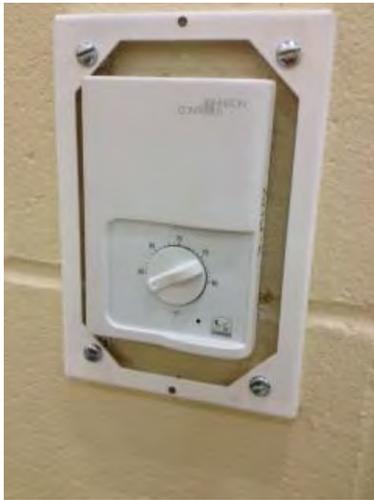
- The user indicated that the computer room was maintained at a comfortable temperature when occupied or unoccupied. The room was comfortable during the walk through.
- The facility engineers and maintenance personnel confirmed that the thermostats throughout the facility were working properly. The user does not have access to the thermostat to adjust temperature. The user has to call or put in a trouble ticket to the DPW to come out and adjust the temperatures. Thermostats were all digital with exception to the one in the common area. This particular thermostat was analog and did not appear to function. Once the cover was removed the temperature setting was at 60 degrees F. The facility engineers indicated that the temperature for this area was set at 75 degrees.

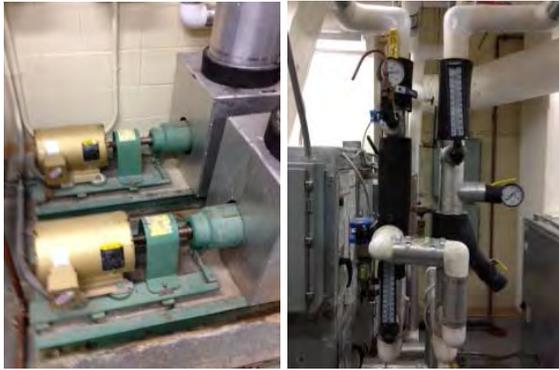
- The mechanical room was very small and cramped with 2 air handling units, an energy recovery system, boiler, fire sprinkler risers, water pumps and piping, etc.

- The mechanical room is very small with the amount of equipment necessary for a functioning facility. Suggest either expanding the footprint of the mechanical room so that mechanical equipment and controls can be properly placed, duct work can be run properly, and major pieces of equipment can be easily removed and installed to and from the room when replacement is necessary. Another suggestion for space savings might be installing a larger unit with VAVs to control the different zones instead of having an air handling unit for each zone.

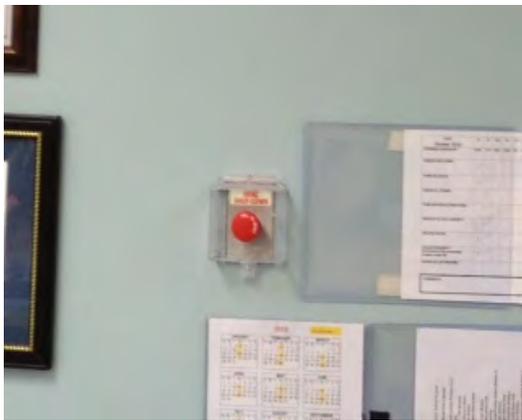
- Plenum returns are ducted.
- Emergency shut off for the HVAC system is located at the front desk

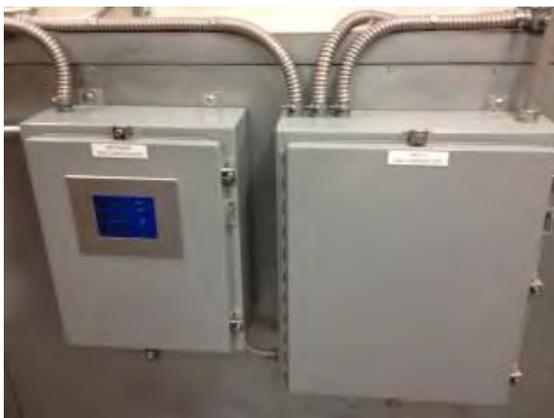
- The digital controls for the air handling units were mounted to the units themselves, because of limited wall space in the mechanical room.

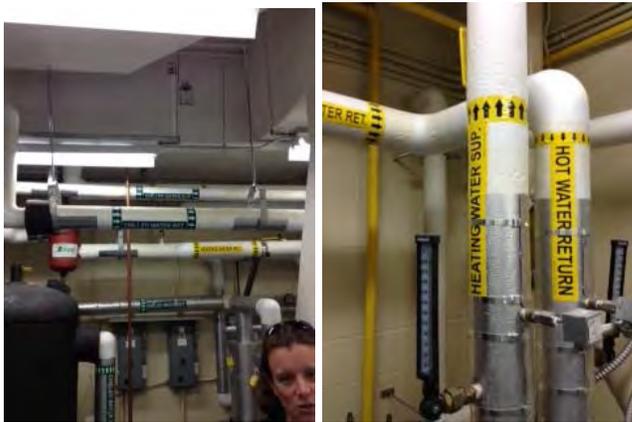
- There were no issues with pressurization of the facility. All doors opened easily.
- The user and facility engineers could not identify any discrepancies between what was built for this facility and what was described in the RFP.
- No innovative technologies, solar / grey water, are planned for this site.
- High efficiency boilers and HVAC energy recovery systems are being used.
- Piping in the mechanical room was labeled and legible.

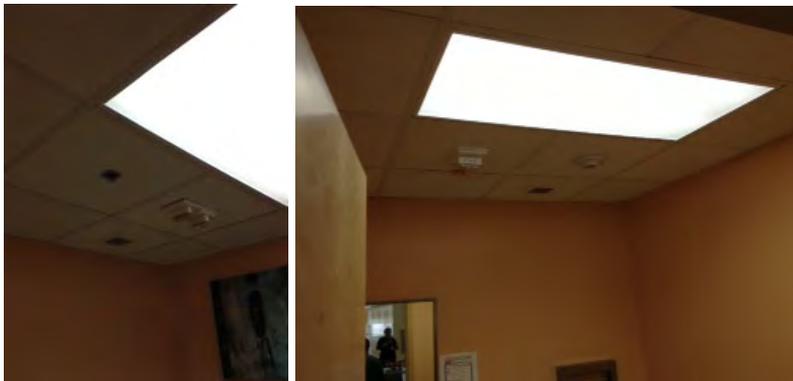
- There were no exhaust fans installed in the Staff/First Aid Office or Visitor Restrooms, just a non fan powered vent.

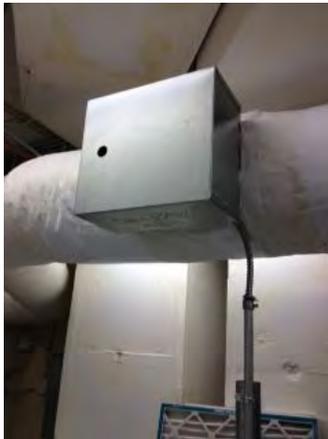
- Facility engineers and maintenance personnel indicated that maintenance schedules were being properly followed.
- Change orders were issued to add VAVs to AHU-2 to control the outside air for that zone.

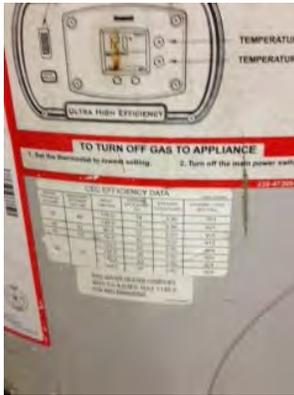
- The boiler used to provide domestic hot water is a high efficiency unit.

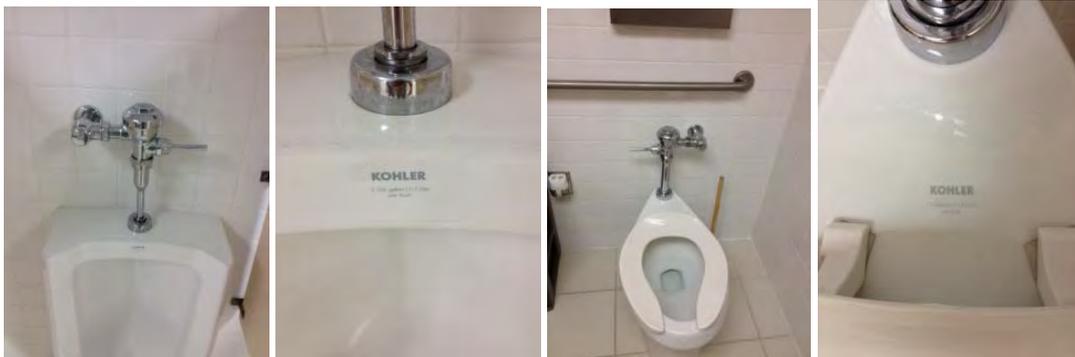
- Toilets and urinals utilized standard flush valves. The toilets had a listed flush rate of 1.28 gallons per flush and the urinals had a listed flush rate of 0.125 gallons per flush.

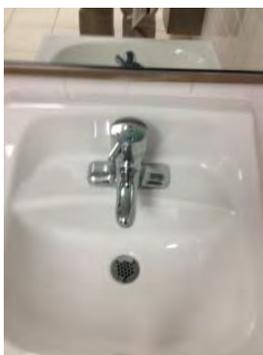
- Low flow lavatories were utilized in the bathrooms.

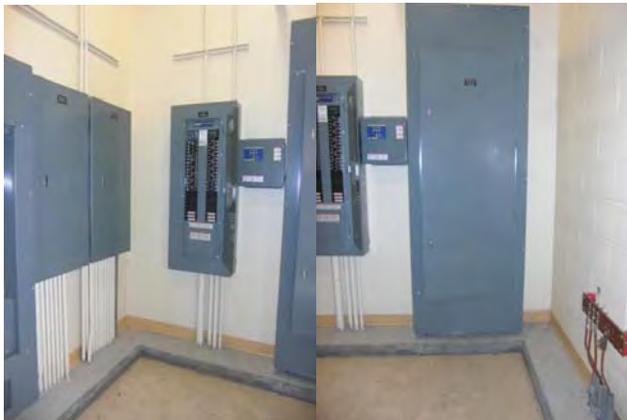
- There is no Service Entrance Panel metering (EMS/UMCS connection)
- All wiring is concealed from view in finished rooms/areas.
- No concealed/flush boxes are used for devices in finished areas and on exterior walls
- There are adequate working clearance for electrical and communication panels.

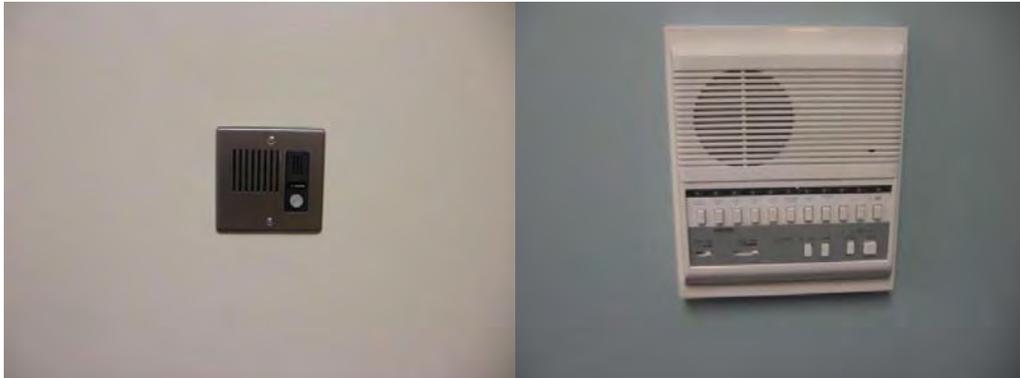
- Document satisfaction with intercom system (announcements understandable). No, the user is not satisfied with the intercom system.

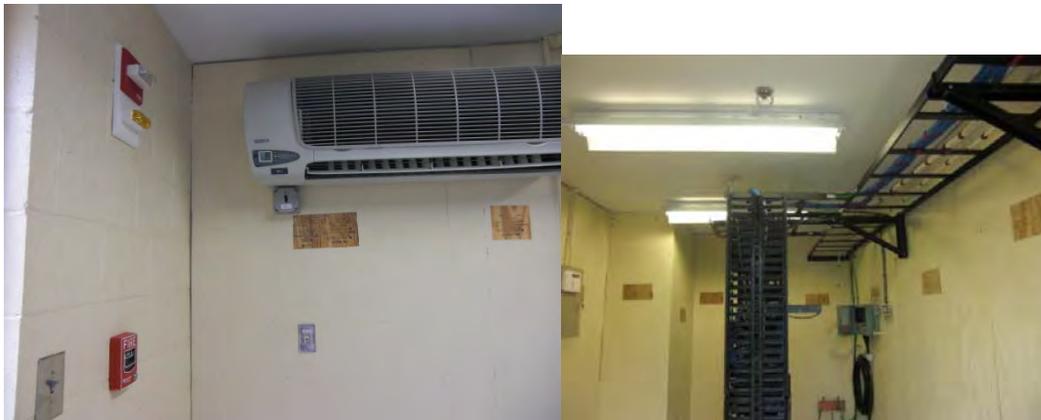
- The intercom system is wall mounted.
- The Telephone/Data/Power outlets meet the user needs at reception and admin areas.
- The Communication Rooms are not adequately heated/cooled. The Communication Room air conditioning unit is not cooling.

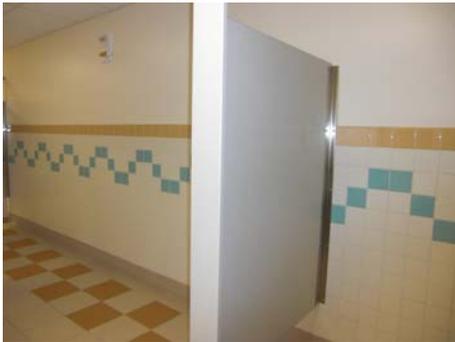
- Toilets off of the multi-purpose room need doors with key locks so they can be opened from the outside using a key.
- Airport entrances into main restrooms led to line of site issues. This was corrected by the addition of a screen inside the restroom.

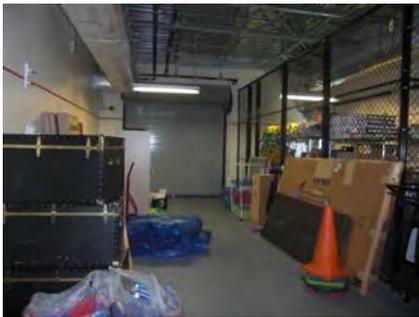
- The large storage room in the Multi-purpose Room only has a roll-up door. It needs a personnel exit as well. The steel cage within the storage room has a personnel door to the outside. They had to provide a door into the caged area with a thumb screw bolt to allow for emergency egress from the storage room through the cage to the outside.

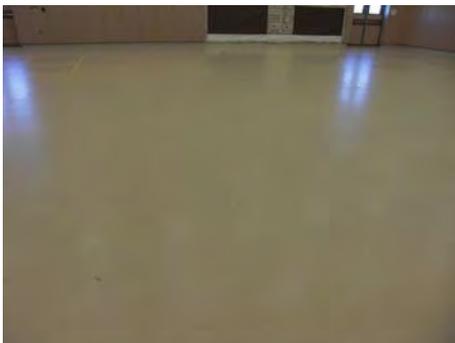
- Flooring in Multi-purpose Room is light and therefore is showing a lot of marks and is difficult to clean.

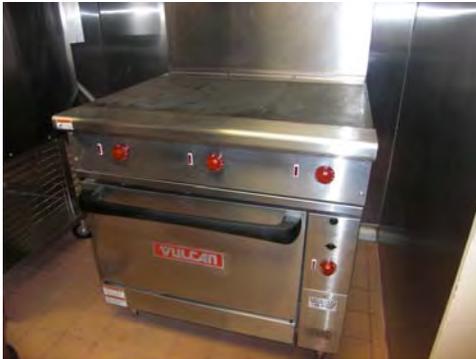
- It was mentioned that this stove, which is the same as in Meadows, is slow to warm up and cook. Also, this stove is not level.

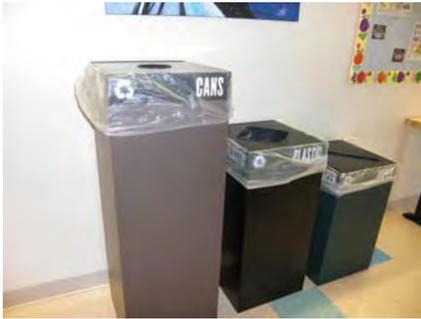
- The recycle bins should have a cover over them. Uncovered trash cans are not allowed.

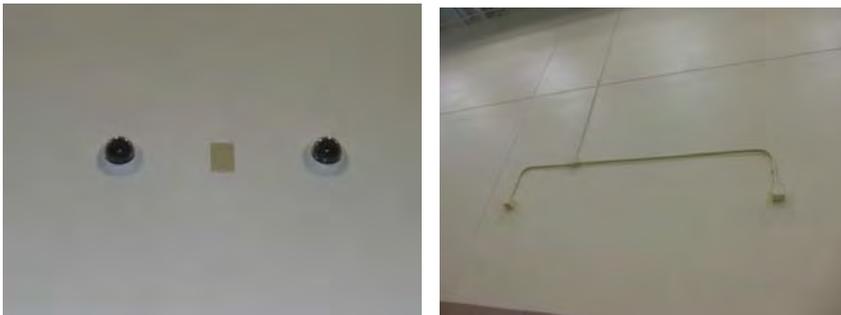
- Camera installers did not use raceways and junction boxes provided by contractor. Instead they used plenum rated wiring and punched a small hole at each camera. This leads to an aesthetic issue of empty plates near each camera, and also a cost issue of providing raceways and boxes that were not required. Need to coordinate the actual requirement.

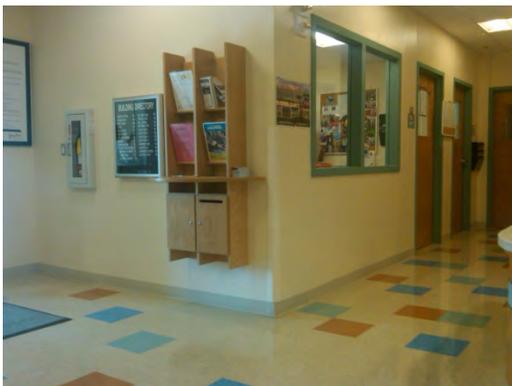
- The director's office has 2 windows facing the desk. The window close to the door is fine, but the other one is not desired; too much of a distraction. A window on the wall facing the entry corridor would be good. One by the door and one facing the entry way would be ideal.

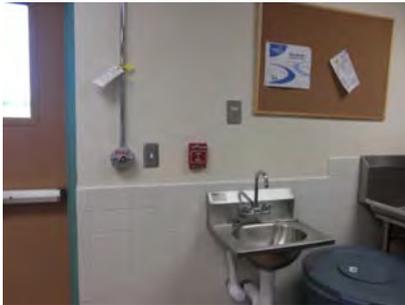
- Telephone outlet was placed over sink, which is not good placement.

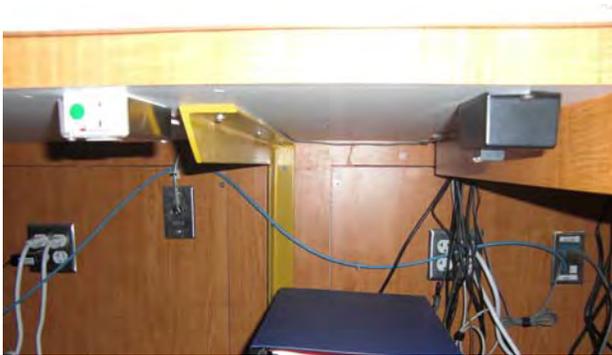
- The kitchen has no room for a desk.
- The duress button is too close to the door release button.

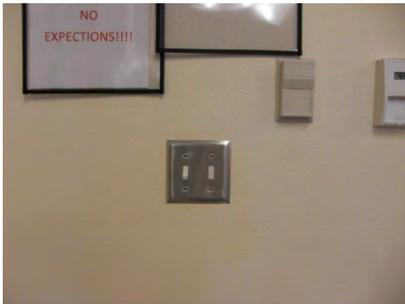
- The lighting is controlled by motion sensors and switches. Lighting control was changed in the activity rooms to be either all on or all off. There is no multi-level lighting capability. Motion sensor lights were left in the offices, toilet rooms in admin area, and the atriums. They are an issue in the offices as they will go off when those rooms are not locked.

2. Replace all damaged light fixtures.
3. Provide 2 level lighting capabilities uniformly arranged throughout the room as required in all activity or similar rooms. This shall be achieved by controlling one lamp in each fixture by one switch and the other lamp in each fixture controlled by the adjacent switch. Thus allowing one switch on to provide a lower light level and both switches on to provide the higher lighting level. As now installed, light is no uniformly and evenly dispersed throughout the room.

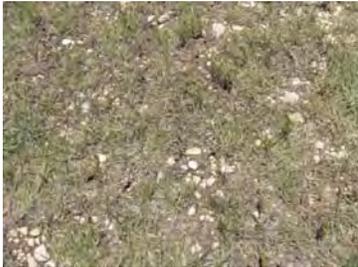
- Due to the rocks and poor grass issue in the soccer field and playground, the contractor ultimately provided sod. There are still a lot of small rocks in the yard around the facility.

- 28. Remove all rocks and stones from the playground and soccer field areas. Provide grass in all non-hard-surfaced areas. The existing areas are unsafe for use by children and others due to the poor surface conditions.**

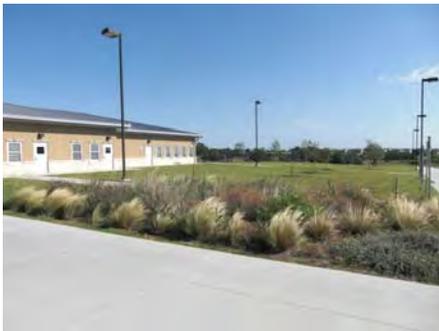
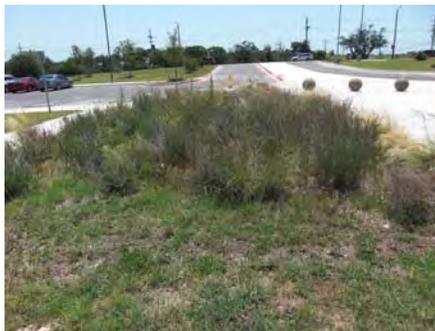
- Users have a concern with the "natural" landscaping that was provided at the main entrance. It looks unkempt, and also provides hiding places for rodents and snakes (very prevalent near this facility).

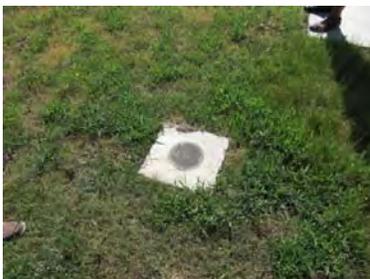
- Sprinklers had to be turned off due to standing water in the playground areas.
- Not enough parking, especially for maintenance and special events.
- Gates on the service drive to provide ATRP protection are routinely left open.
- There are drain cleanouts located in the playground areas

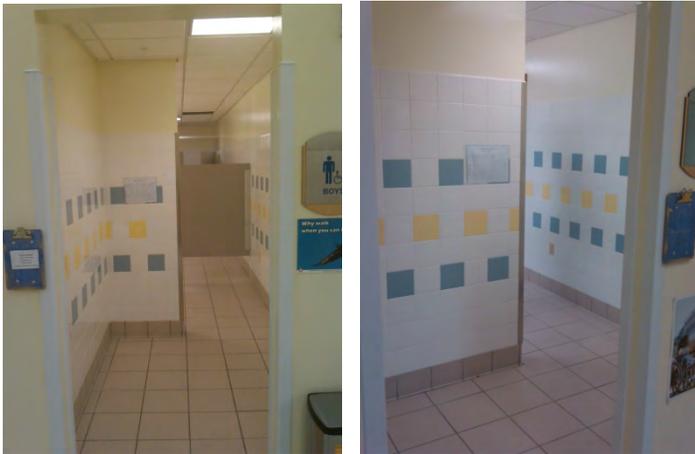
- There was a major issue with line of sight into the restrooms. In the 2 larger restrooms, the contractor installed (by mod) a toilet partition to block the sight. In the other 2 restrooms, the contractor re-did the openings and eliminated the line of sight issues by moving them as far towards each other as they could.

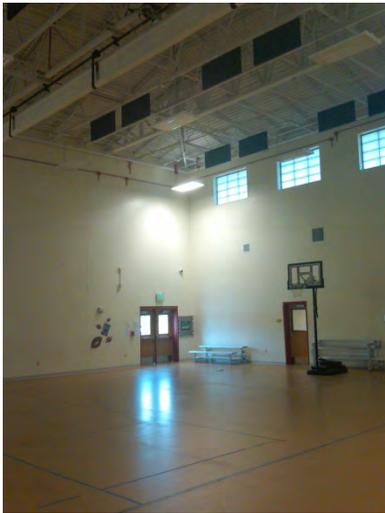
- The acoustics in the Multi-Purpose Room are poor. There are only a few acoustical panels suspended in the structure above.

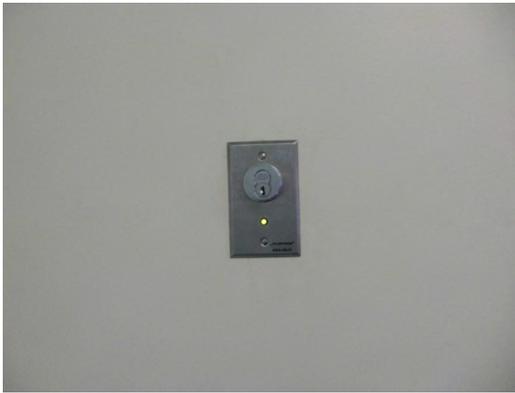
- There is a timed over-ride at the main entrance for janitorial staff.

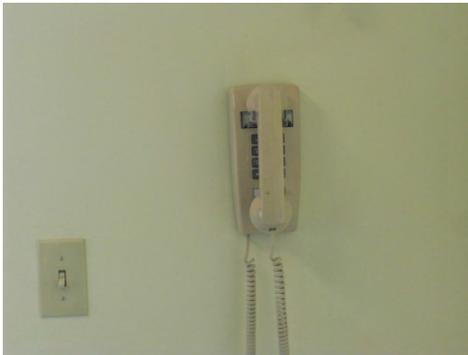
- There is a telephone in the electrical room.

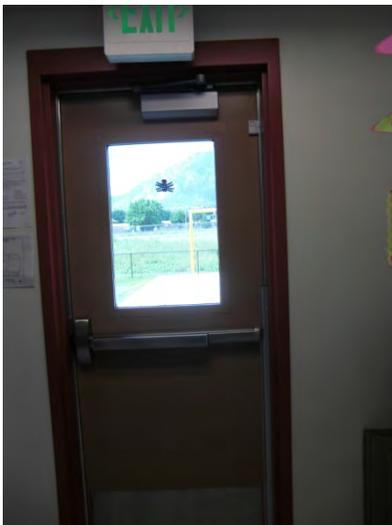
- On all of the doors into the fenced area, the users added their own alarms. The one set of double doors that do not open into the fenced area has an alarm built into the panic hardware.

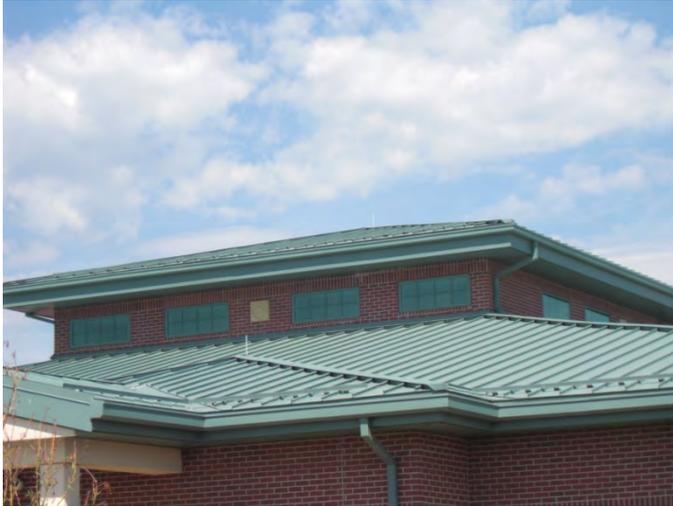
- There is multi-level lighting in the administration and other areas.
- Lightning Protection was installed.

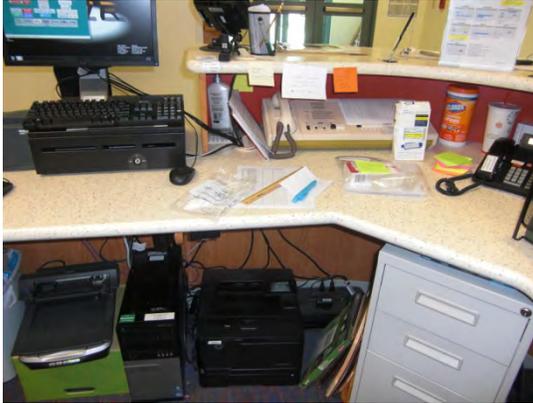
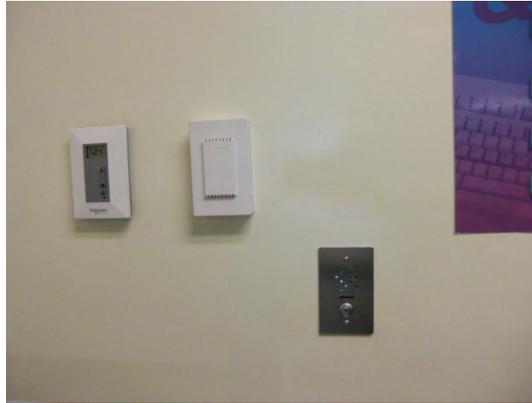
- The intercom is wall and desk mounted.

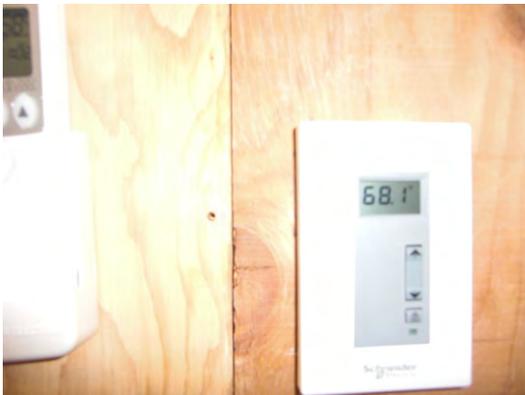
- The communication room is adequately heated and cooled.

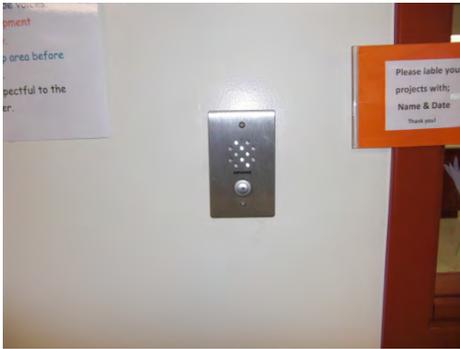
- The occupant is satisfied with the security system.
- The users are satisfied with the Intercom System; however, in actuality it is not often used. Walkie-Talkie is preferred over the intercom system. Walkie-Talkie allows the instructor to be mobile.

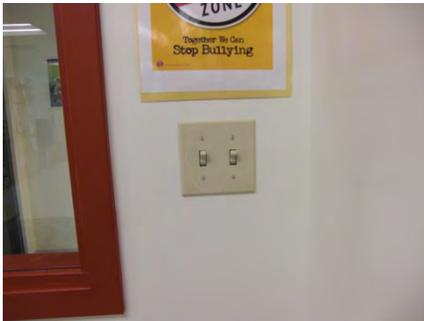
- None of the lights are on dimmers. The lighting levels are controlled with switches.

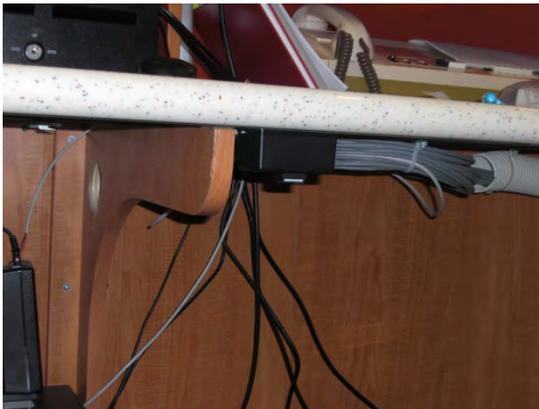
- A duress button was added.

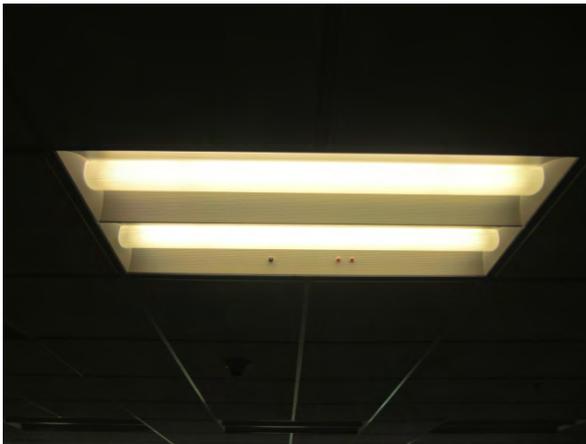
- The emergency lights beeped once installed. This took about nine months to fix. The installation is concerned how this was actually resolved.

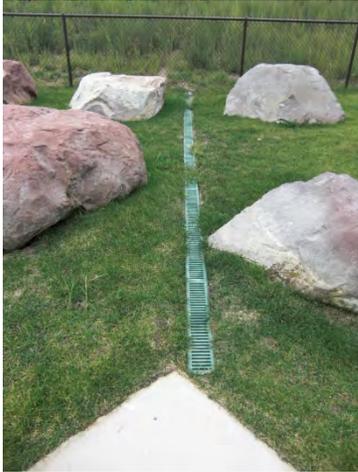
- A trench drain is located in the playground area to collect water from the quiet area.

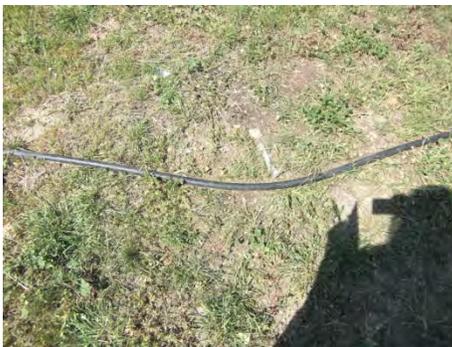
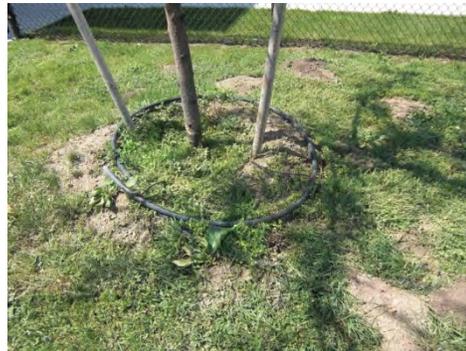
- The irrigation system was not buried as required in the RFP.

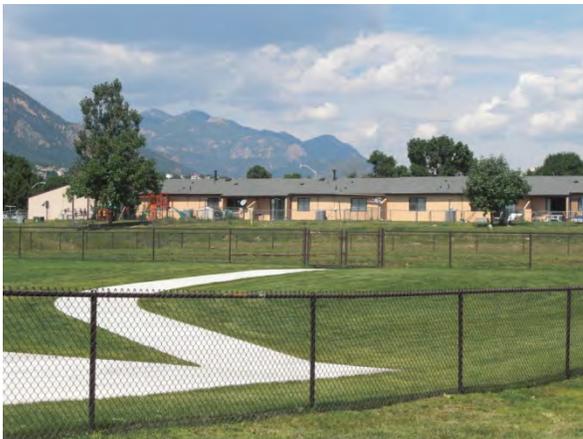
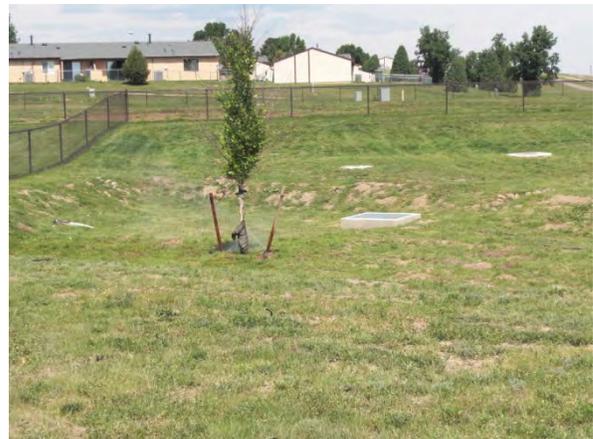
- The soccer field was enlarged per G-9 requirements. When the building had to be re-sited, the area left over for the soccer field was inadequate. The installation was able to delete a future DPW parking lot, re-grade the area, and provide a larger area for the soccer field.

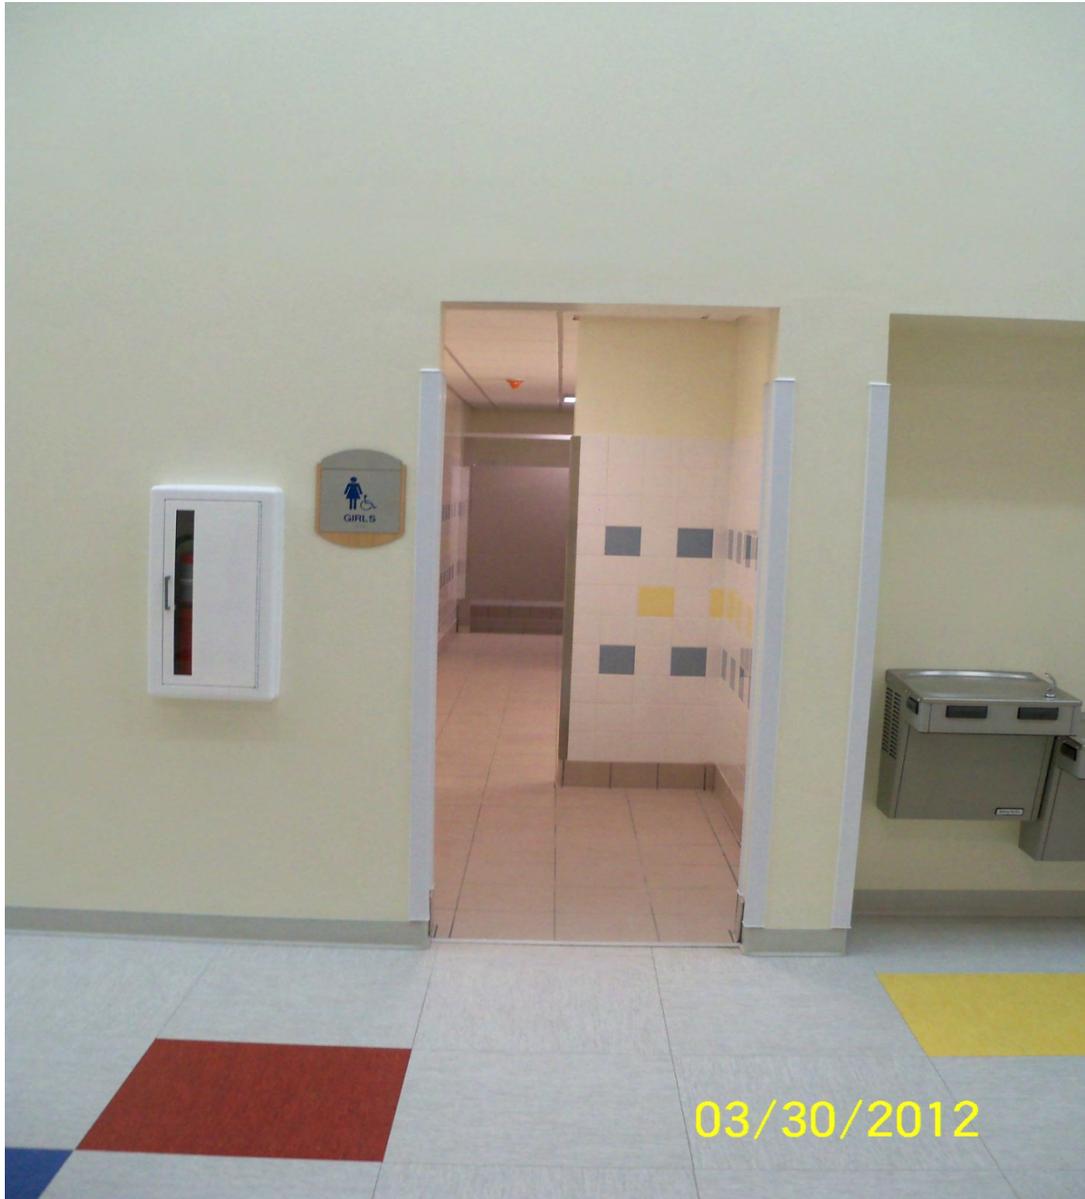
1. The existing airport style entry into the Boys Toilet Room #117 and 139, and Girls Toilet Room #118 and 140 do not satisfactorily block visibility into the toilet rooms. This does not comply with the requirements of the Room by Room Descriptions page 60-63, which states “Provide airport style entry to block visibility into room, but to allow staff to monitor by listening”. The Facilities Specialist of the G-9 Inspection Team recommends adding a toilet partition in each room to improve the screening effect. This was discussed in detail with Paul Glover, Atlantic Marine.

Refer to RFP, section 01 10 00, p. 60 of 560, #18, 19, 20, 21.: “ DOORS/FRAME: No doors in this area. Provide airport style entry to block visibility into room but allow staff to monitor by listening.” A visual block is required in the RFP at all child restrooms.

Please dictate whether or not an additional toilet partition should be added to block the current view of the ADA stall at the contractor’s expense.

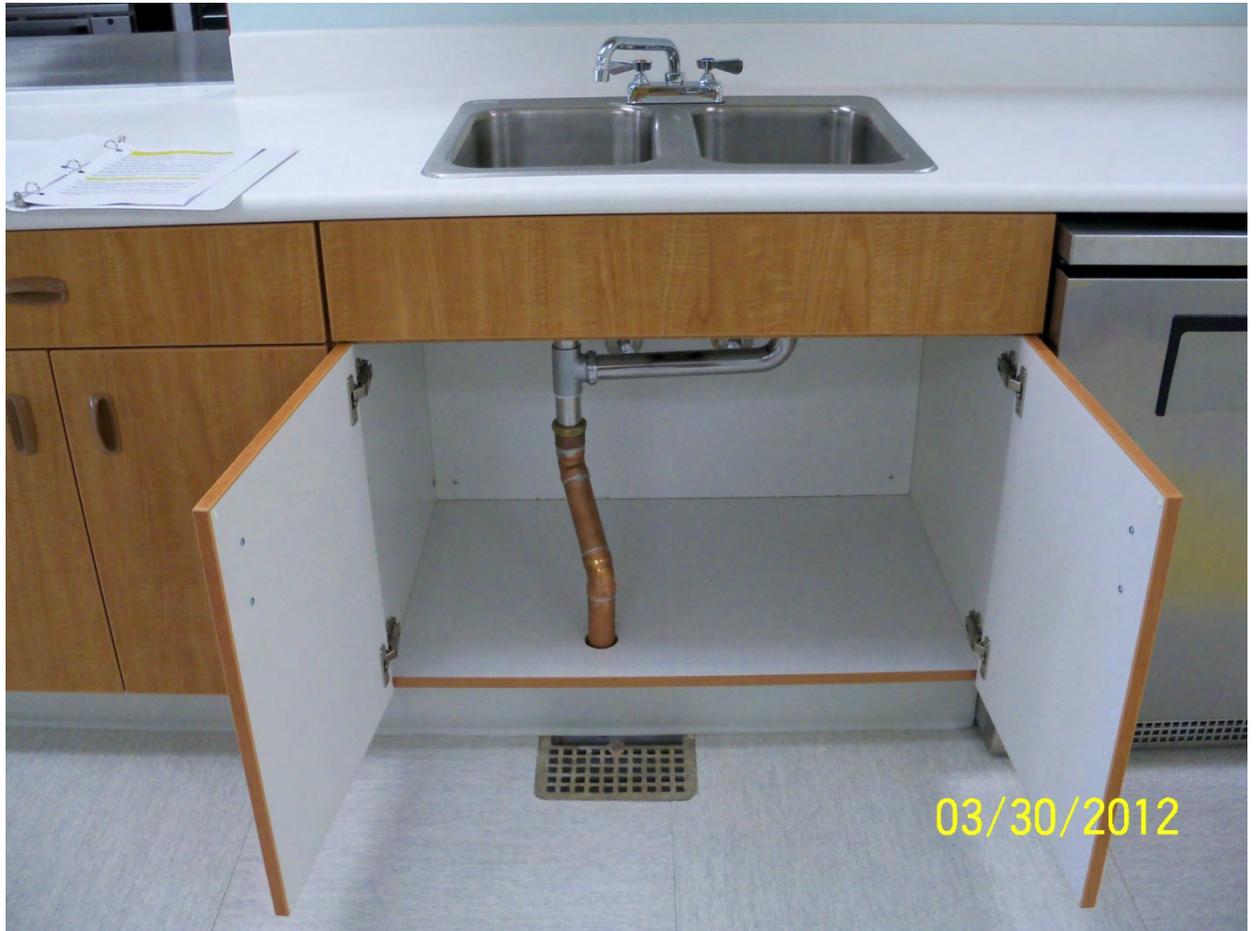
2. In the Demo Kitchen 2-well sink, switch the piping from indirect to direct waste, remove the floor sink and repair the cabinetry. According to the Room-By-Room description, this is a teaching kitchen (not part of the commercial kitchen). This recommendation also prevents water damage to the millwork and facilitates sealing the cabinetry from pest harborage.

The drain for this (2) compartment sink seems too plumbed in accordance with the approved contractor drawings (refer to P-901 kitchen sanitary schematic). There are (3) sinks drained in this way on the schematic. Refer to the International Plumbing Code (IPC), Section 802.1.1 which states that the requirement for indirect waste connections extends to all storage, cooking and preparation equipment, including vegetable sinks, food washing sinks, refrigerated cases and cabinets, ice boxes, ice making machines

This demonstration sink will surely be used to wash food among other uses.

Please dictate whether or not the drain must be changed from indirect to direct.

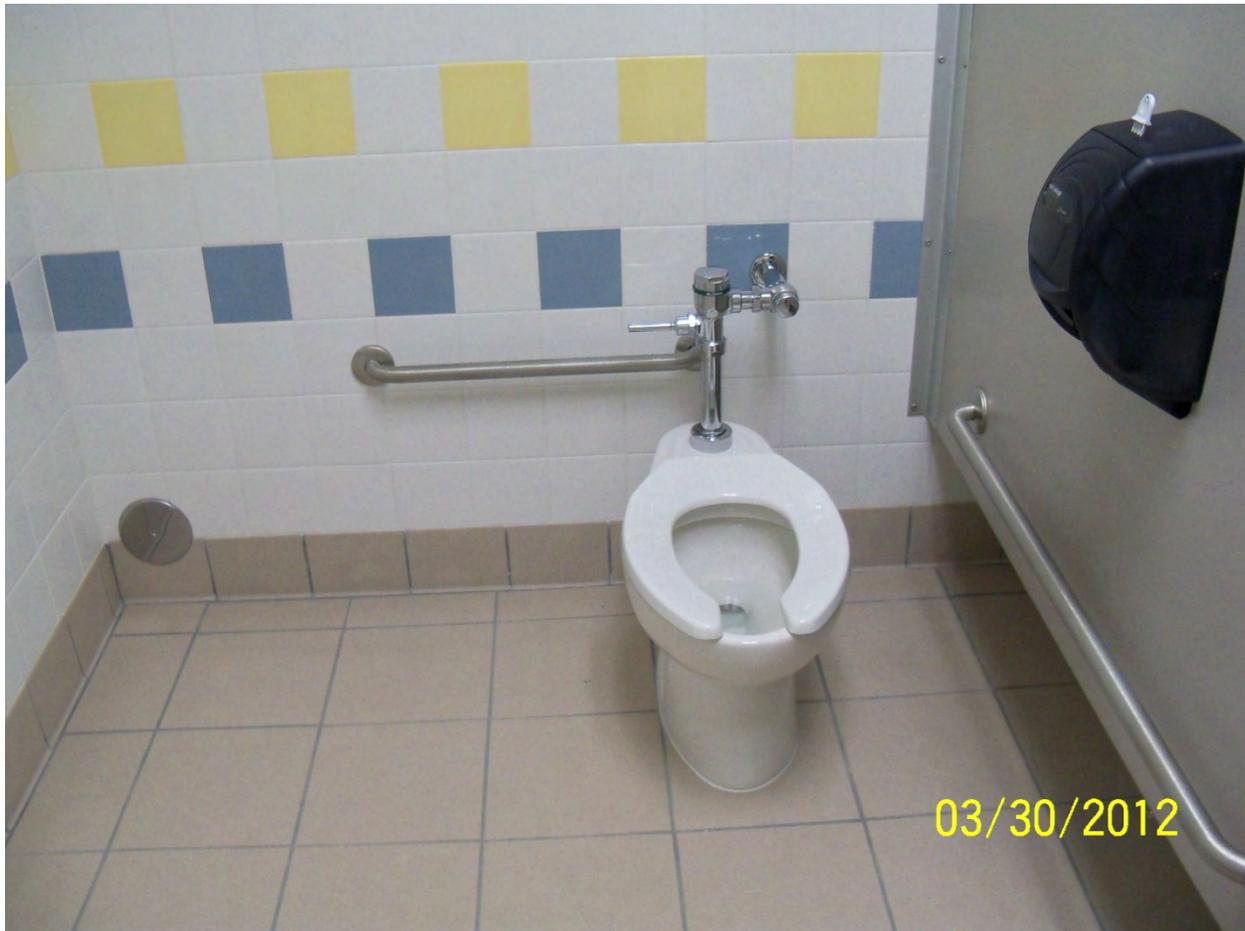
3. Replace the 24" length rear wall grab bars in all ADA accessible child toilet stalls and rooms with 36" length grab bars as required on the drawings sheet A-401 and A-402 IAW ICC/ANSI A117.1, Section 604.5.2.

The code quoted by IMCOM does require a 36" long grab bar which would extend further to the right.

Please dictate whether or not to replace 24" long grab bars with 36" grab bars at contractors expense.

side of the flush valve. Either choice is acceptable; however replacement with one 36" bar is preferred.

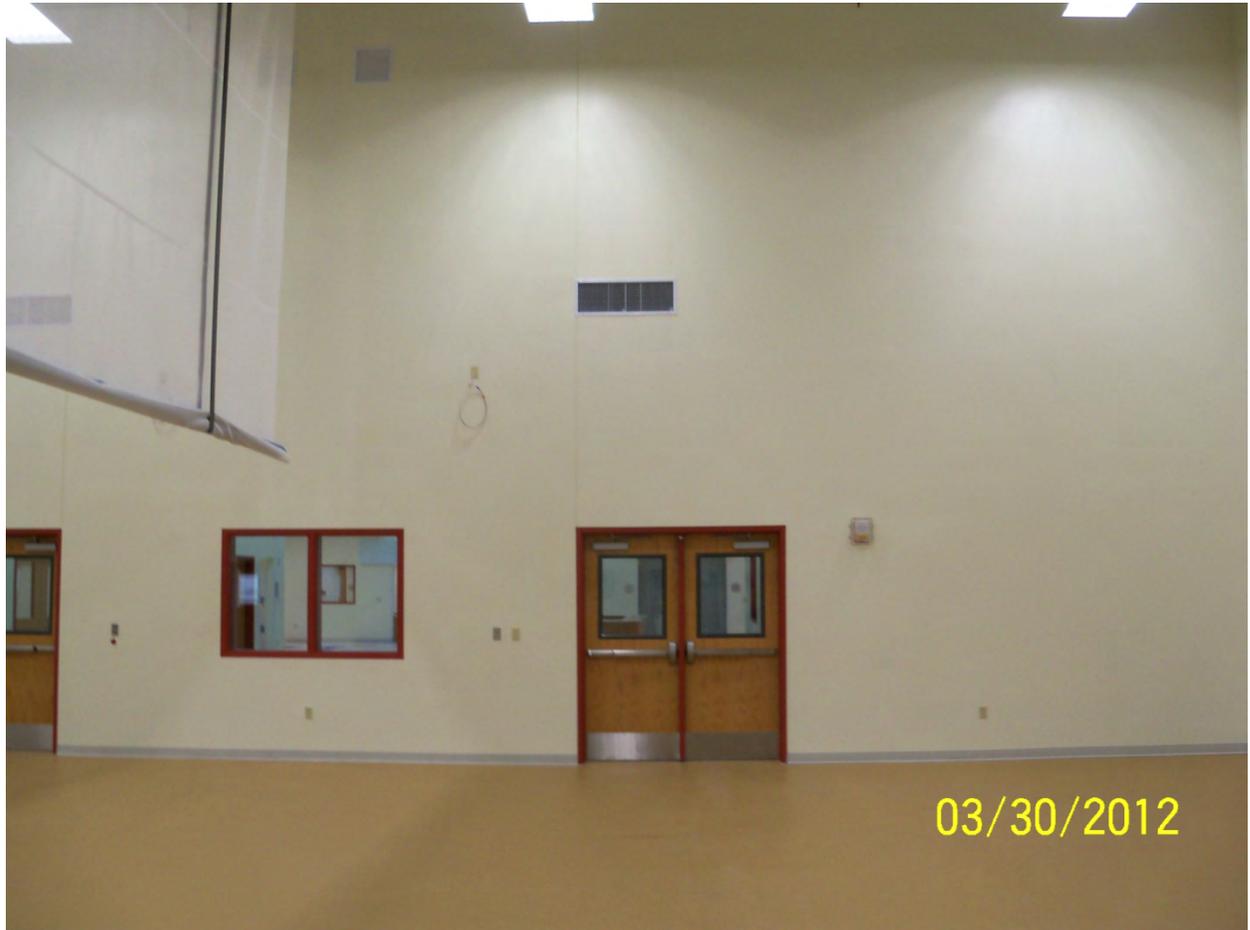
1. Provide exit signs above the interior egress doors leading into the Atrium from the Multi-Purpose Room (on the Multi-Purpose room side only) and in corridor 128 (on the Multi-Purpose room side only) as required in UFC 4-740-06, paragraph 3-5.3.2.5.

The UFC 4-740-06, paragraph 3-5.3.2.5. does not require additional exist signs at these interior doors.

Please dictate whether or not additional exist signs are required at the contractor's expense.

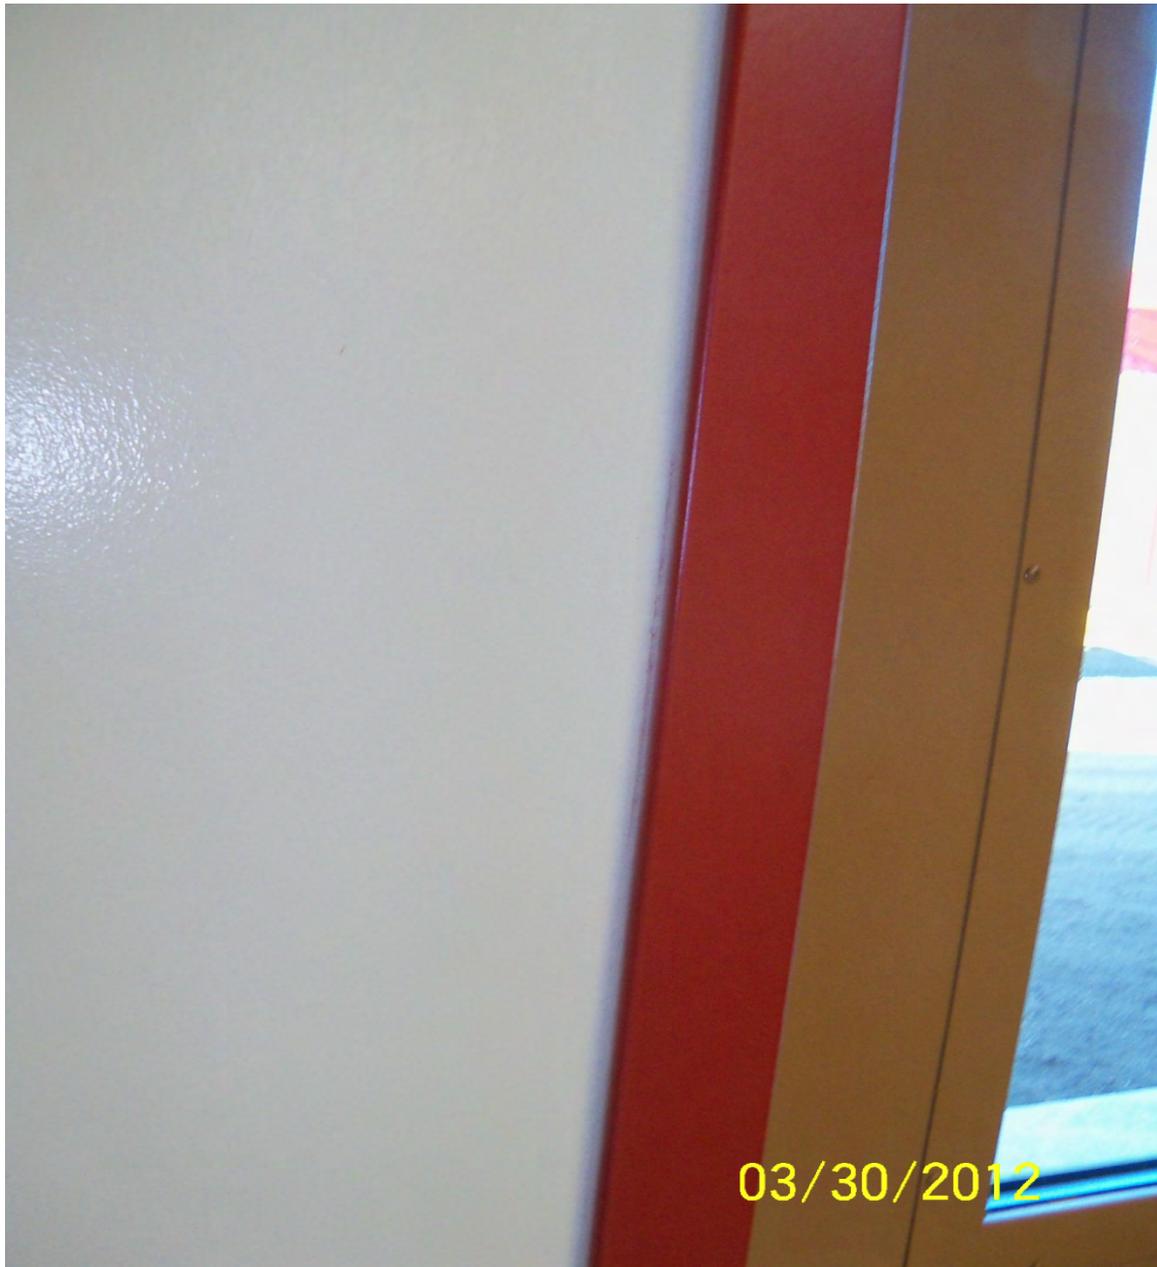
1. Reduce harborage and entry of pests inside the facility by caulking and sealing around all escutcheons, wall and floor penetrations where sinks are mounted to the wall and floor, around all types of plumbing, base board molding, expansion joints and where shelves and cabinets meet walls and door frames per Pest Management Program and Technical Guide (TG) No. 29.

The document quoted by IMCOM G9 does recommend sealing all cracks along with other measures to control insect infiltration. Is Pest Management Program and Technical Guide (TG) No. 29 a part of the contractor's contract? If so do we want the contractor to caulk every possible joint even if no crack exists?

Please dictate whether or not the contractor should caulk all possible joints at its' expense.
