**U.S. Army Corps
of Engineers**
Engineering and Support
Center, Huntsville

School Age Center

**Building 7160
Fort Stewart, GA**

**POTR – Phase 1
Project No 71177**

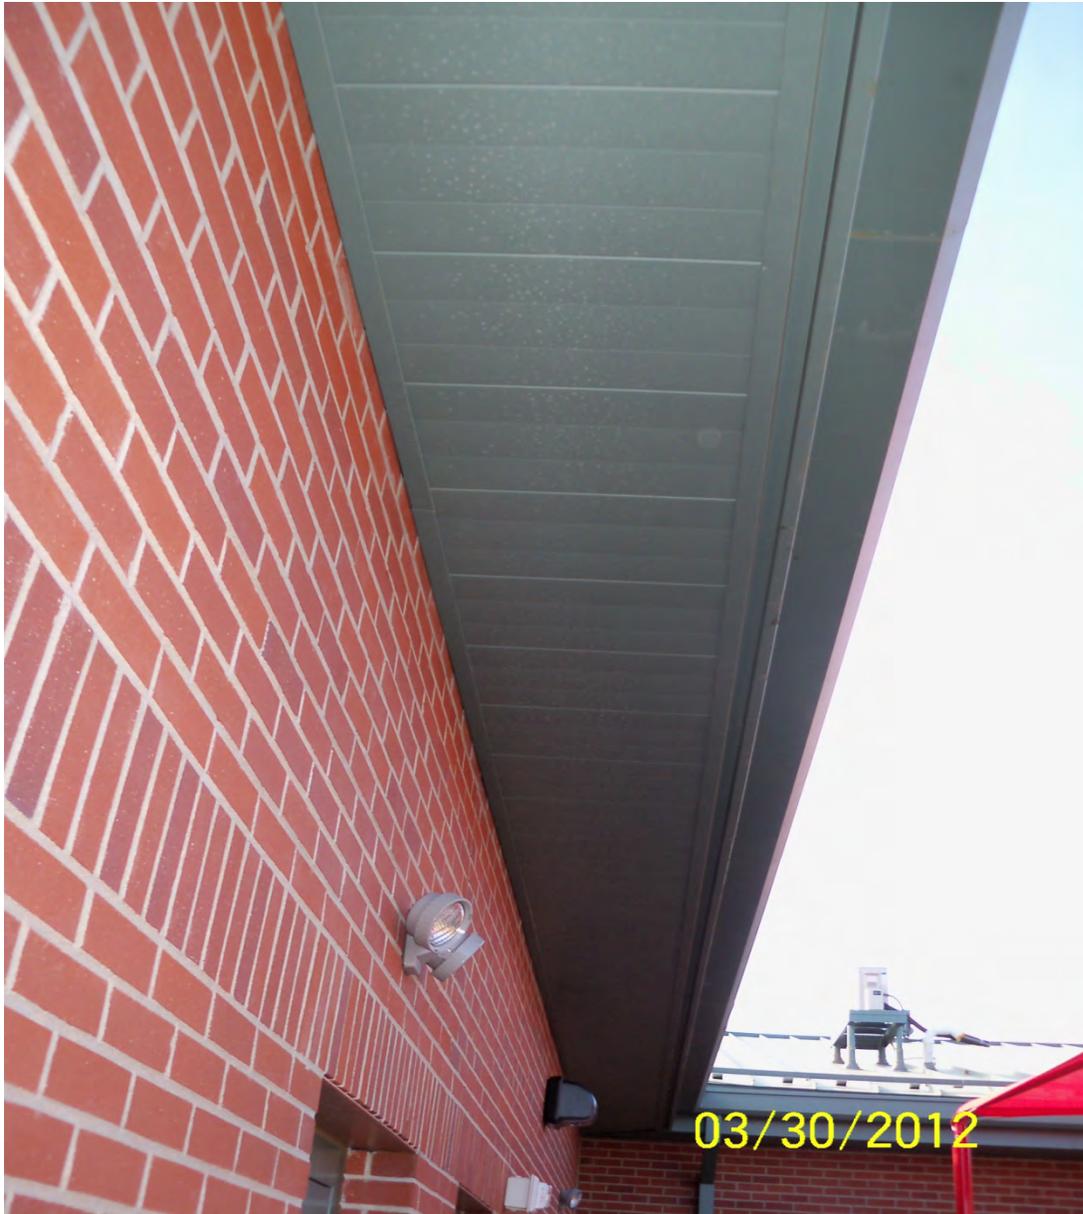
1. Seal the joint between the overhang soffit and the face brick wall. The wall details shown on sheet A-312 show no gap between the face brick and the "J" soffit closure.
2. Ensure the weep holes around the facility do not allow entry by insects.

The document quoted by IMCOM G9 does recommend sealing all cracks along with other measures to control insect infiltration. Is Pest Management Program and Technical Guide (TG) No. 29 a part of the contractor's contract? If so do we want the contractor to caulk every possible joint even if no crack exists?

Please dictate whether or not the contractor should caulk all possible joints at its' expense.

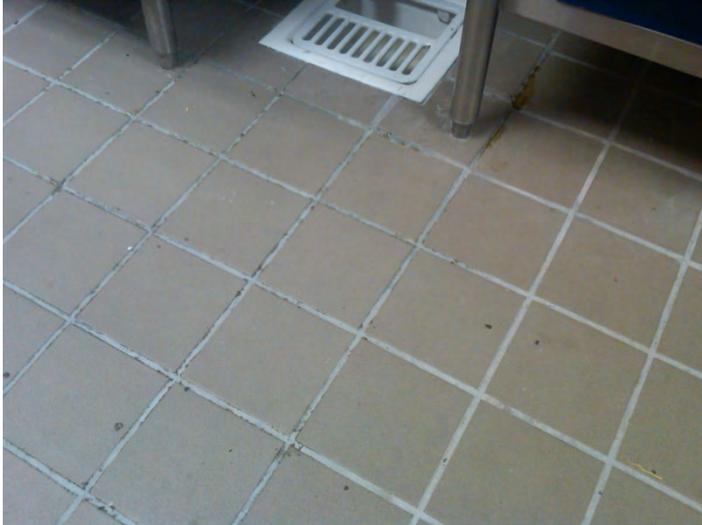
- There is some sort of substance that is oozing up through the floor. Very difficult to clean it off and don't know what's causing it.

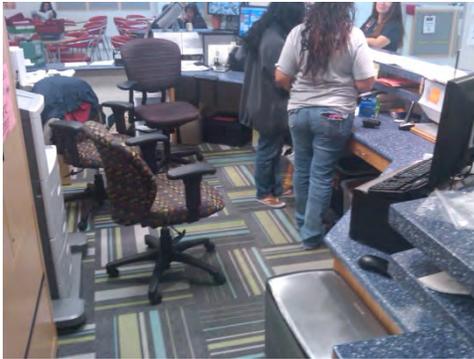
- The users love the openness and all the natural light. Everyone, including parents, love all the vision panels so you can see what is going on in each of the spaces.
- Activity rooms are well sound proofed. There is no sound transmission between the activity rooms and the atrium.
- The space at the reception counter is awful. There are no built-ins. Need more space. Need storage for files and medication. Also need some way to secure the workers' personal items. There were enough data/electrical outlets.

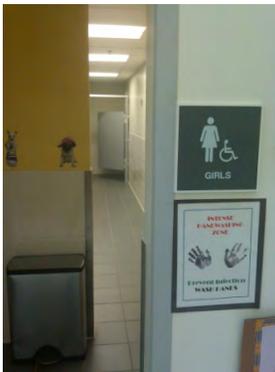
- There is a line of sight issue with all of the restrooms, and no “fix” has been implemented.

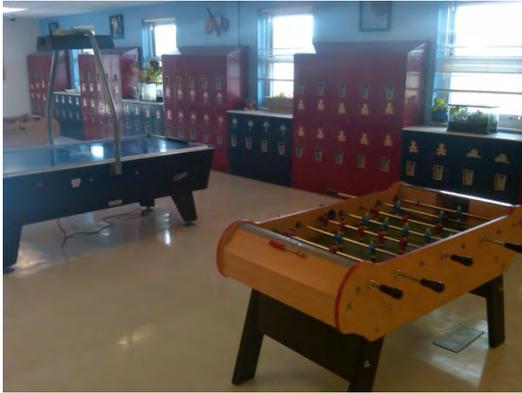
- Doors not into a fenced area are alarmed, but they have been disabled as they were a nuisance. The alarms would randomly go off. Now, even with them disabled, they are beeping. It seems the batteries are low, but we cannot figure out how to replace the batteries.
- Acoustics are an issue at the reception desk. They moved the game area to the side atrium, and that has helped since that area is a smaller volume and has better acoustics.

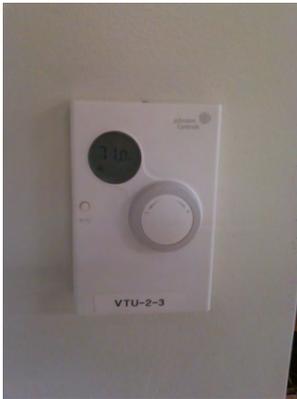
- The sink in the Arts and Crafts room is great!
- Thermostats appear to be set at 71 degrees, and the users have an adjustment of +/- 1 degree.

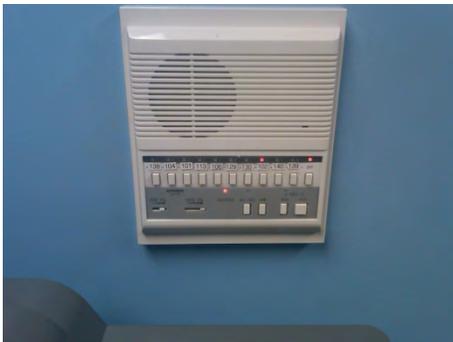
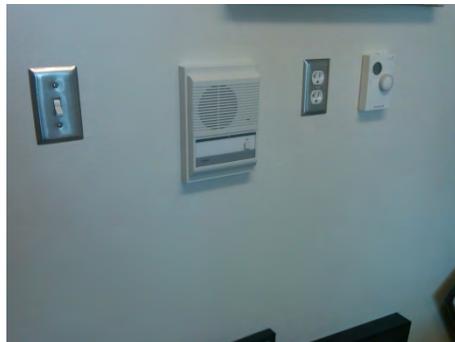
- There is no duress alarm in this facility.
- The intercom system is wall mounted, but they do not know how it works. There is no intercom or PA in the atriums.

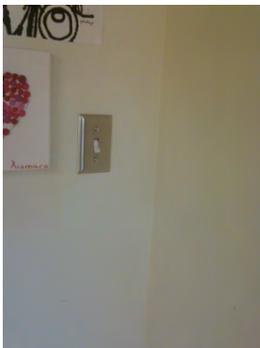
- There is no 3-way lighting in the activity rooms. In addition, there is only one switch which changes the lighting level from dim to full. They can turn off all the lights from the front desk. They can also program a timer at the front desk to turn the lights off automatically.

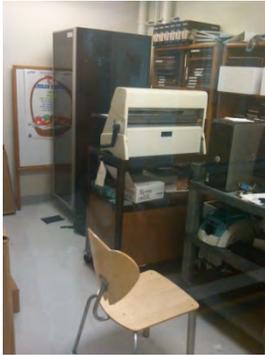
- The video room is so large that they have added an office to the front of the room.

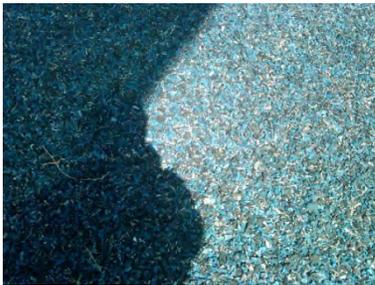
- Playgrounds include soccer field, paved area, shade structure and play element. However, these are open for use by the community as a whole, and ultimately they get damaged. In addition, shredded rubber mulch was used as a safety zone, which is a maintenance headache. It moves around, and children like to throw it.

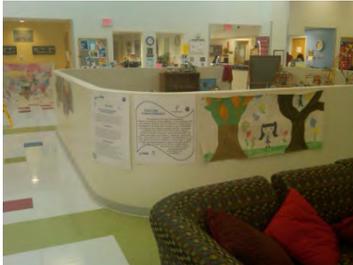
- Walls around the waiting area are too tall and block the view of what is happening in this space from the desk. Had to convert the area to a “Lego” area, and have a staff member present when in use.
