**U.S. Army Corps  
of Engineers**  
Engineering and Support  
Center, Huntsville

## **Replica SAC**

**Building 5037  
Fort Bliss, TX**

**POTR – Phase 1  
Project No 74516**

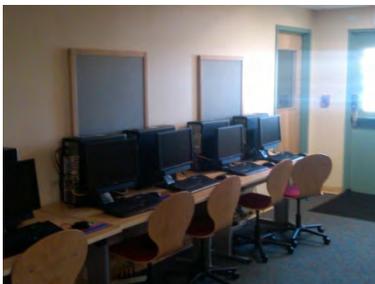
- They have a door connecting the Computer Lab with the Homework Room. They stated this is a good idea.

Replace the existing lock set on the door between the Computer Lab and Homework Center with a passage latch.

Replace the door stop on the floor behind the door between the Computer Lab and Homework Center with a door limiter to allow the door to open without hitting the window.

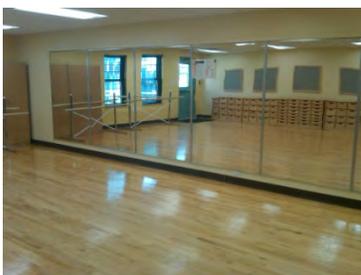
- Doors that do not lead into fenced areas are alarmed.
- The laundry room has quarry tile floor and gyp. bd. ceiling.
- The fine arts room has a wood floor system.

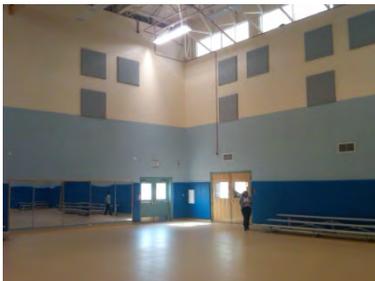
- The Multi-Purpose Room has a poured in place athletic flooring, exposed structure, and a few acoustical panels on the walls.

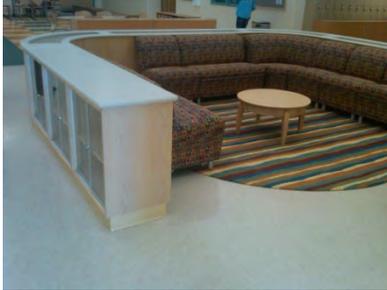
- The waiting area is surrounded by low walls with planters and display case. This works much better than the taller half-walls at some SAC.

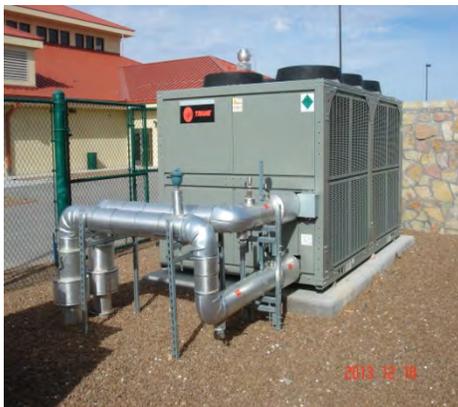
- HVAC system consists of an air-cooled chiller, a gas-fired boiler, two built-up air handling units serving variable air volume terminal boxes and one constant volume air handling unit. Two communications rooms are served by split system direct expansion air-conditioning units.
- The mechanical equipment room is adequately sized to provide required maintenance access clearances to the equipment. All equipment was operational and appeared to be running properly.
- The air-cooled cooling equipment is located in an equipment enclosure located approximately 50 feet from the building.

- Direct expansion refrigeration equipment such as the air-cooled condensing units located approximately 50 feet from the building should always be installed next to the building as close as possible to the indoor unit they serve. Refrigerant lines should not be run below grade or for long distances because it can reduce the service life of the equipment significantly and reduce the energy efficiency. This should be coordinated by the designer with ATFP requirements and playground location.

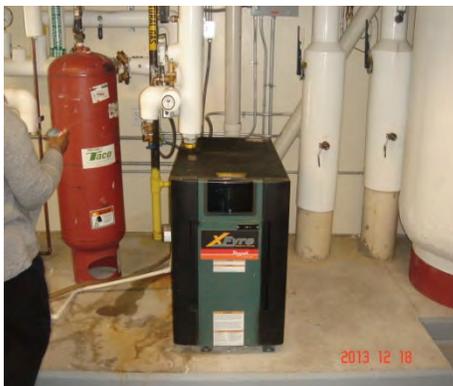
- The facility is provided a high efficiency condensing boiler for building heating. A variable speed heating hot water pumping system is also provided to reduce pumping energy.

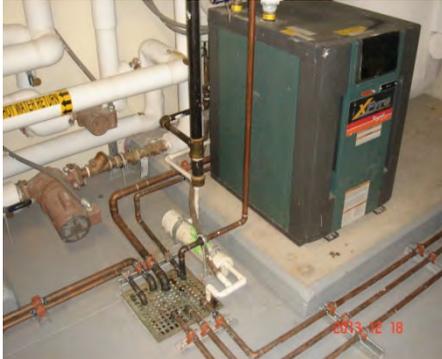
- Domestic hot water is provided by a high efficiency gas-fired condensing water heater.

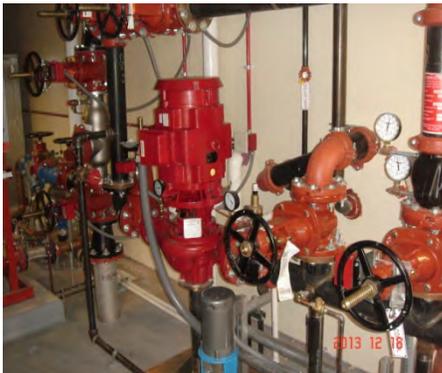
- The building is protected by a wet pipe sprinkler system using a 500 GPM fire pump. No fire protection issues were identified by the user.

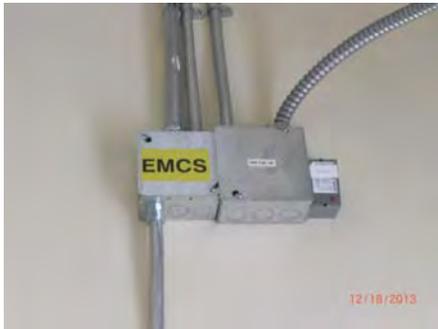
- They provided the same type of indirect/direct light fixture in the Computer Lab as in the rest of the facility. This is a better choice than the parabolic lenses provided in the Computer Labs in most SAC.
- The metering logs of the facility (peak demand, monthly usage) are not recorded. This is a small building compared to the other facilities on the installation. The energy usage is minimal compared to other buildings, therefore it is not tracked.
- The equipment is tied into an Energy Management Control System (EMCS).

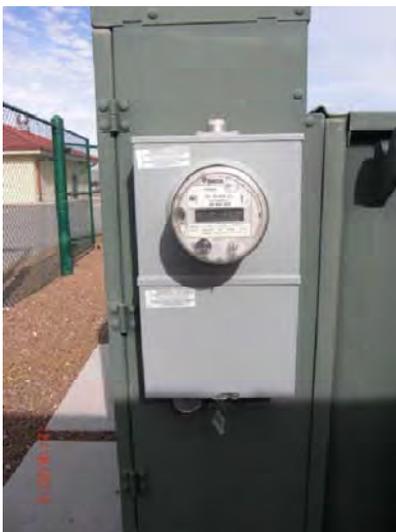
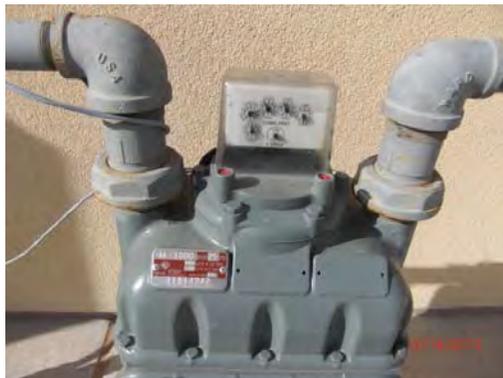
- There is a Service Entrance Panel metering at the site

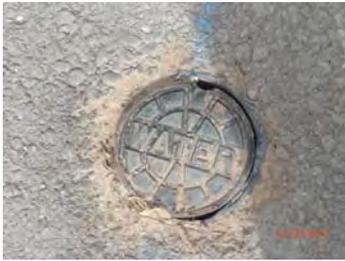
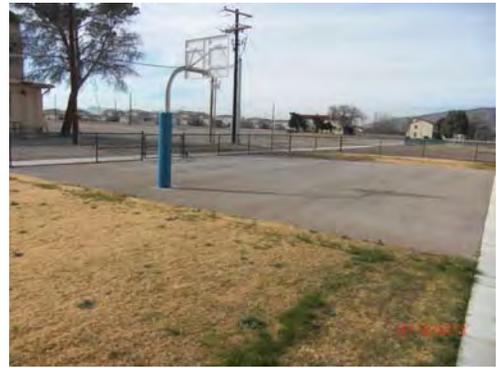
- There is a water cover plate and Cathodic Protection Test well in the basketball court.

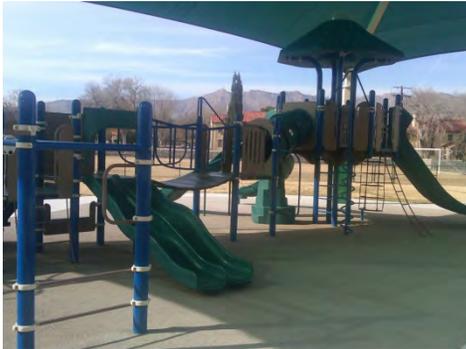
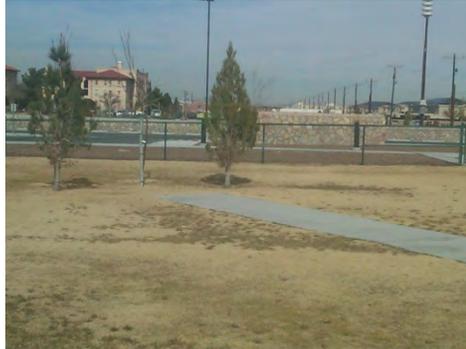
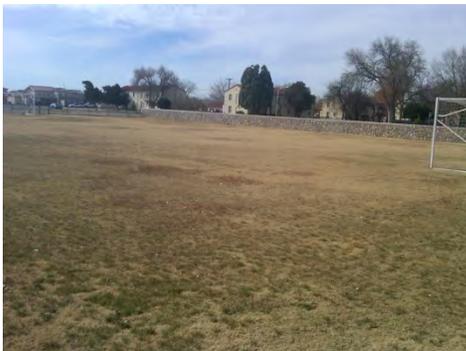
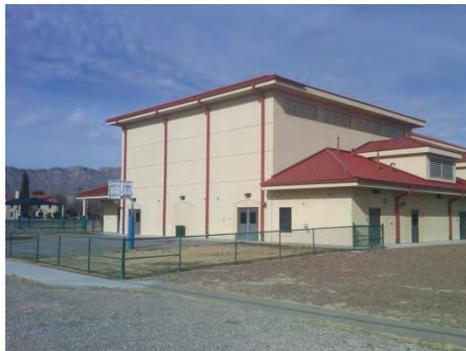
- Playgrounds include a soccer field of natural turf, a paved area, shade structure, a play element, and swings.
