## **TRAINING SUPPORT CENTER**

**Building 77680  
Fort Riley, KS**

**POTR – Phase 1  
Project No 19389**

**DATE: 20 March 2012**

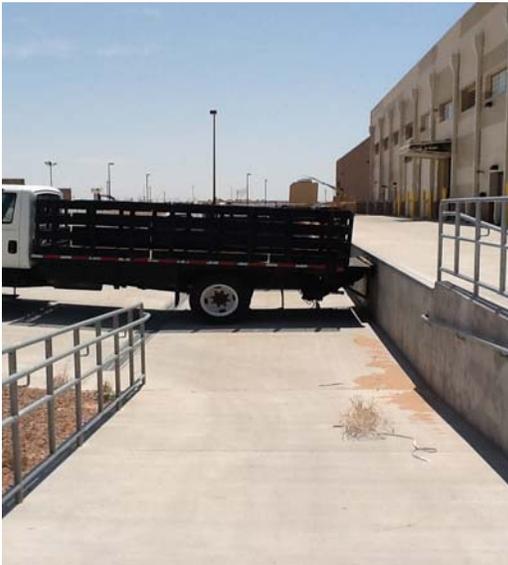
- The height of the loading dock is too high and dock does not include a dock leveler.

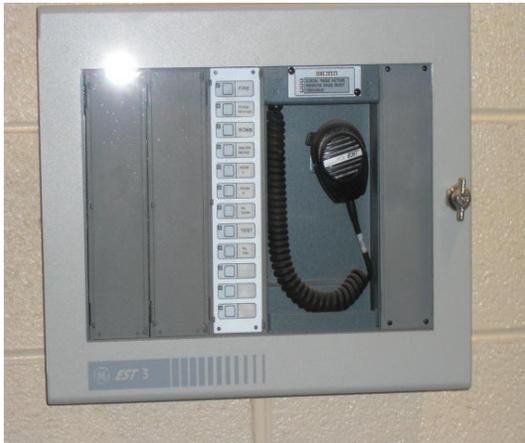
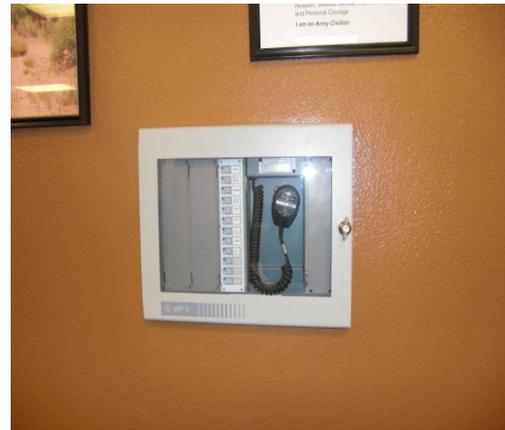
- The mass notification system serves as the building-wide zoned public address system. A remote microphone station/control is located in Room 106. No remote microphone station/control in room106. Remote microphone station/control is in the warehouse.

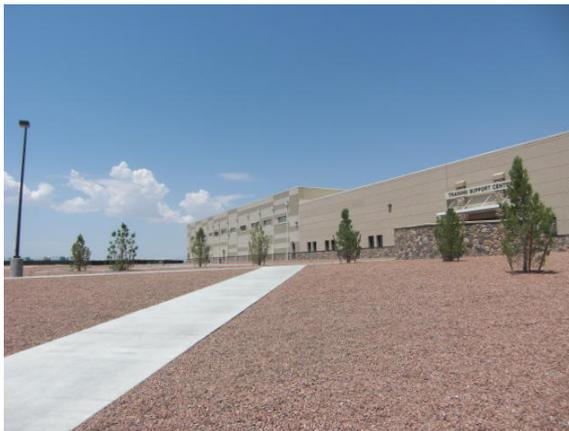
- Main entrance sidewalk did not go directly to the parking lot. Original design had the sidewalk going to the drop off circle then proceeding back to the parking area. Installation has added an extension off the existing sidewalk to go directly to the parking area.

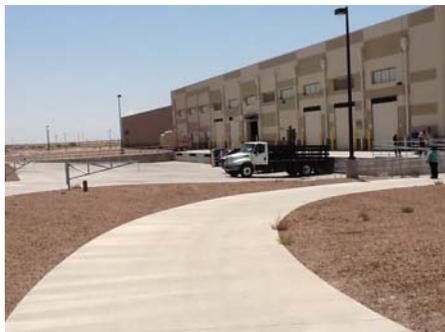
- Loading dock entrance was set up with two entrances with swing arms. Nothing was placed in between the two swing arm entrances to keep anyone out.

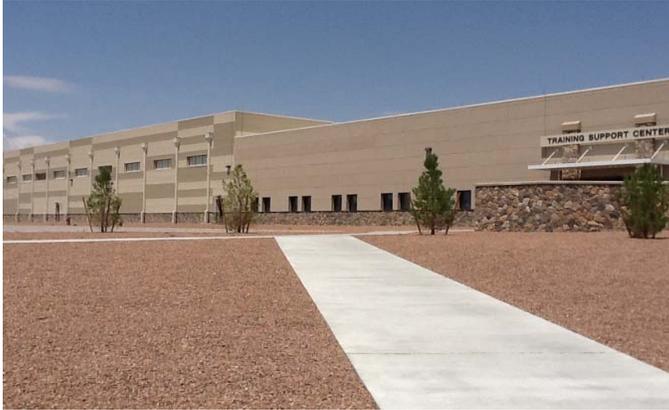
2. Document satisfaction with traffic and pedestrian flow. A sidewalk was added to the front of the building.

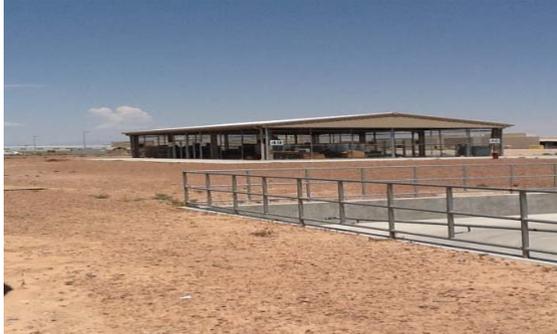
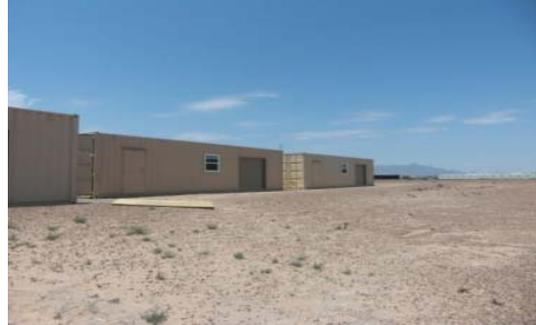
Document Hazardous Material Storage Area: A separate facility will be required for this storage area.

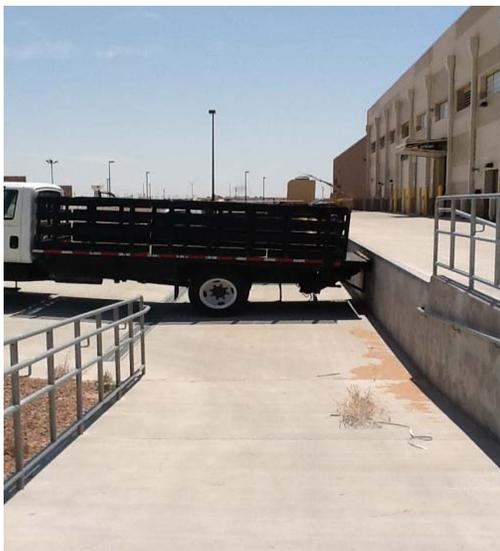
Document any structural related problems/concerns. The loading Dock is too high for 18 wheelers trucks to unload. The loading dock needs an adjustable ramp.

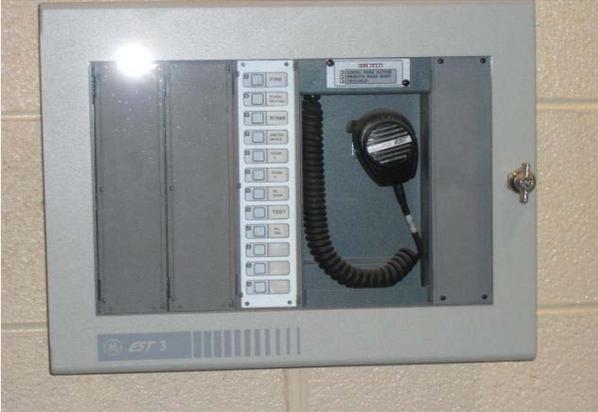
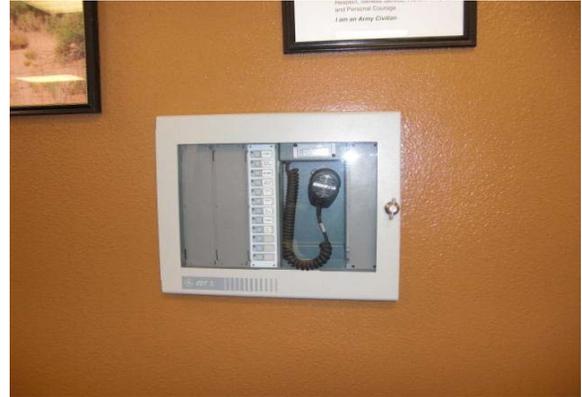
The mass notification system serves as the building-wide zoned public address system. A remote microphone station/control is located in Room 106. No remote microphone station/control in room 106. Remote microphone station/control is in the warehouse.

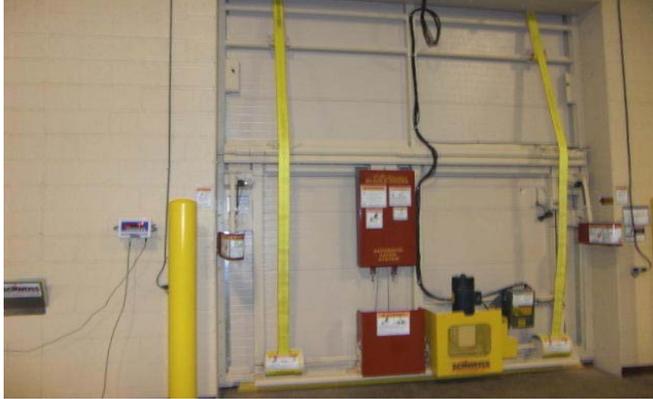
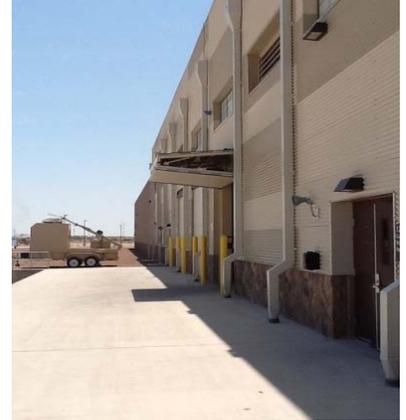
The roll up door is not connected to the electrical switch. These doors fold up instead of rolling up.

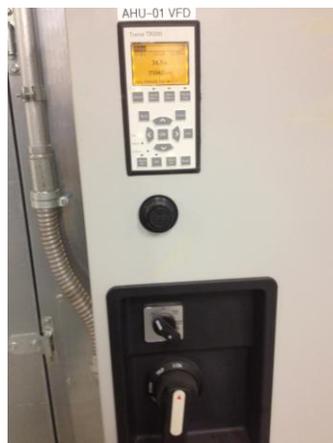
- The main air handler is AHU-1, which has a VFD fan, and it ties into the VAV boxes to supply air throughout the facility.

- Maintenance/service schedules of the HVAC system needs to start being properly followed. Currently the air filters are not being replaced as frequently as they should.

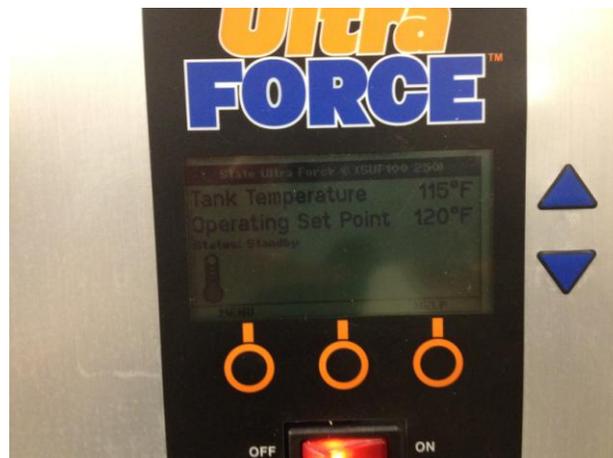
- The POC for plumbing related issues the user encounters is DPW.
- Water is not being stored at 140 degree F. It is instead being stored at 120 degree F. UFC 3-420-01 requires the storage hot water heater to store the water at a temperature of 140 degree F.

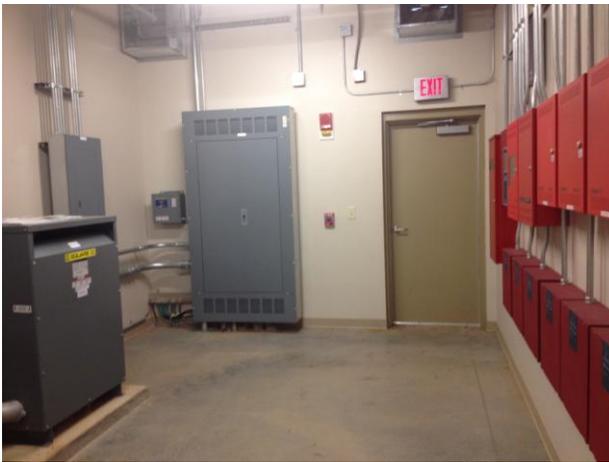
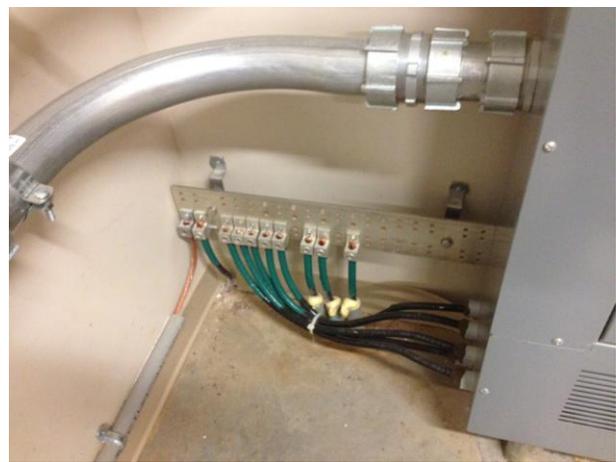
- Lighting. Occupancy sensors are on light switches. The user agreed that emergency lights have come on in the event of a power loss.
- Lightning Protection System. Installed at unknown depth.
- Wiring. Concealed and adequately labeled for finished rooms. Some exposed wiring in the mechanical/electrical room was low on exterior walls and if flooding occurred it would be vulnerable.

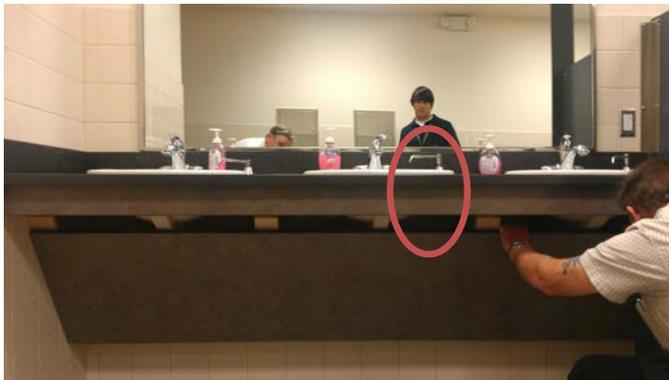
- Parking: There are not enough parking spots to fully support troops on high demand days. Currently, the facility has approximately 50 parking spots and overflow parking is located across the street in a grass field.
- Break Room: N/A
- Restrooms: There are an adequate amount of restrooms available throughout the facility. They did note that the hand soap dispensers underneath the sinks were inaccessible due to covering.
