**U.S. Army Corps  
of Engineers**  
Engineering and Support  
Center, Huntsville

## **Fire Station #5**

**Building 2620  
Fort Riley, KS**

**POTR – Phase 2  
Project No 54914**

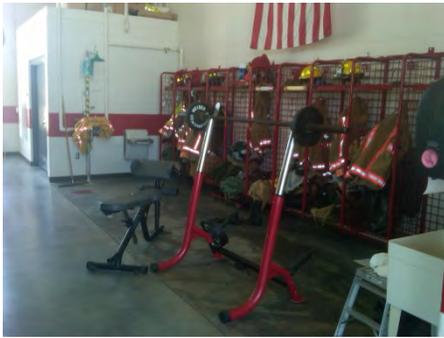
- There is not enough storage space for the inventory of items stored. They have a shed outside for additional storage.
- This facility does not have a fitness room. What had originally been designated as the fitness room is the small inner room that was opened up to create the Chief's Office. The space as originally designed was too small and was not practical for the function.

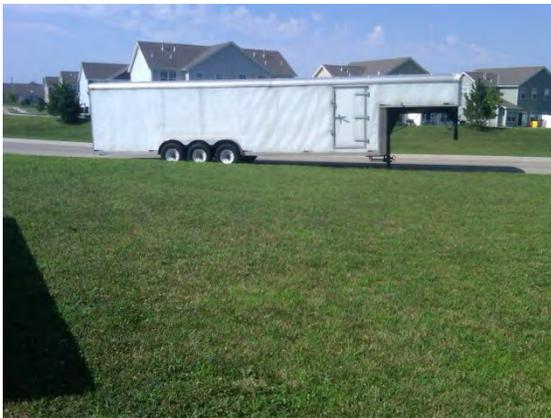
- They need a place for the HAZMAT trailer. Would be nice to have like an extended parking space with a decorative fence. Also could use some protection for their pickup truck.

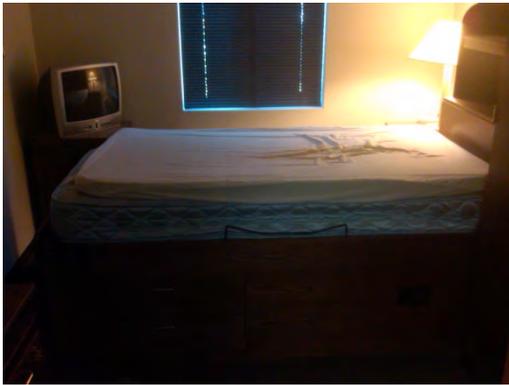
- They have had problem with the kitchen settling and the doors not closing properly.
- They really like the kitchen design, and say it is perfect for a one-company facility.
- Need to provide commercial appliances, to include the dishwasher. They are constantly replacing the dishwasher.
- Ft. Riley has a central dispatch for all EMS, which is run by the police.
- They have had some issues with the VCT flooring. Some tiles have been damaged and have had to be replaced.
- Dorm rooms are too small. Power/data outlets should be on each wall. The street lights shines through the windows. Provide shades or blinds for windows that keep out light.

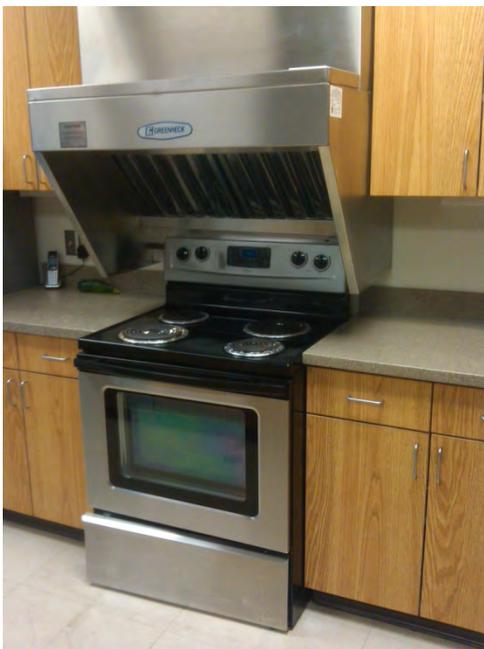
- The solid surfacing counter is OK. Granite is not allowed due to sanitation. One L section of the solid surfacing had to be replaced because it cracked.
- The users like the open dayroom/kitchen/dining concept. Training is done in the larger office in the facility.
- The type of range hood provided does not contain a light (which is desired), and also keeps the range from going all the way back to the wall which is resulting in the range being damaged.

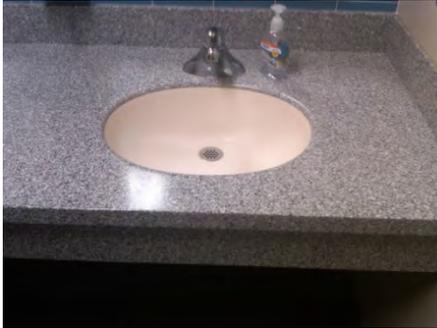
- They would like a cascade system to fill air bottles. This may be something to be considered for the standard.
- They like the undermount sinks in the restrooms.

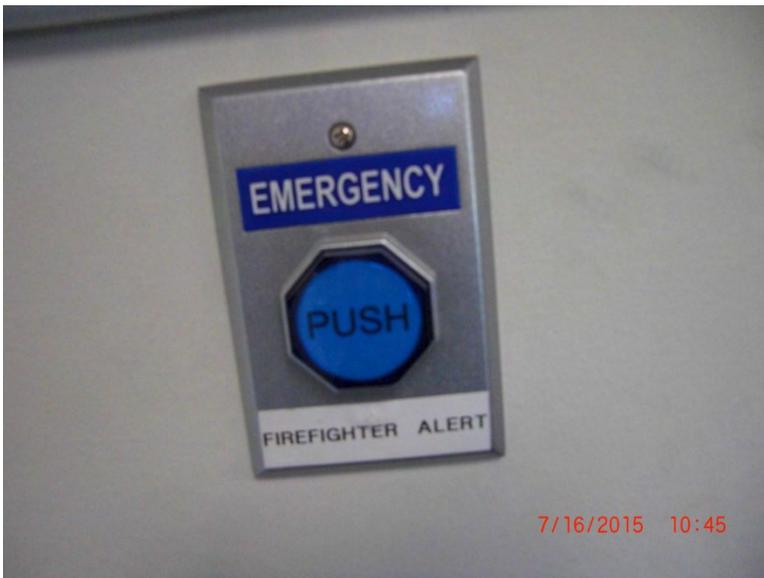
- The Firefighter Alert System controls audible alert in the Dorm Rooms. There is no dedicated alert lighting in the dorm rooms.
